The Northern California Pipe User's Group
25th Annual Sharing Technologies Seminar

Berkeley, CA
February 23, 2017

FORCE MAIN CIPP CHALLENGES

Jonathan Tristao¹, Thomas Grau², and Donald Chang³

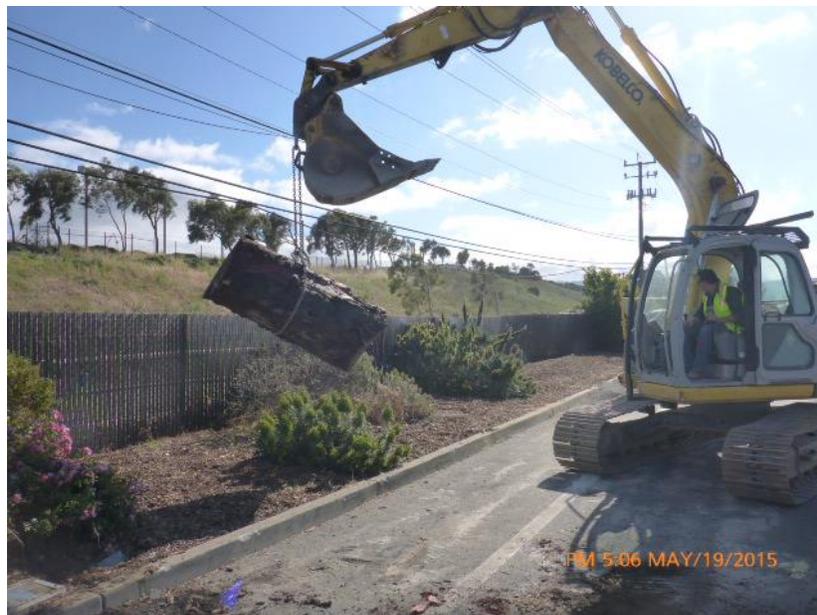
As previously mentioned, the project area was once part of the Bay and had been filled in to allow for development. Additionally, a portion of the land adjacent to the project site was previously a landfill, which was later capped and converted to the Burlingame Golf Center. Due to this history, several issues were encountered during construction excavation. There were five separate instances of manmade buried debris found in the nine excavations required for project construction. Four of the five objects were buried concrete, and the fifth object was a three-by-six-foot tree stump. These unforeseen conditions led to some minor delays and extra costs. In one of the excavations adjacent to the Burlingame Golf Center, when the excavator operator dislodged the buried tree stump, a surge of water came rushing up from beneath the ground. It was unclear where the water was coming from, but it did not appear to be coming from the Bay. The water was tested and determined to be groundwater. The contractor mobilized bypass pumping setup to dewater the excavated pit and facilitate installation of the force main manhole at that location. The groundwater was pumped into a settling tank and then to the City wastewater treatment plant approximately 800 feet away. It was later theorized that the source of the groundwater was runoff from the clay cap installed over the landfill directly west of Airport Boulevard, which had then percolated into the ground and built up at the toe of the landfill slope.

Figure 4. Tree stump encountered during excavation.

Any time work is being performed underground there is the potential for unknowns to arise. In this case, the fact that the project site was predominantly situated in a fill area and adjacent to a closed landfill increased the likelihood for encountering unanticipated debris. The fast-track nature of the design schedule reduced the feasibility of performing extensive potholing. Although no amount of potholing or soil boring can eliminate all unknowns, this project illustrates some of the benefits of a comprehensive pre-construction subsurface investigation. Also, a general understanding of the history of the project area is recommended to enable the design team as well as the contractor to anticipate some of the types of issues that may arise and be prepared to adjust if they do. For example, during construction an old record drawing of the project area was found; it included the name of a former area cement company on one of the land parcels. Had the map been discovered during the design phase, the project team could have anticipated the possibility of encountering buried concrete debris, and the contractor could have arranged to have pneumatic breaker attachments on-site to speed up the process of concrete removal.

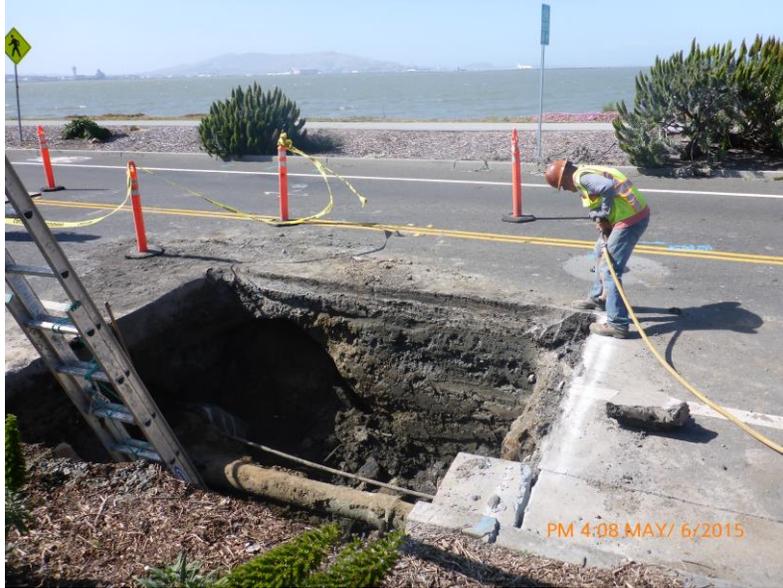
Whenever a project involves excavations and work on a sanitary sewage force main in such close proximity to an environmentally sensitive area, precautions are required. For this project, approximately 3,000 feet of 10-inch self-restrained, spline joint pipe was installed as the backbone of the bypass system. The contractor elected to use this pipe due to their familiarity with it and the ease of assembling and dismantling the pipe. Additionally, they were able to rent and return the pipe and fittings to their supplier rather than having to store and find use for the pipe afterward, such as with fused HDPE. The majority of the bypass piping was installed within 50 to 100 yards of the Bay and several of the excavations took place no more than 20 yards away. All storm drain catch basins in the area drain directly to the Bay. This proximity to an environmentally sensitive area provides very little recovery time in the event of an accident or spill. Therefore, the contractor was required to implement special precautions in addition to the typical stormwater best management practices.

Figure 5. Excavation near the San Francisco Bay.

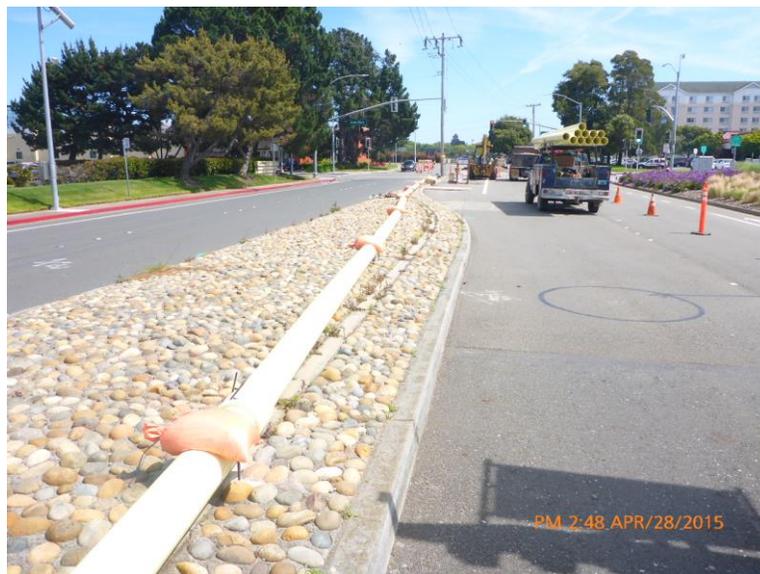
All the rubber gaskets on the bypass pipe couplings were replaced with new ones for the project, and the contractor performed a hydrostatic pressure test on the bypass system to check for leaks prior to diverting the sewage flow from the permanent force main into the bypass piping system. When the rehabilitation work was complete, the bypass line was flushed with chlorinated water and then potable water to remove solids and disinfect the pipeline. The contractor used a vacuum trailer and plastic tubs to dewater the bypass lines and contain leakage during the dismantling process.

Figure 6. Temporary bypass pipe in Airport Boulevard median.

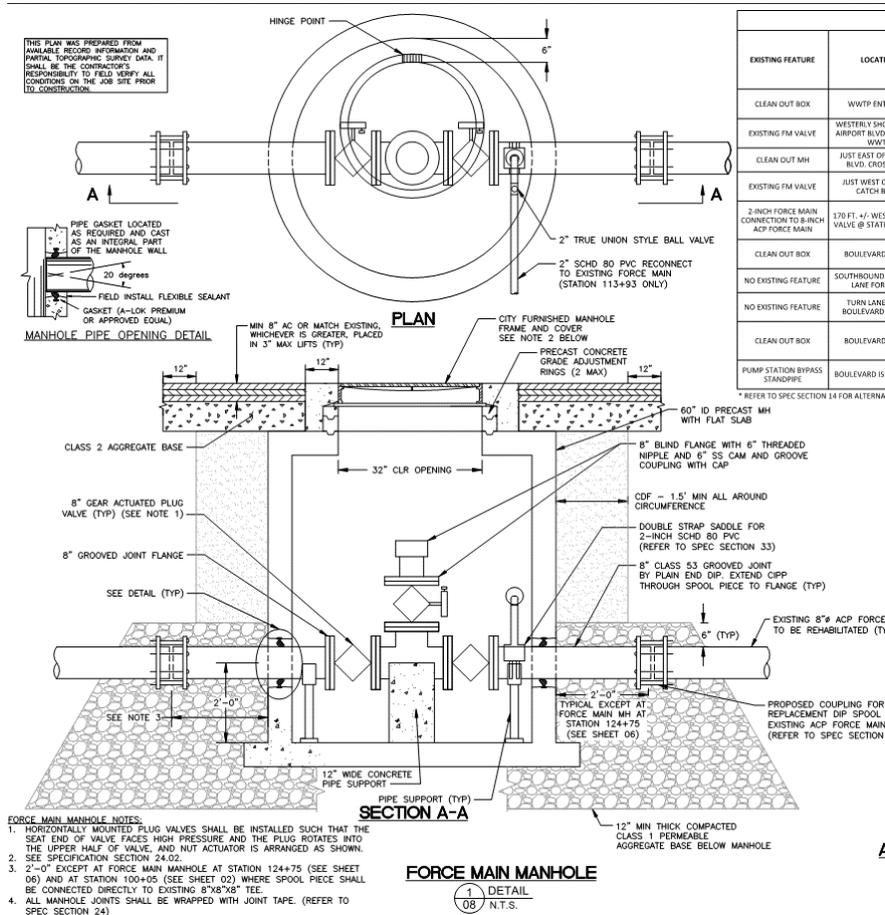
Figure 7. Force main manhole detail

As noted earlier, Mott MacDonald designed four 60-inch-diameter manholes along the force main alignment. These manholes contain an 8-inch x 8-inch x 8-inch tee with three 8-inch plug valves attached. The branch ends of the tees were faced upward toward the ground surface. A blind flange with a

threaded nipple was installed on the top using a 6-inch stainless steel cam and groove coupling and cap to seal it off. The design enables City maintenance crews to isolate any side of the tee and connect hoses and pumps to bypass a section of the force main for repairs. The City's preferred structure was a 60-inch precast manhole and a 32-inch hinged manhole cover.

As previously mentioned, the force main manholes included plug valve assemblies to allow for bypass pumping of segments of the force main. Force mains are typically shallow and in order to fit all the equipment into a 60-inch precast manhole, the tolerances and clearances in those manholes were very tight. In hindsight, a larger precast structure would have allowed for more space to bolt up and install the plug valve assemblies. Also, at the shallowest manhole, fitting the plug valve operating nuts below the manhole opening at the ground surface was difficult. One alternative to address this would be to install a larger structure below ground, space out the two valves installed along the force main axis and place a conventional small valve box above them. A standard 24-inch manhole cover would then be installed over the upward-facing center valve equipped with quick-connect cam-lock coupling for attachment of the DPW's bypass hosing. This would enable the operation of all three valve nuts from the road surface with a valve key through either the manhole cover or the valve covers, as well as man-entry through the manhole cover when necessary. A second option would be to install a larger manhole cover, such as a 48-inch, with a 24-inch concentric inner lid. This would allow easy access through the smaller cover and full access through the larger cover when necessary. The disadvantage to this approach is that all valve actuators would not be operable from the surface.

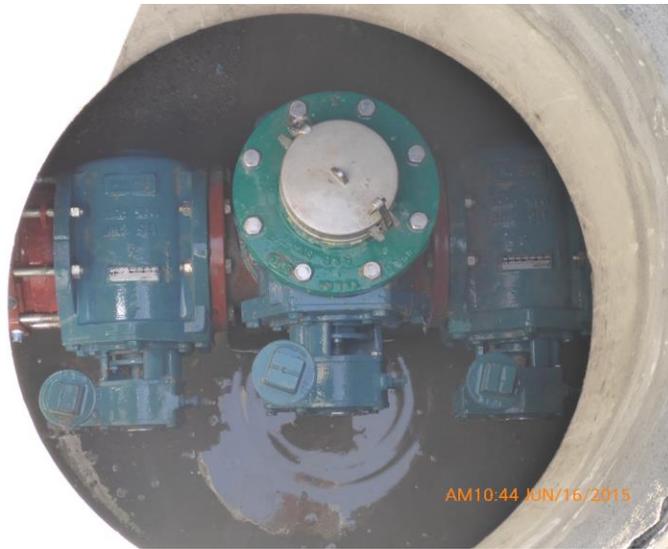
During construction, the contractor experienced some difficulty fitting the equipment into the manholes. Rather than using flange-to-flange connections, the contractor proposed the use of restrained flange adapters to provide greater clearance for fitting equipment in the field. Additionally, for the shallower manholes especially, it was difficult to fit all three of the valve operating nuts below the manhole cover to allow operation from the ground surface above. Some modifications to the shallowest manhole were made in the field. Upon project completion, all plug valves in all four manholes were operable from the surface.

Figure 8. Completed plug valve assembly inside one of the force main manholes.

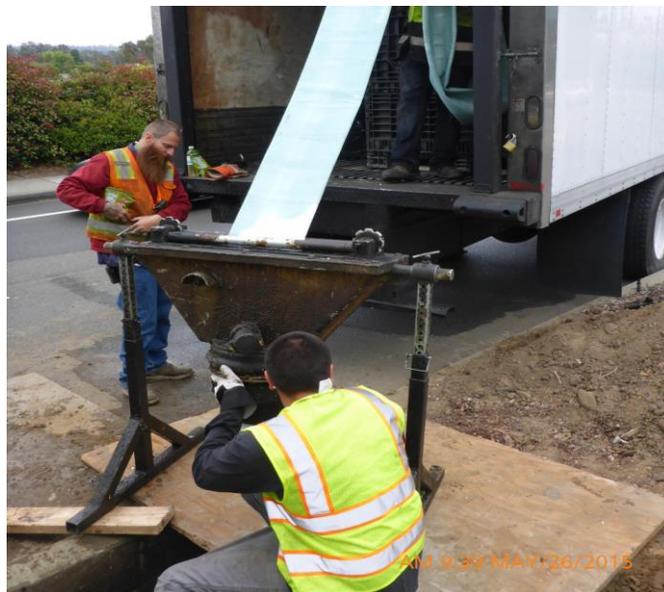
The installation of the CIPP liner was arguably the most critical operation of this project. During the installation of the liner, several complications arose. The lining contractor kept the sections of liner runs to a maximum of 400 feet to minimize issues during the liner inversion process. Due to the fiberglass reinforcement, the liner was thicker than a typical felt liner used for gravity sewer line rehabilitation, which led to difficulty during inversion. The contractor primarily used pressurized air to invert the liner but periodically used water as well when the liner became stuck. However, in one instance the air pressure got too high and an unrestrained section of the liner standpipe split open. The installation crew had to manually pull the liner back out of the host pipe, refold it, cut out the ruptured section, and start the installation process over. After installation was complete, post-construction CCTV video showed some minor damage and blistering to the polyurethane layer on the interior of the liner as well as some circumferential wrinkling of the liner. These issues will be discussed further in the “Lessons Learned” section of this paper. Ultimately, it was determined no repairs needed to be made to the liner. The force main was placed back into service and no issues have been reported to date.

Figure 9. Installation of cured-in-place-pipe (CIPP) liner on Airport Blvd.

Post-construction CCTV video of the CIPP liner showed several instances of circumferential wrinkling of the liner and scuffs on the polyurethane coating. The scuffs to the interior coating are believed to have occurred when the crew had to pull out and reinstall the liner section where the blowout occurred. The contractor's liner supplier provided the City and Mott MacDonald with a written explanation stating the polyurethane coating's primary purpose was to contain the resin during transportation, installation and curing and was not a key structural element. No remedial action was taken regarding the scuffs. The circumferential wrinkles were of more concern as they appeared to be greater than the five percent of the cross-sectional diameter of the host pipe allowed per the project specifications. It was agreed that the lining contractor would provide an additional maintenance bond for a period of six months, after which they would return to the site and perform a CCTV re-examination of the liner. If no issues were reported with the pipe and the CCTV inspection showed no excessive accumulation of solids or grease at the wrinkles, the City would release the bond. Is it suspected that the issues during liner inversion caused the wrinkle formation.
