The Northern California Pipe User's Group  
22nd Annual Sharing Technologies Seminar

## KEEP IT FLOWING – BYPASS STATION INSTALLATION ON A 35-YEAR OLD FORCE MAIN

Jeff Fidelin, Jessica Adams, Timothy Monahan, Tanya Yurovsky<sup>1</sup>, and Anthony Pullin<sup>2</sup>

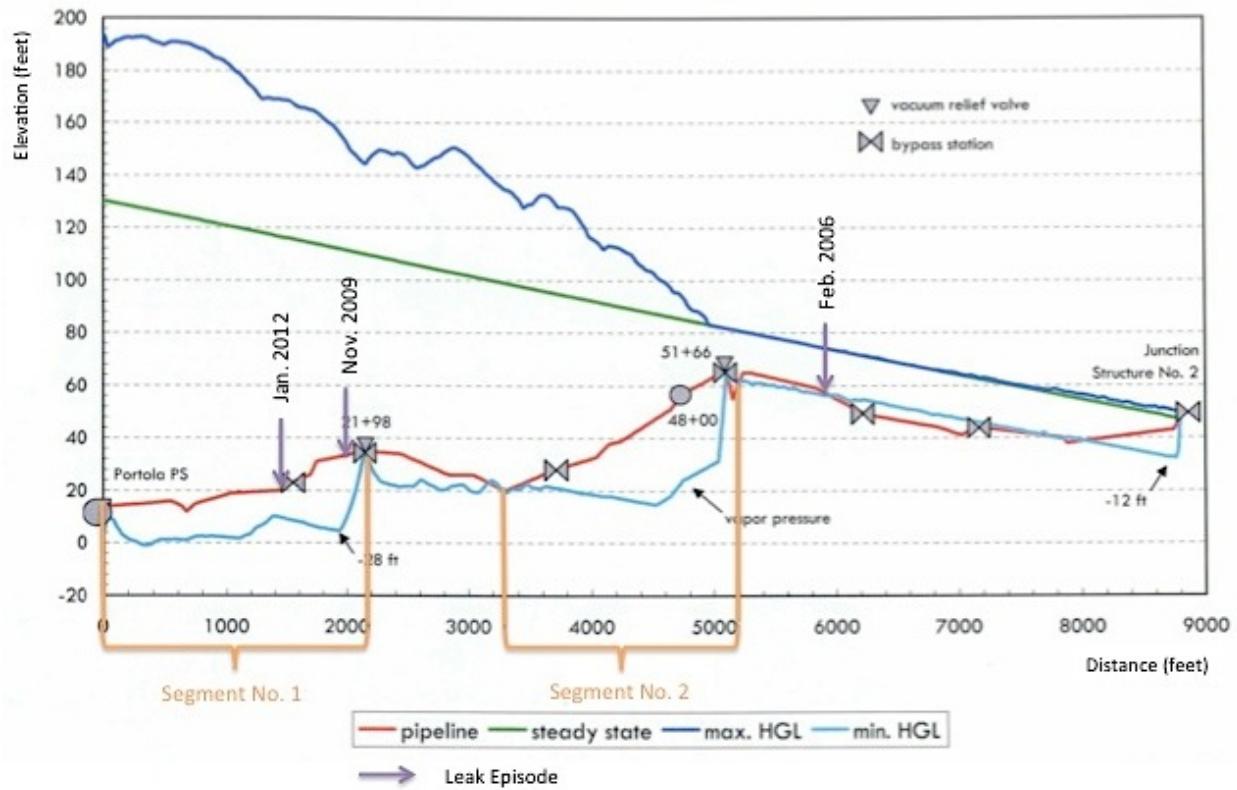
**Figure 1: Granada FM Profile, HGL Elevations Envelope, and Recent Leak Sites**

Staff records listed three recent leak episodes for the Granada FM: February 2006, November 2009, and January 2012. The leak sites are shown on Figure 1 (located on next page). Two of the three leaks (2009 and 2012) occurred immediately downstream of the Portola Pump Station. The origins of the 2006 and 2012 leaks were not investigated. The 2009 leak study performed by Winzler & Kelly identified corrosion triggered by sediment impingement as the probable cause of the quarter-sized hole found on the pipe invert. SRT later determined that the minimum scouring velocity of 2 to 3 feet per second is only achieved during high flows caused by heavy rainstorms.

SRT also determined that surge protection within the FM was insufficient. Flow Science was retained to perform a surge pressure analysis of the FM. Figure 1 (located on next page) shows the FM profile and the hydraulic grade line (HGL) elevations. Flow Science determined that two FM segments can experience high vacuum pressures following loss of power at Portola Pump Station:

1. Segment No. 1 – From Portola Pump Station (STA 0+00) to the first high elevation point (STA 22+00).
2. Segment No. 2 – The rising portion of FM to the highest elevation point from STA 33+00 to STA 52+00.

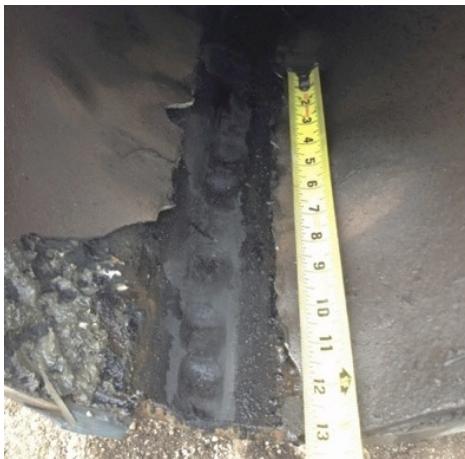
The eight shutdowns required to install the bypass stations were performed successfully without any sewage spills. These shutdowns and associated FM drainages also presented a unique opportunity to inspect the pipe interior for the first time in 35 years. Such inspection was carried out using CCTV and revealed significant corrosion damages to the pipe invert along Segment No. 2 as shown on Figure 26. The origin of these damages has not been fully investigated at this time, Cavitation is most likely the cause. The new bypass stations will be utilized when SAM elects to repair or replace these damaged sections of the FM.

Fig. 26: Invert Damage at STA 51+50

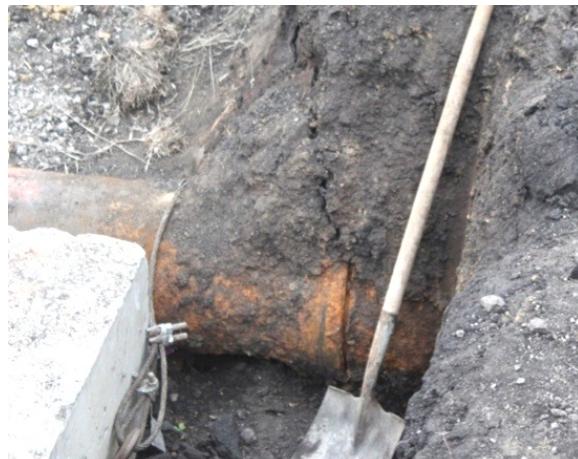
Fig. 27: FM Has Slid a Little
