**Silicon Valley
Mid-Summer Emergency:
Santa Clara Addresses Peak-Demand
Repair of 96-inch Pipeline**

Mike Larsen

Anna Pridmore, PhD, PE

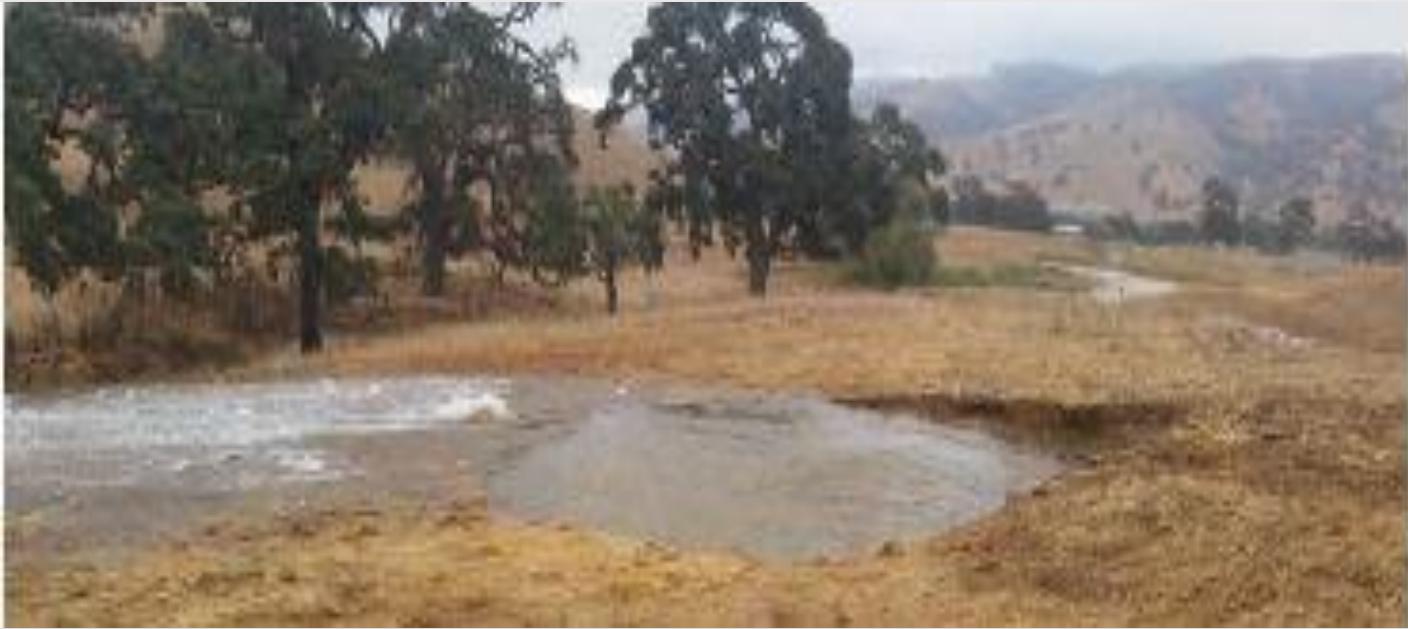
Site of ruptured pipe

- ~6:30 AM August 1, 2015
- Drastic pressure loss along Santa Clara Conduit
- Investigation determined location
- Rupture occurred during a power outage
- **20 million gallons** of water lost due to rupture

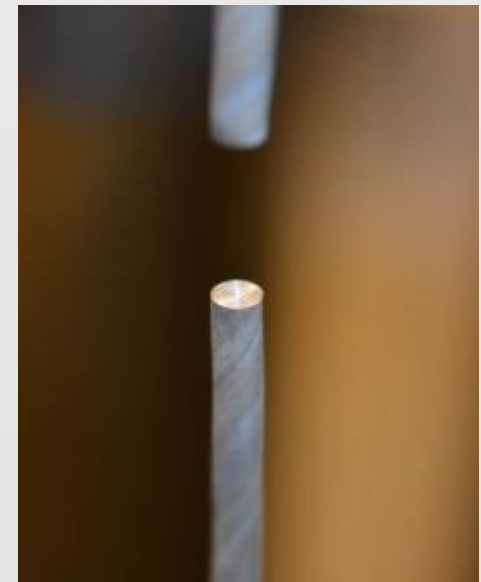
Torsion fracture surface of uncorroded wire

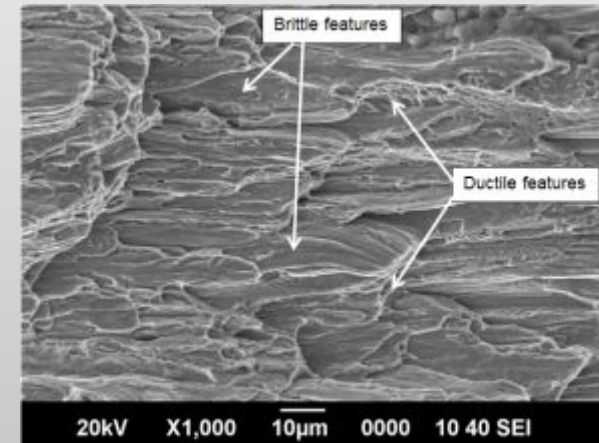
SEM micrograph of stepped fracture surface with mixed-mode (ductile and brittle) fracture

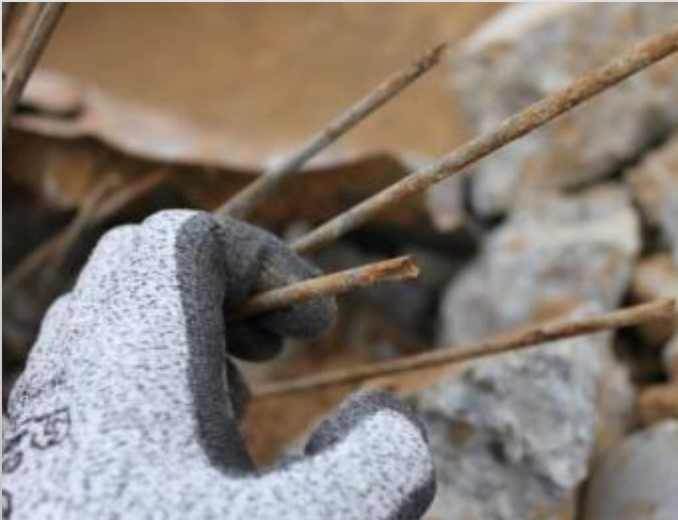
- Prestressing wire
 - All wires broken between 1 and 12 ft from the downstream joint
 - Corroded wires with brittle fracture surfaces
 - Only a few wires in the failure zone had necking indications of ductile failure.
 - Mechanical tests show prestressing wire unaffected by corrosion has good strength and ductility

Brittle wire fracture surface

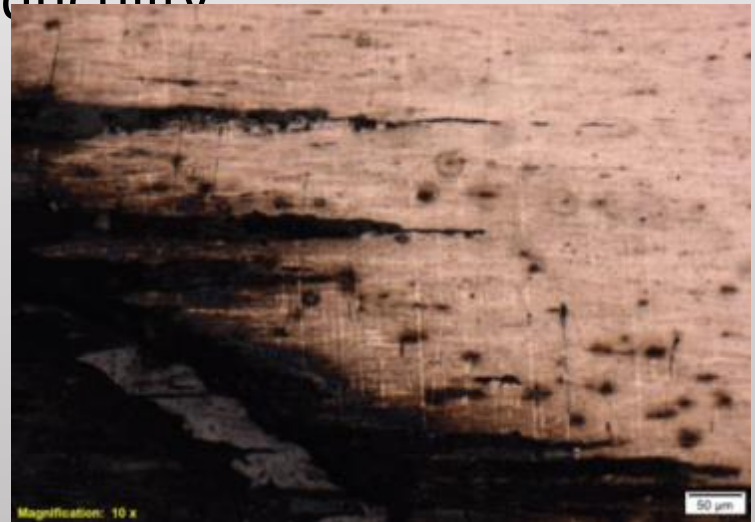
Longitudinal splits and corrosion oriented along the wire axis

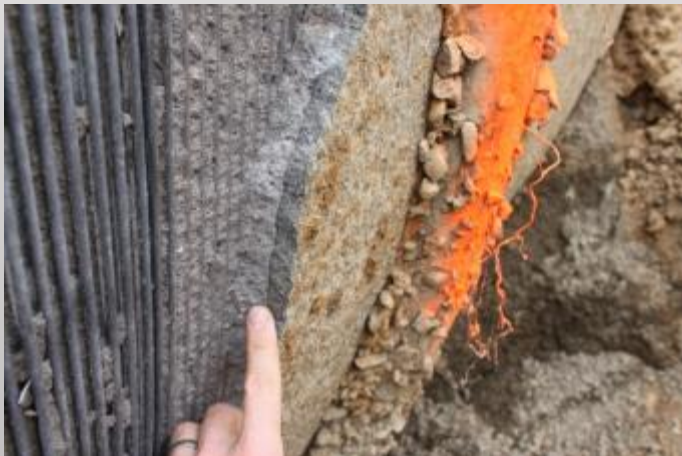
- Mortar coating
 - Corrosion staining on fractures through the thickness
 - Two distinct layers
 - inner layer lightly colored (higher w/cm ratio and/or higher void content)
 - Petrographic analysis identified high air void content and interconnected air voids in the mortar coating specimens
 - Chloride ion content low on outside and higher on inside surface

Layered mortar coating near downstream joint. Outer layer applied as a local patch.

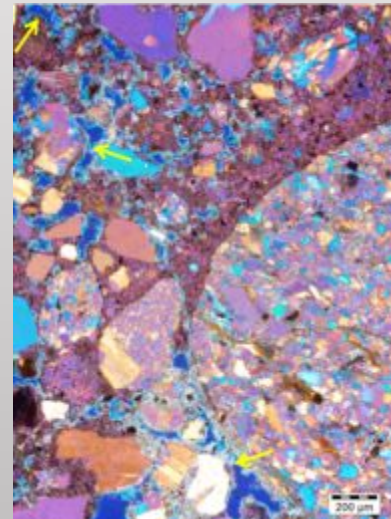
Ultrathin section of mortar with interconnected entrapped air voids (yellow arrows).

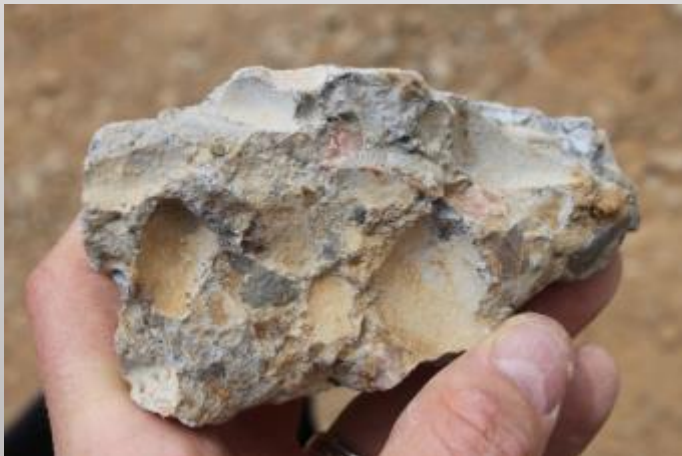
- Concrete core
 - Fracture surfaces did not show fracture through the aggregates, an indication of weak concrete.
 - Concrete core from the failure area washed away during the rupture and removed during initial pipe demolition prior to inspection.
 - Petrographic analysis identified weak bond between the aggregate and cement paste, likely due to excess bleed water (wet aggregate).

Aggregate pullout in concrete core

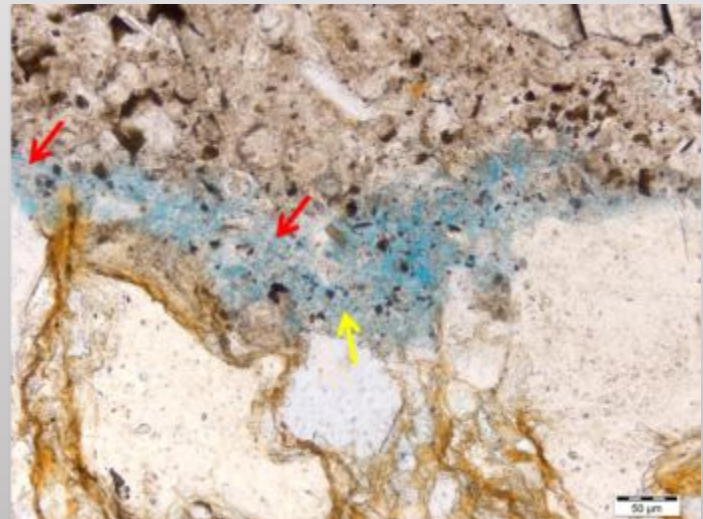
Ultrathin section of concrete core showing bleed water along a coarse aggregate particle

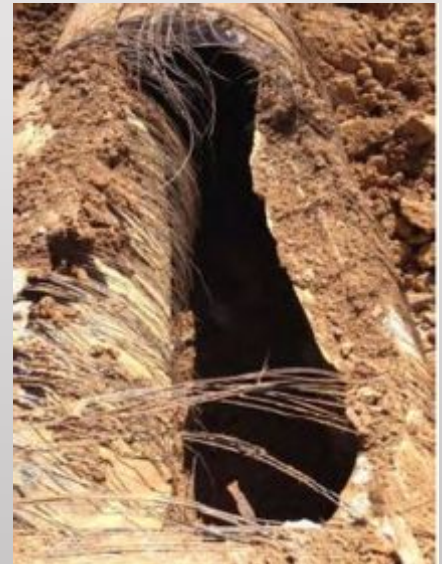
Ruptured pipe visible after water subsided

- Carbon Fiber-Reinforced Polymer (CFRP) liner as alternative to replacement of distressed segments
- Multiple specialty CFRP companies contacted – Work awarded based on experience and responsiveness
- Mobilization immediately after access available
- Repairs began within 7 days
- CFRP repairs completed in 8 days, including cure
