The Northern California Pipe User's Group
26th Annual Sharing Technologies Seminar

HIGHLIGHTING INNOVATION AND SUSTAINABILITY BY RENEWING AC PIPELINES WITH CURED-IN-PLACE PIPE

Tara Sweet and David Katzev

East Bay Municipal Utility District, Oakland, CA

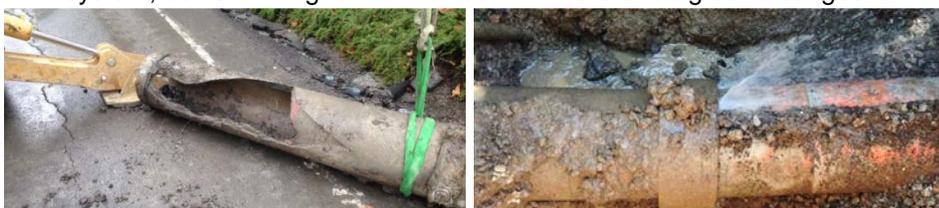
This 1956 AC distribution main was located on a high traffic roadway. The 12-inch main had broken 29 times since the 1990s, and four times since 2015 (Figure 1). Maintenance crews had difficulty making repairs due to the size of the failures, depth of the pipe and traffic on the road, and large claims were filed against EBMUD in this affluent neighborhood.

Figure 1. Two main breaks on Pilot 4 (12-inch AC main) in 2016

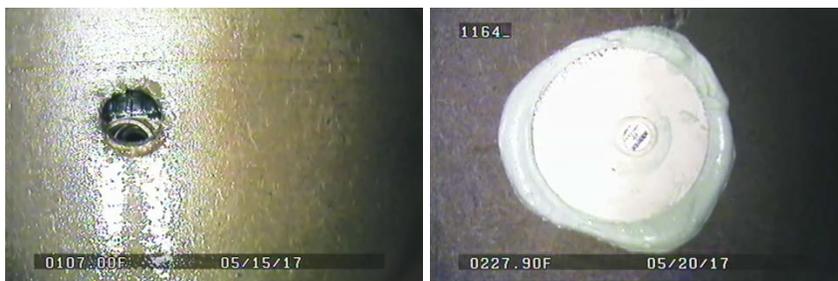
In all four pilot projects, the host pipe was thick-walled rough barrel AC, so the services did not protrude beyond the pipe wall. This required service patches, rather than the standard plugs. The robot could install multiple plugs on one trip into the pipe, but only one patch per trip, so the patching process was slower than expected. EBMUD didn't have records on the thickness of the pipe or whether the services protruded into the pipe, so this could only have been known once the pipe was taken out of service and inspected.

Figure 5. Offset service (left), patched service (right)

The patches or plugs were adhered to the inside of the host pipe by a technician using a camera and robot inside the pipe (Figure 5). The status and location (i.e., footage measurements on inspection videos) of all services were documented by both the manufacturer and EBMUD to ensure all services that needed to be reinstated, were in fact reinstated, and that older abandoned services were not.

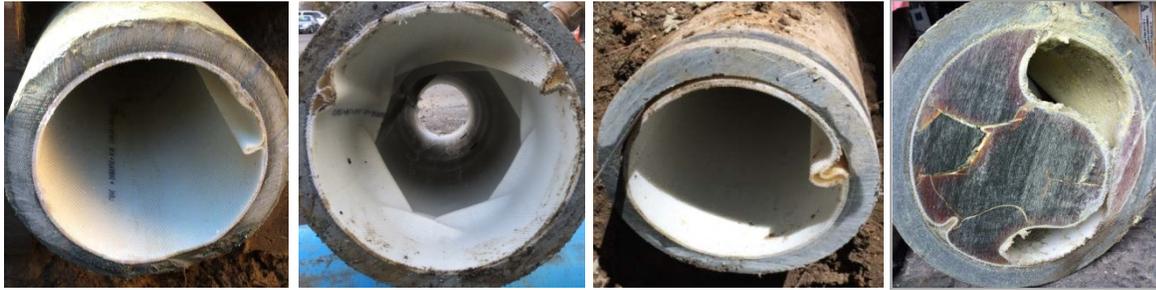
Over the course of the four pilots, 12,823 of the 12,940 feet of Aqua-Pipe installed was accepted; there were three rejected sections totaling 117 feet (Figure 6). The 12-foot rejection on Pilot 2 was a “donut” that formed due to the inside and outside sleeves of the liner being different lengths, a manufacturing flaw. The 100-foot rejection on Pilot 3 was caused by water management problems (see the Water Management section). The 5-foot rejection on Pilot 4 was due to the resin beginning to harden before the foam pig reached the exit pit, resulting in a solid blob of resin adjacent to an access pit. Each of these issues were removed and repaired by EBMUD crews, and reimbursed by the manufacturer.

Figure 6. Accepted CIPP, rejected CIPP on Pilot 2, Pilot 3, and Pilot 4 (left to right)

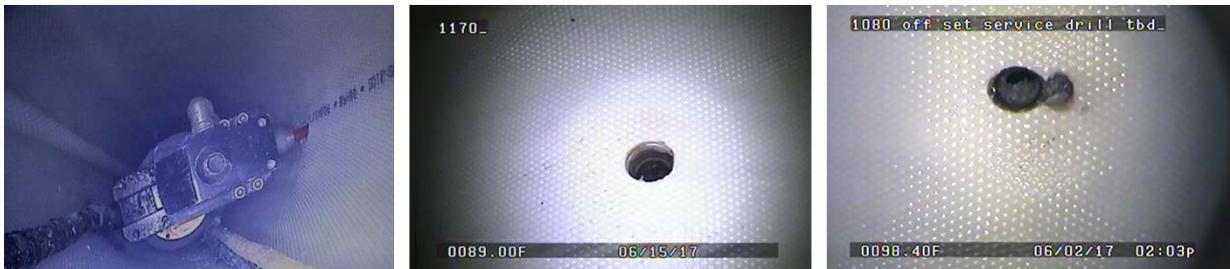
After pressure testing, services were reinstated by a technician using a robotic drill and a camera (Figure 7). For Pilots 3 and 4, 83 percent and 96 percent of services were reinstated robotically, respectively. Examples requiring excavation included services that were:

- Located behind the fold;
- Misdrilled; and
- Unable to be located.

Figure 7. Service reinstatement robot (left), accepted drill (center), misdrill (right)
