The Northern California Pipe User's Group
24th Annual Sharing Technologies Seminar

Approach to Inspecting Large Diameter Concrete Pressure Pipe, Bar-Wrapped, Steel Cylinder Type (AWWA C-303)

Emily Sing, P.E.¹, Tim Harrison, P.E.¹, and Pete Bellows, P.E.²

¹ Contra Costa Water District, Concord, CA

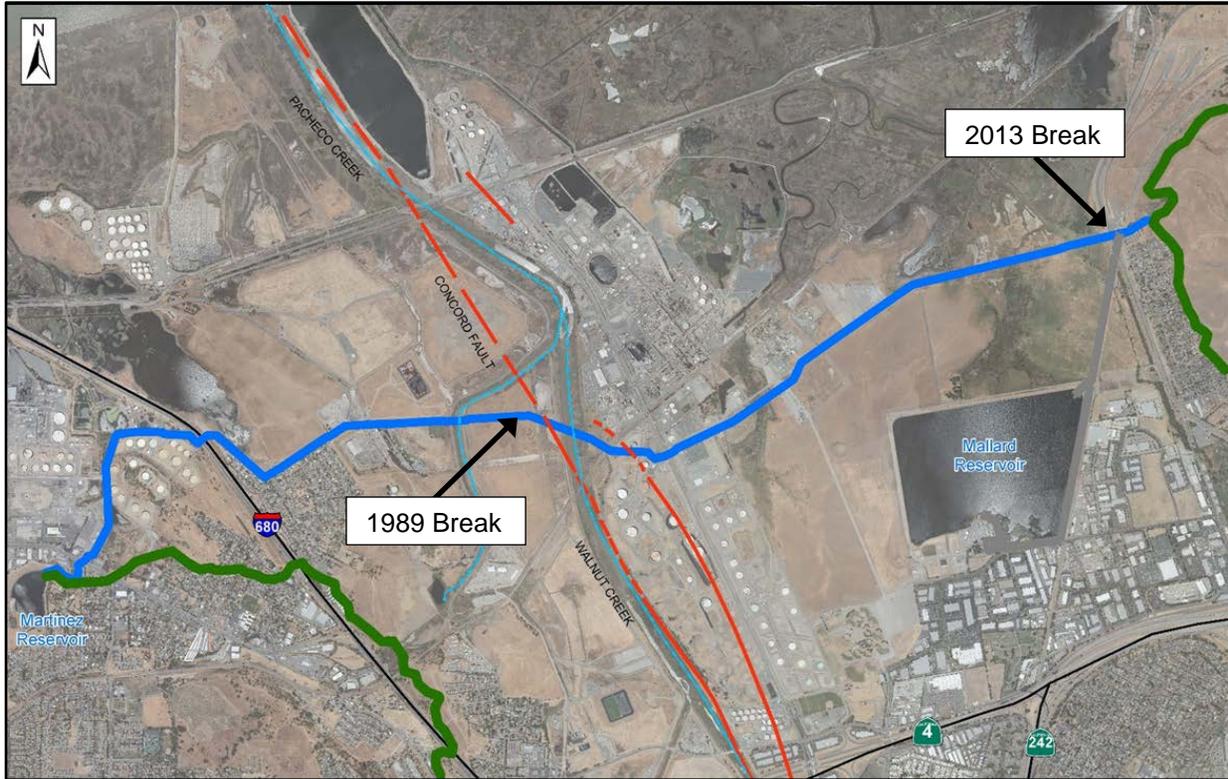
The SCPL incurred two failures since construction. In 1989, a failure occurred between Walnut Creek and Pacheco Creek in an area that had storage ponds. The break was located under a storage pond levee that was constructed after the SCPL. A field investigation exposed approximately 100 feet of pipe and found three cracks in the concrete casing of the pipeline and damage to the steel cylinder. The investigation report concluded that the cracks found in the concrete casing may have been caused by the additional weight created by constructing the levee and that the damage to the steel cylinder was consistent with earthquake damage.

A second failure occurred in 2013 near Port Chicago Highway. The pipe failed at the bottom of a steep downhill section. The failure was projected to occur from high stresses. Corrosion was determined to not be a factor.

Figure 4 SCPL Alignment

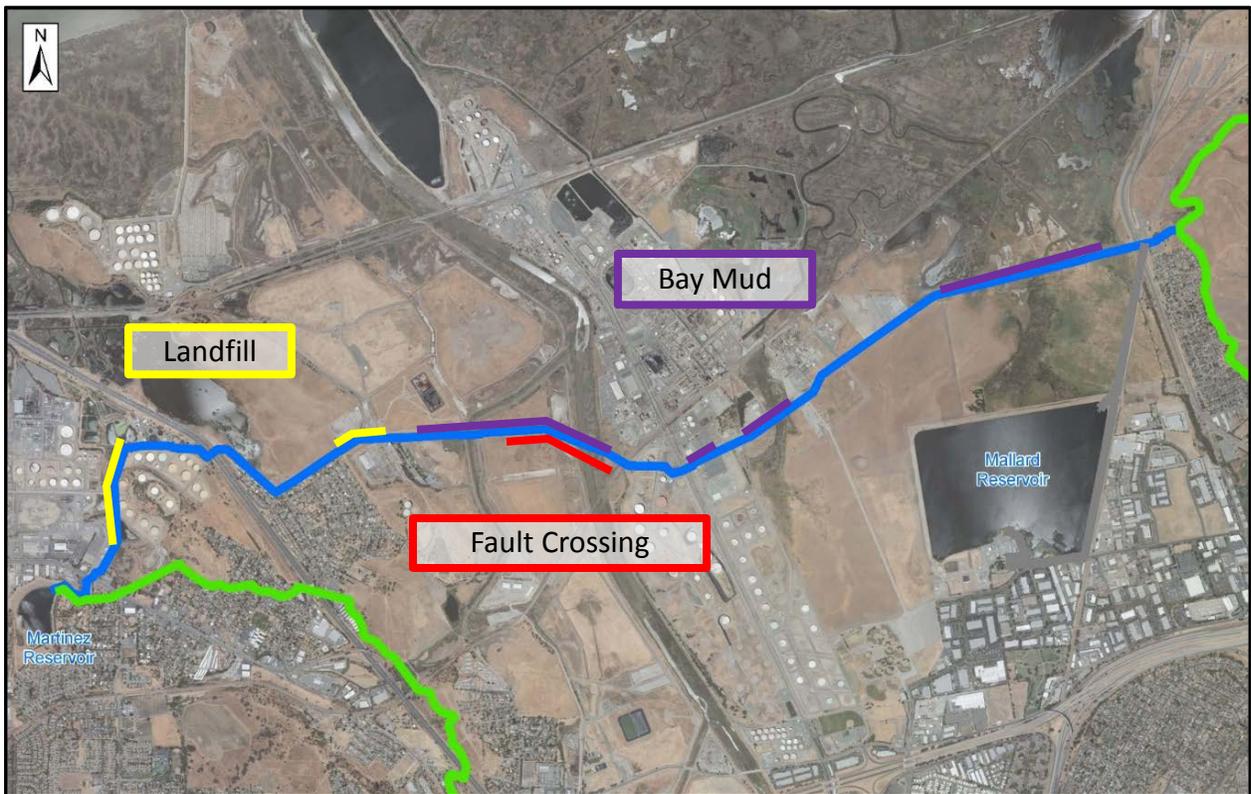
Differential Settlement. SCPL is susceptible to differential settlement because of the native soils Bay mud and later fill. Earthquake activity would exacerbate the impacts of Bay mud and fill on the pipeline. These geotechnical hazards are highlighted on Figure 5. Bay mud is located along portions of the pipeline between Walnut Creek and Pacheco Creek and the wetlands between Port Chicago Highway and the Tesoro refinery. The original construction of SCPL included 11 settlement gages located between Walnut Creek and the Martinez Gun Club. Survey data from the settlement monitors is shown on Figure 6 and demonstrates that extensive differential settlement has occurred. The 1989 break in SCPL occurred in this area.

Figure 5. Locations of Potential Failure Mechanisms

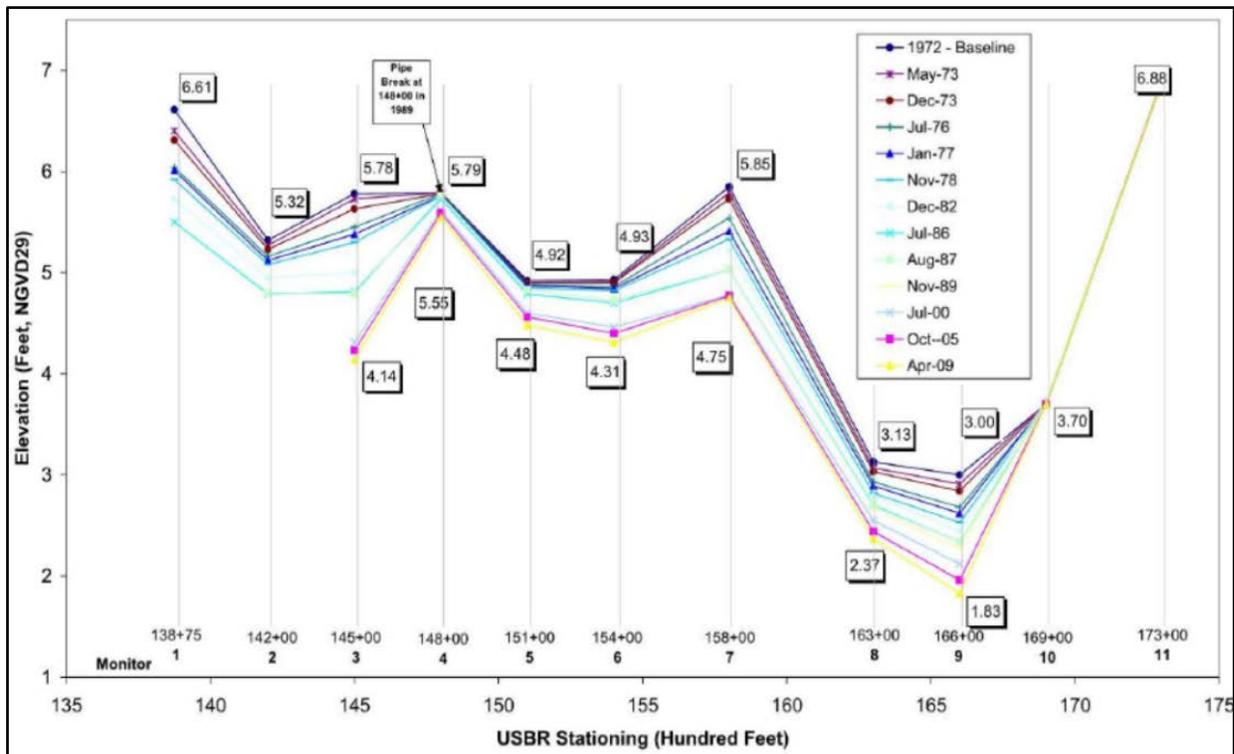
Figure 6. Differential Settlement from 1972 to 2009

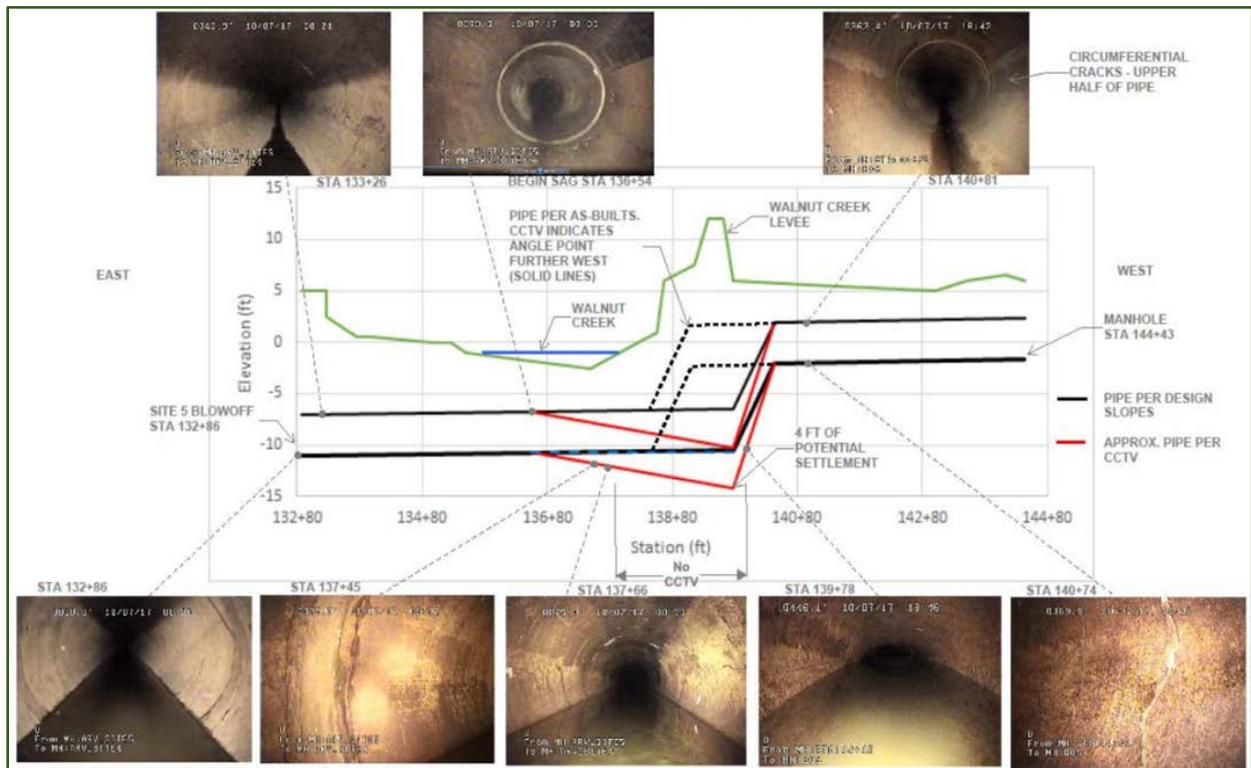
A major sag was found under the Walnut Creek levee. The sag is about four feet and over a short distance that includes the rising limb where the pipeline rises from dropping under the creek. The pipeline was constructed with welded joints in this area and significant cracks were observed at both ends of the sag. The sag is shown on Figure 8.

Figure 8. CCTV inspection at Walnut Creek levee

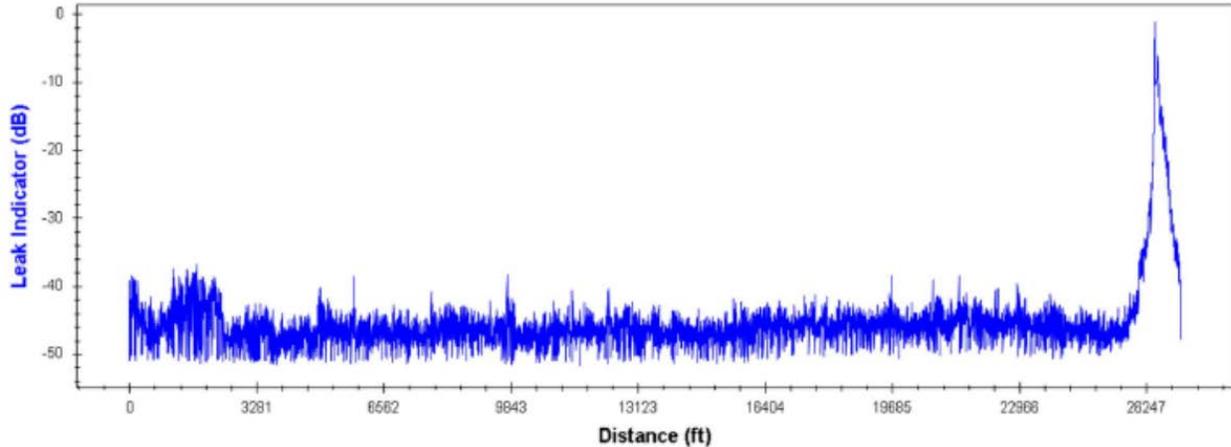
Acoustic Leak Detection. Internal acoustical sensor profiling is the only inspection method used that could identify leaks, which would indicate a failing pipe and condition that could require immediate repair. Acoustic leak detection was performed using a Smart Ball, an inspection product of Pure Technologies. A Smart Ball was used because it allowed inspection of the entire pipeline using a single mobilization while providing critical information (location and magnitude) of leaks and air. The inspection occurred while the pipeline was in service. The pipeline must be in service so that the water flow will propel the Smart Ball. Due to the passive propulsion of the device, all turnouts along the pipeline had to be isolated which impacted customers for a short time. The acoustic data obtained during the inspection are shown on Figure 9. One acoustic anomaly indicative of a leak was found at the downstream end of the pipeline. It was later determined to be caused by the valve used to throttle flow. The inspection did not locate any air pockets.

Figure 9. Smart Ball acoustic data
