The Northern California Pipe User's Group  
29th Annual Sharing Technologies Seminar

## LOOKING IN HARD TO REACH PLACES – SAN JOSE-SANTA CLARA REGIONAL WASTEWATER FACILITY YARD PIPING CONDITION ASSESSMENTS

Clinton McAdams, P.E.<sup>1</sup>, Tim Tran, P.E.<sup>2</sup>, and Noy Phannavong, P.E.<sup>3</sup>

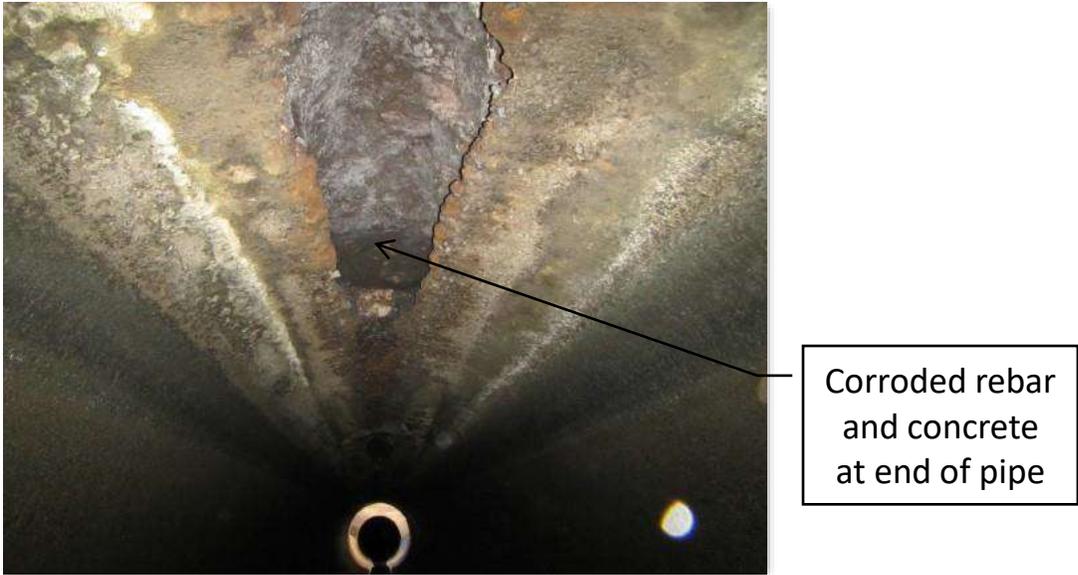
The condition assessment in 2018 discovered the 96-inch and 87x136-inch concrete pipelines were in severe condition due to crown corrosion, as seen in Photo 1 and Photo 2. Pipe failure would have disrupted facility operation, so the project team split the two pipelines into a separate project for early construction, which repairs were completed in 2020. The initial design for a corroded 96-inch concrete pipeline was CIPP yet condition data determined that the last few feet of the pipeline was corroded and CIPP would not reach the end of the pipeline. The design was revised to include PDCCR for the last ten feet of the pipeline.

Photo 1: Severe crown corrosion at 96-inch PE pipe

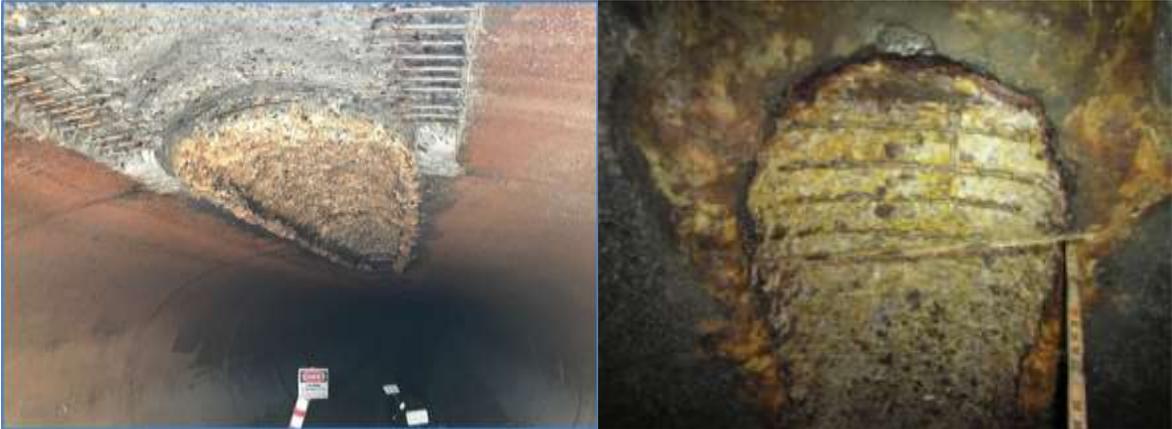
Photo 2: Concrete and rebars exhibited severe corrosion for 96-inch and 87x136-inch pipelines

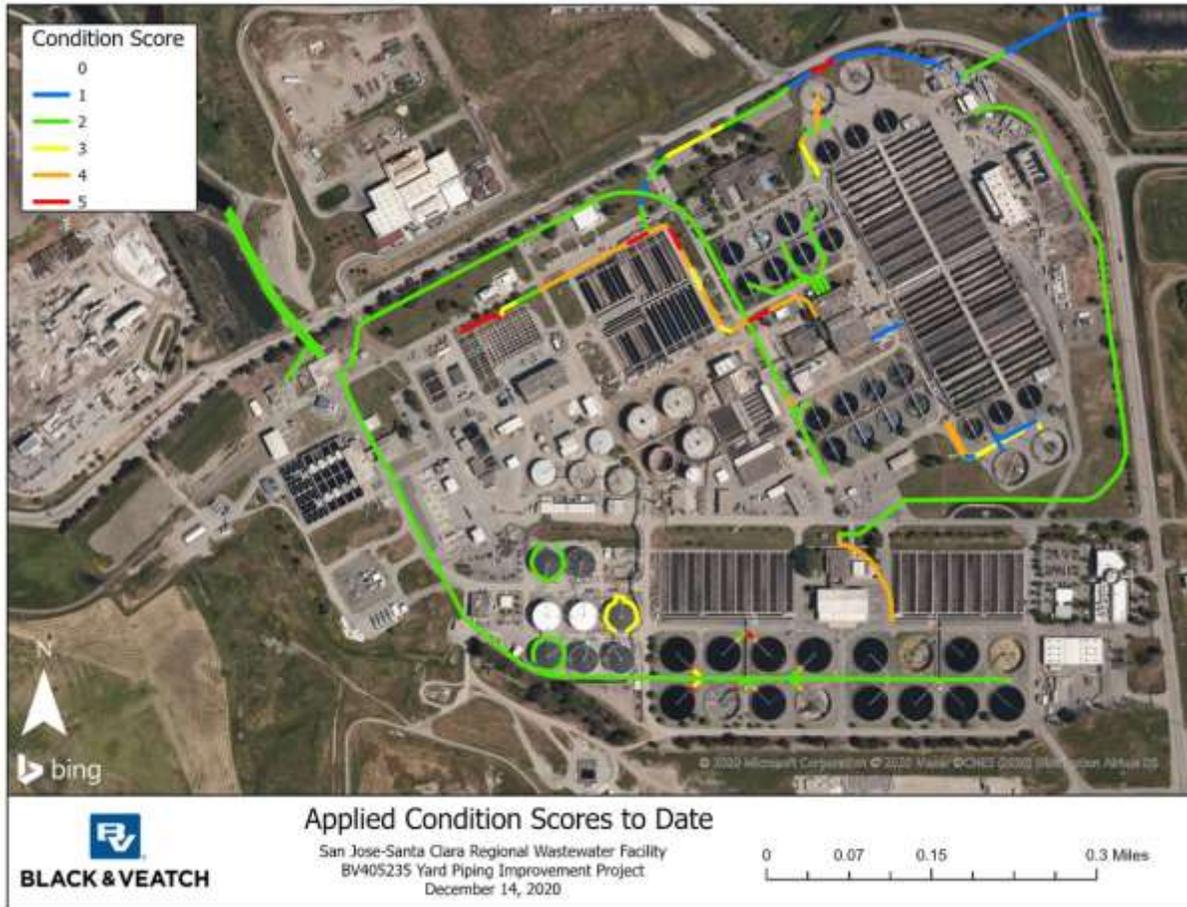
Figure 4: Assessed Condition to Date

Assessed pipelines were primarily in good condition with localized damage identified. Figure 4 shows the condition scored to date. Trends were not identified between pipe material type and documented damage. Primarily concrete type pipe has been inspected yet was primarily in good condition indicating minimal headspaces within the lines. The Settled Sewage piplines exhibited progressive damage compared to the other pipelines assessed which can be attributed to identified headspaces and the corrosive internal atmosphere. Trends were not identified between pipeline age and documented damage. Some of the oldest pipelines installed within the facility were evaluated and found to be in similar condition to pipelines installed during the 1980s and earlier. Process stream appeared to be the main correlator for potential damage.
