INSPECTION OF A 50-YEAR OLD OUTFALL FORCEMAIN TO SAN PABLO BAY

NATIONAL PLANT SERVICES
A Carylton Company

February 16, 2023

**PUG Sharing
Technologies Seminar**

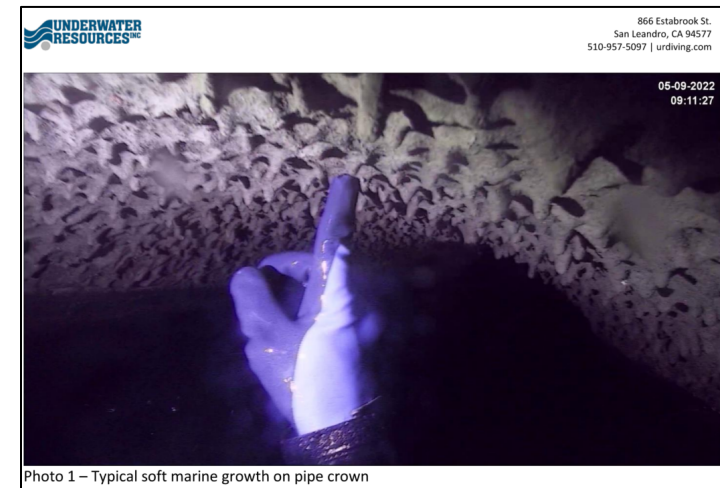
Photo 1 – Typical soft marine growth on pipe crown

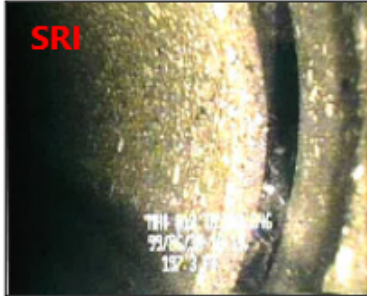
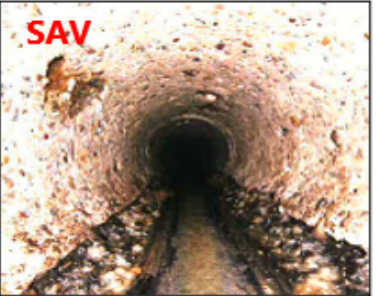
NASSCO Defect Code	Sample Photo	
<p>SRI – Roughness Increased SAV – Aggregate Visible</p>

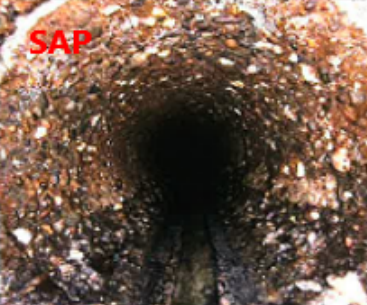
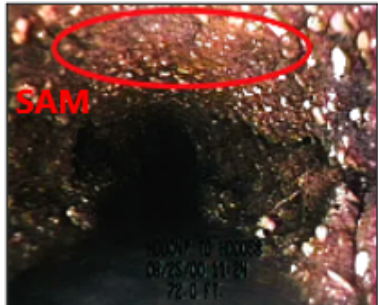
<p>SAP – Aggregate Projecting SAM – Aggregate Missing</p>

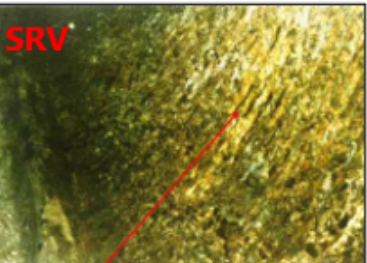
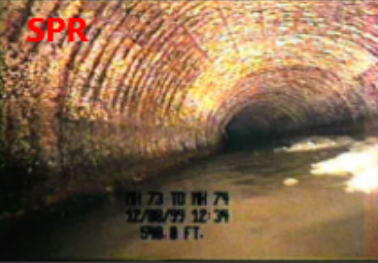
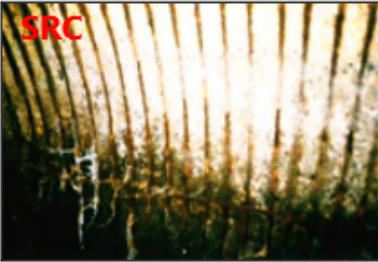
<p>SRV – Reinforcement Visible SPR – Reinforcement Projecting SRC – Reinforcement Corroded</p>

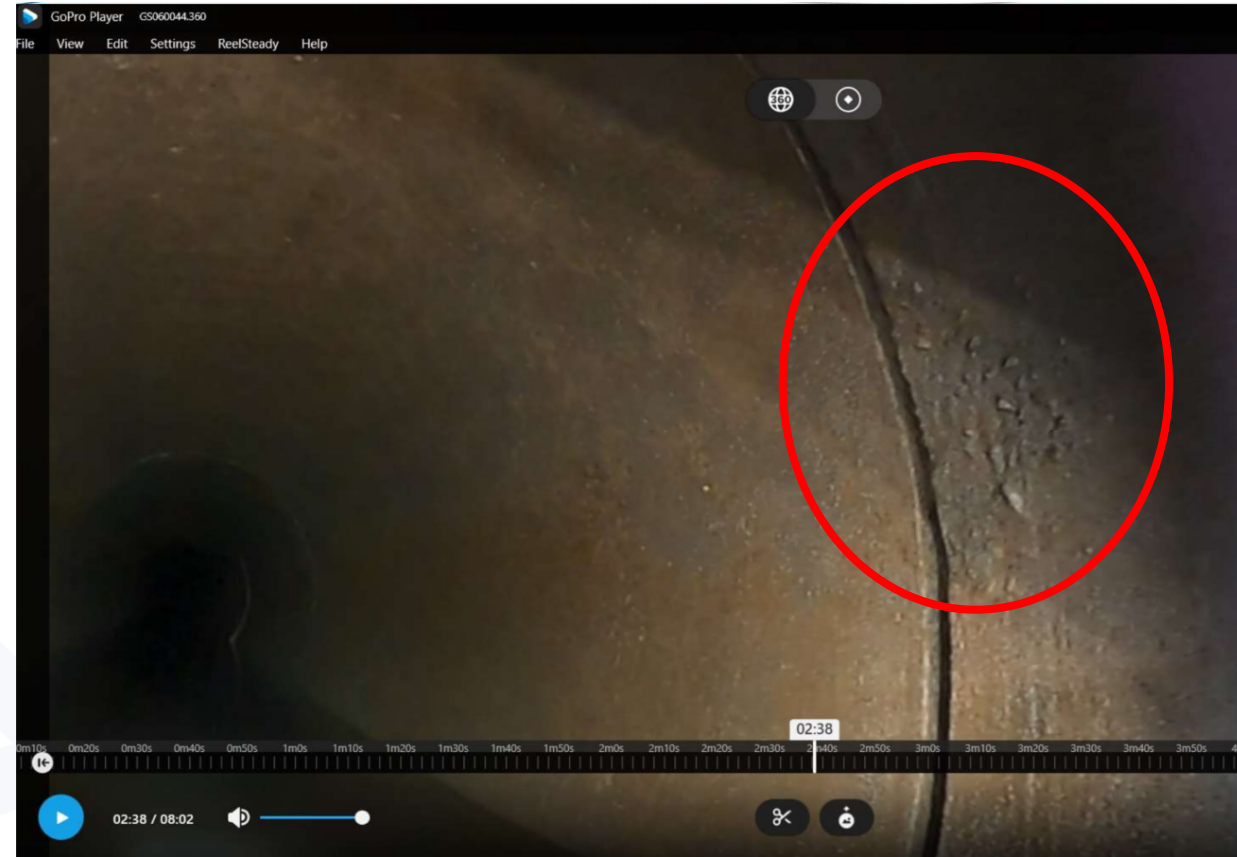
**In good
condition
overall**

NOVATO
LEVERONI/ACCESS POINT 3A
JB3A ← JB4
54 Reinforced Concrete Pipe
JB3A_JB4

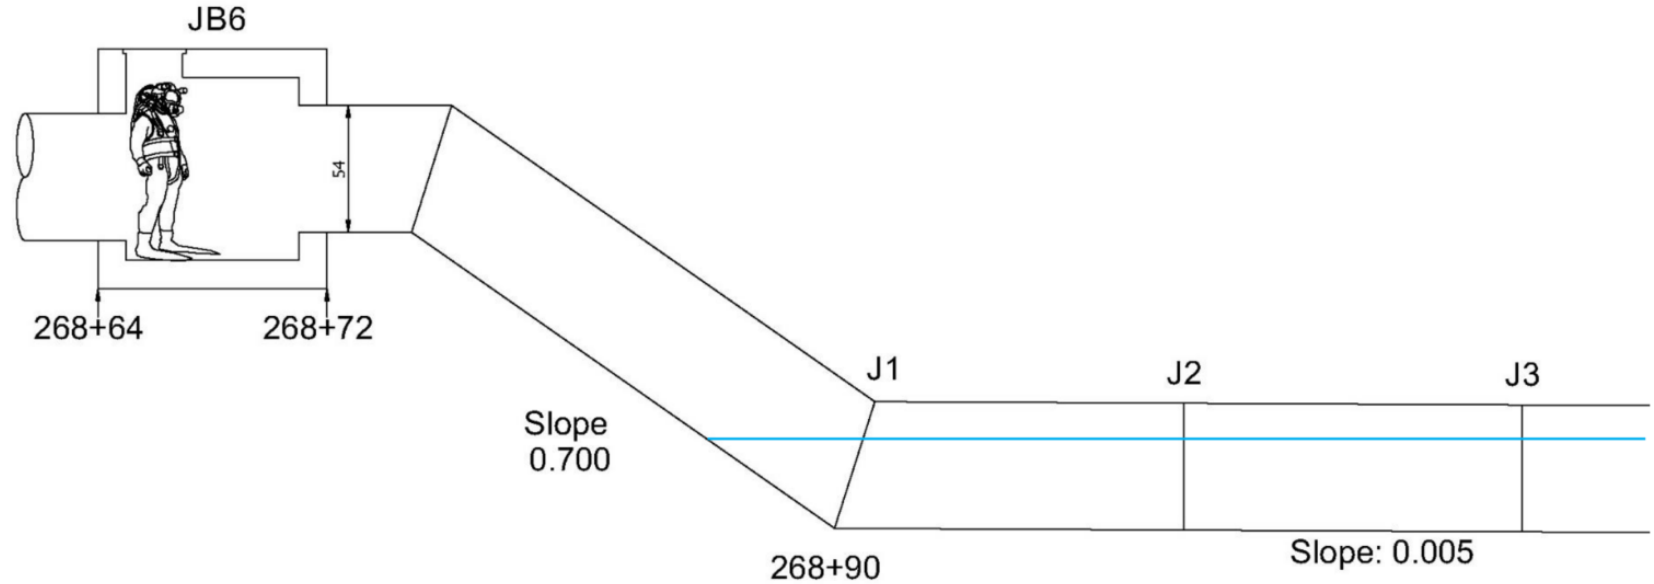
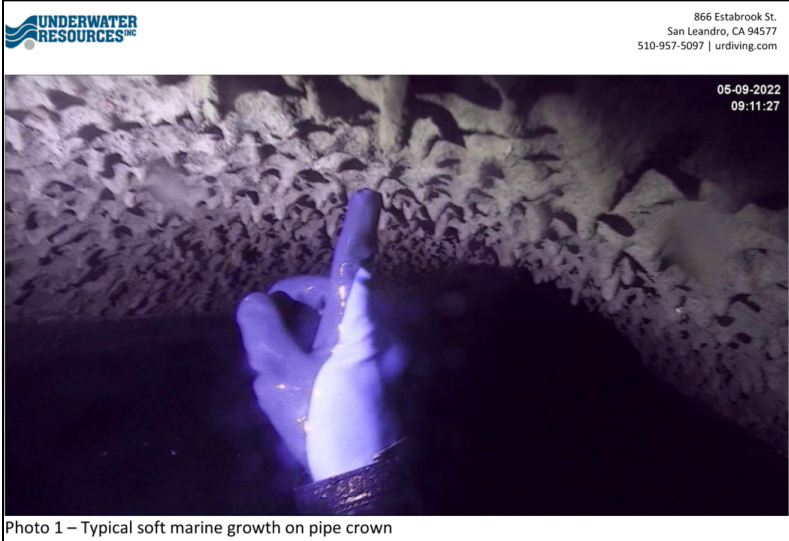
Figure 1 – Point of Entry to Joint 3

Video Time Stamp	Joint No.	Joint Gaps (in.)				Sedi-ment (in.)	Dive Hose Dist (ft)	Notes
		Invert 6:00	North 9:00	Crown 12:00	South 3:00			
09:06:15	1	0	1/16	0	1/4	0	0	Slippery pipe
09:07:55	2	1	1/2	1/16	1/2	1/16		1/8" wide spall at 10:00 position.
09:09:47	3	0	0	0	0	1/8		1/8" of soft marine growth on pipe crown
09:11:53	4	1/4	1.5		5/8			2" x 2" spall at 4:00. 3" x 6" spall at 5:00.
09:14:39	5	0	3/8	0	1/8	1/16		Pipe sections are 3/8" offset at crown
09:15:34	6	0	1/8	1/8	1/8	1/8		
09:16:21	7	0	1/4	3/16	1/2	1/16		Joint spall at 12:00 – 12"L x 0.5"W
09:17:12								Diver notes pipe is half full of water.
09:17:30	8	0	7/8	1	1/2	1/16		
09:18:30	9	0	5/8	1	1/4			Pipe sections are 0.5" offset at invert
09:19:22	10	0	1/8	1/8	1/4	1/8		Joint spall at 12:00 – 6"L x 4"W x 0.5"D.

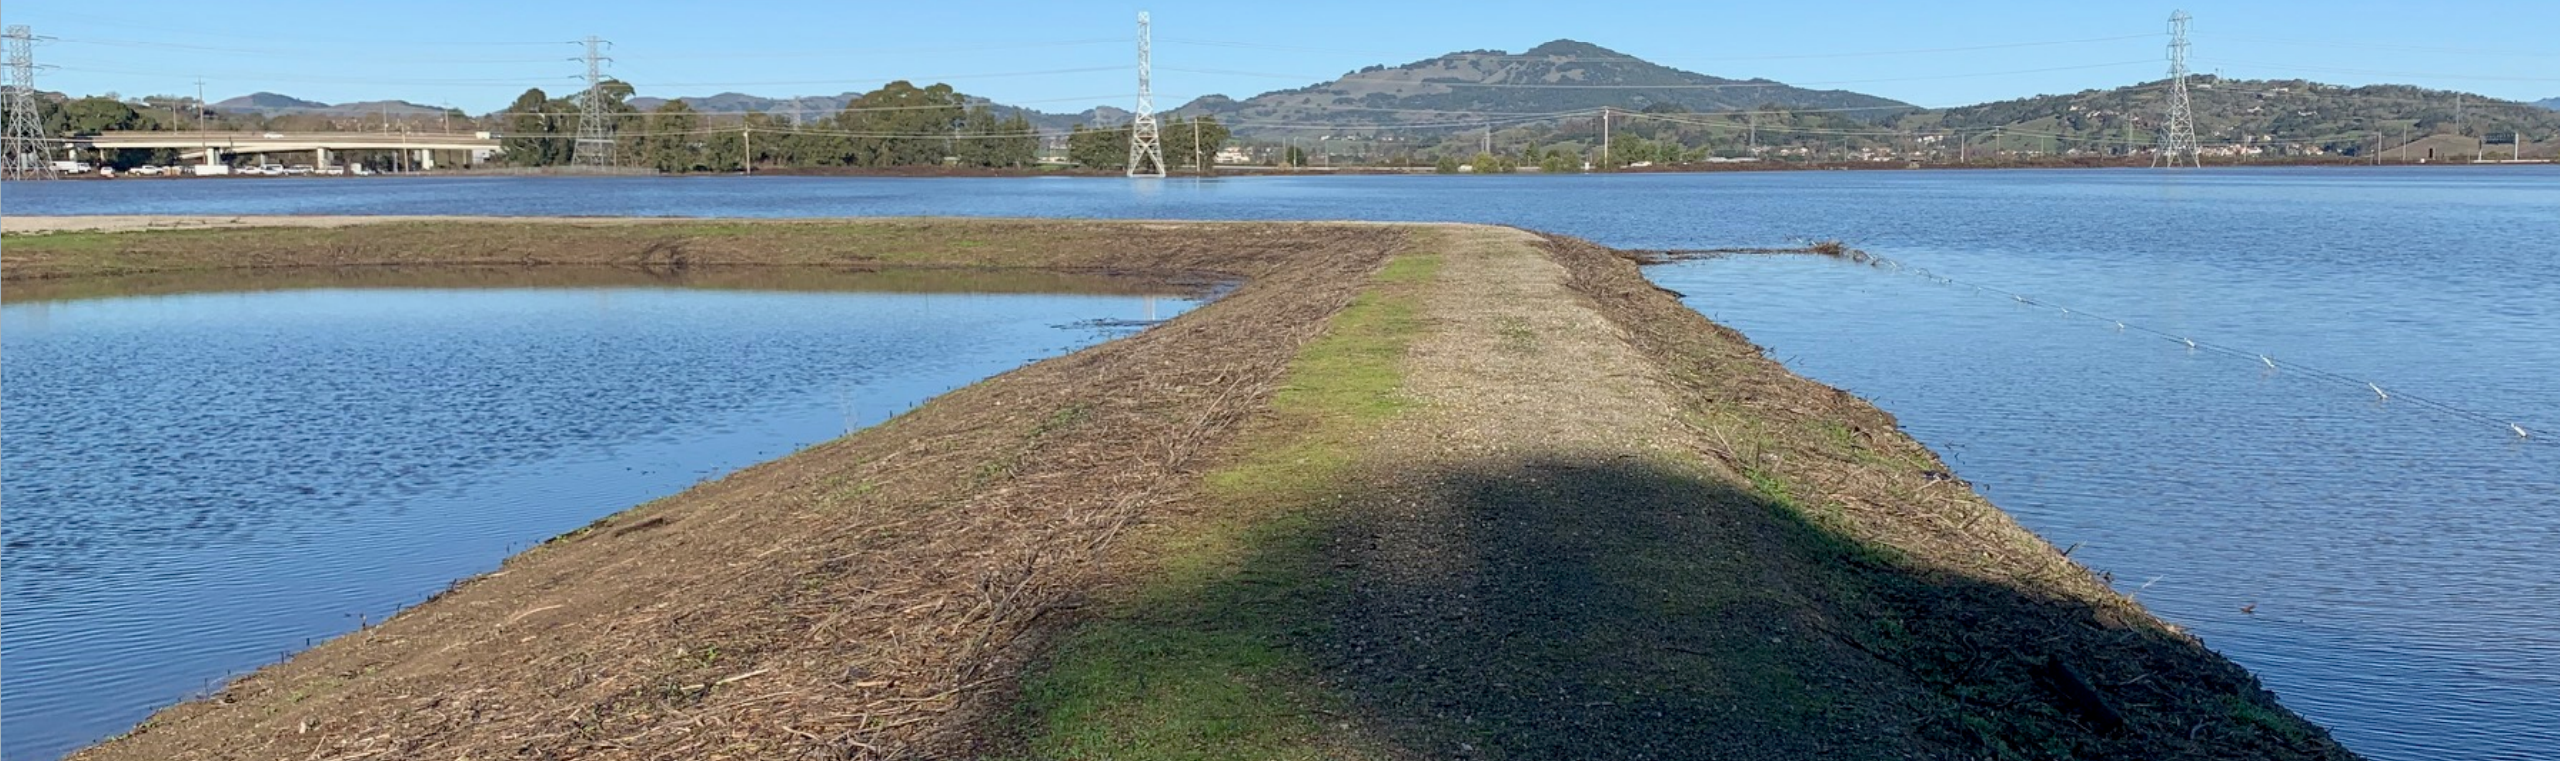
Novato Creek spilled
over into the basin
where the Outfall
follows Novato Creek.

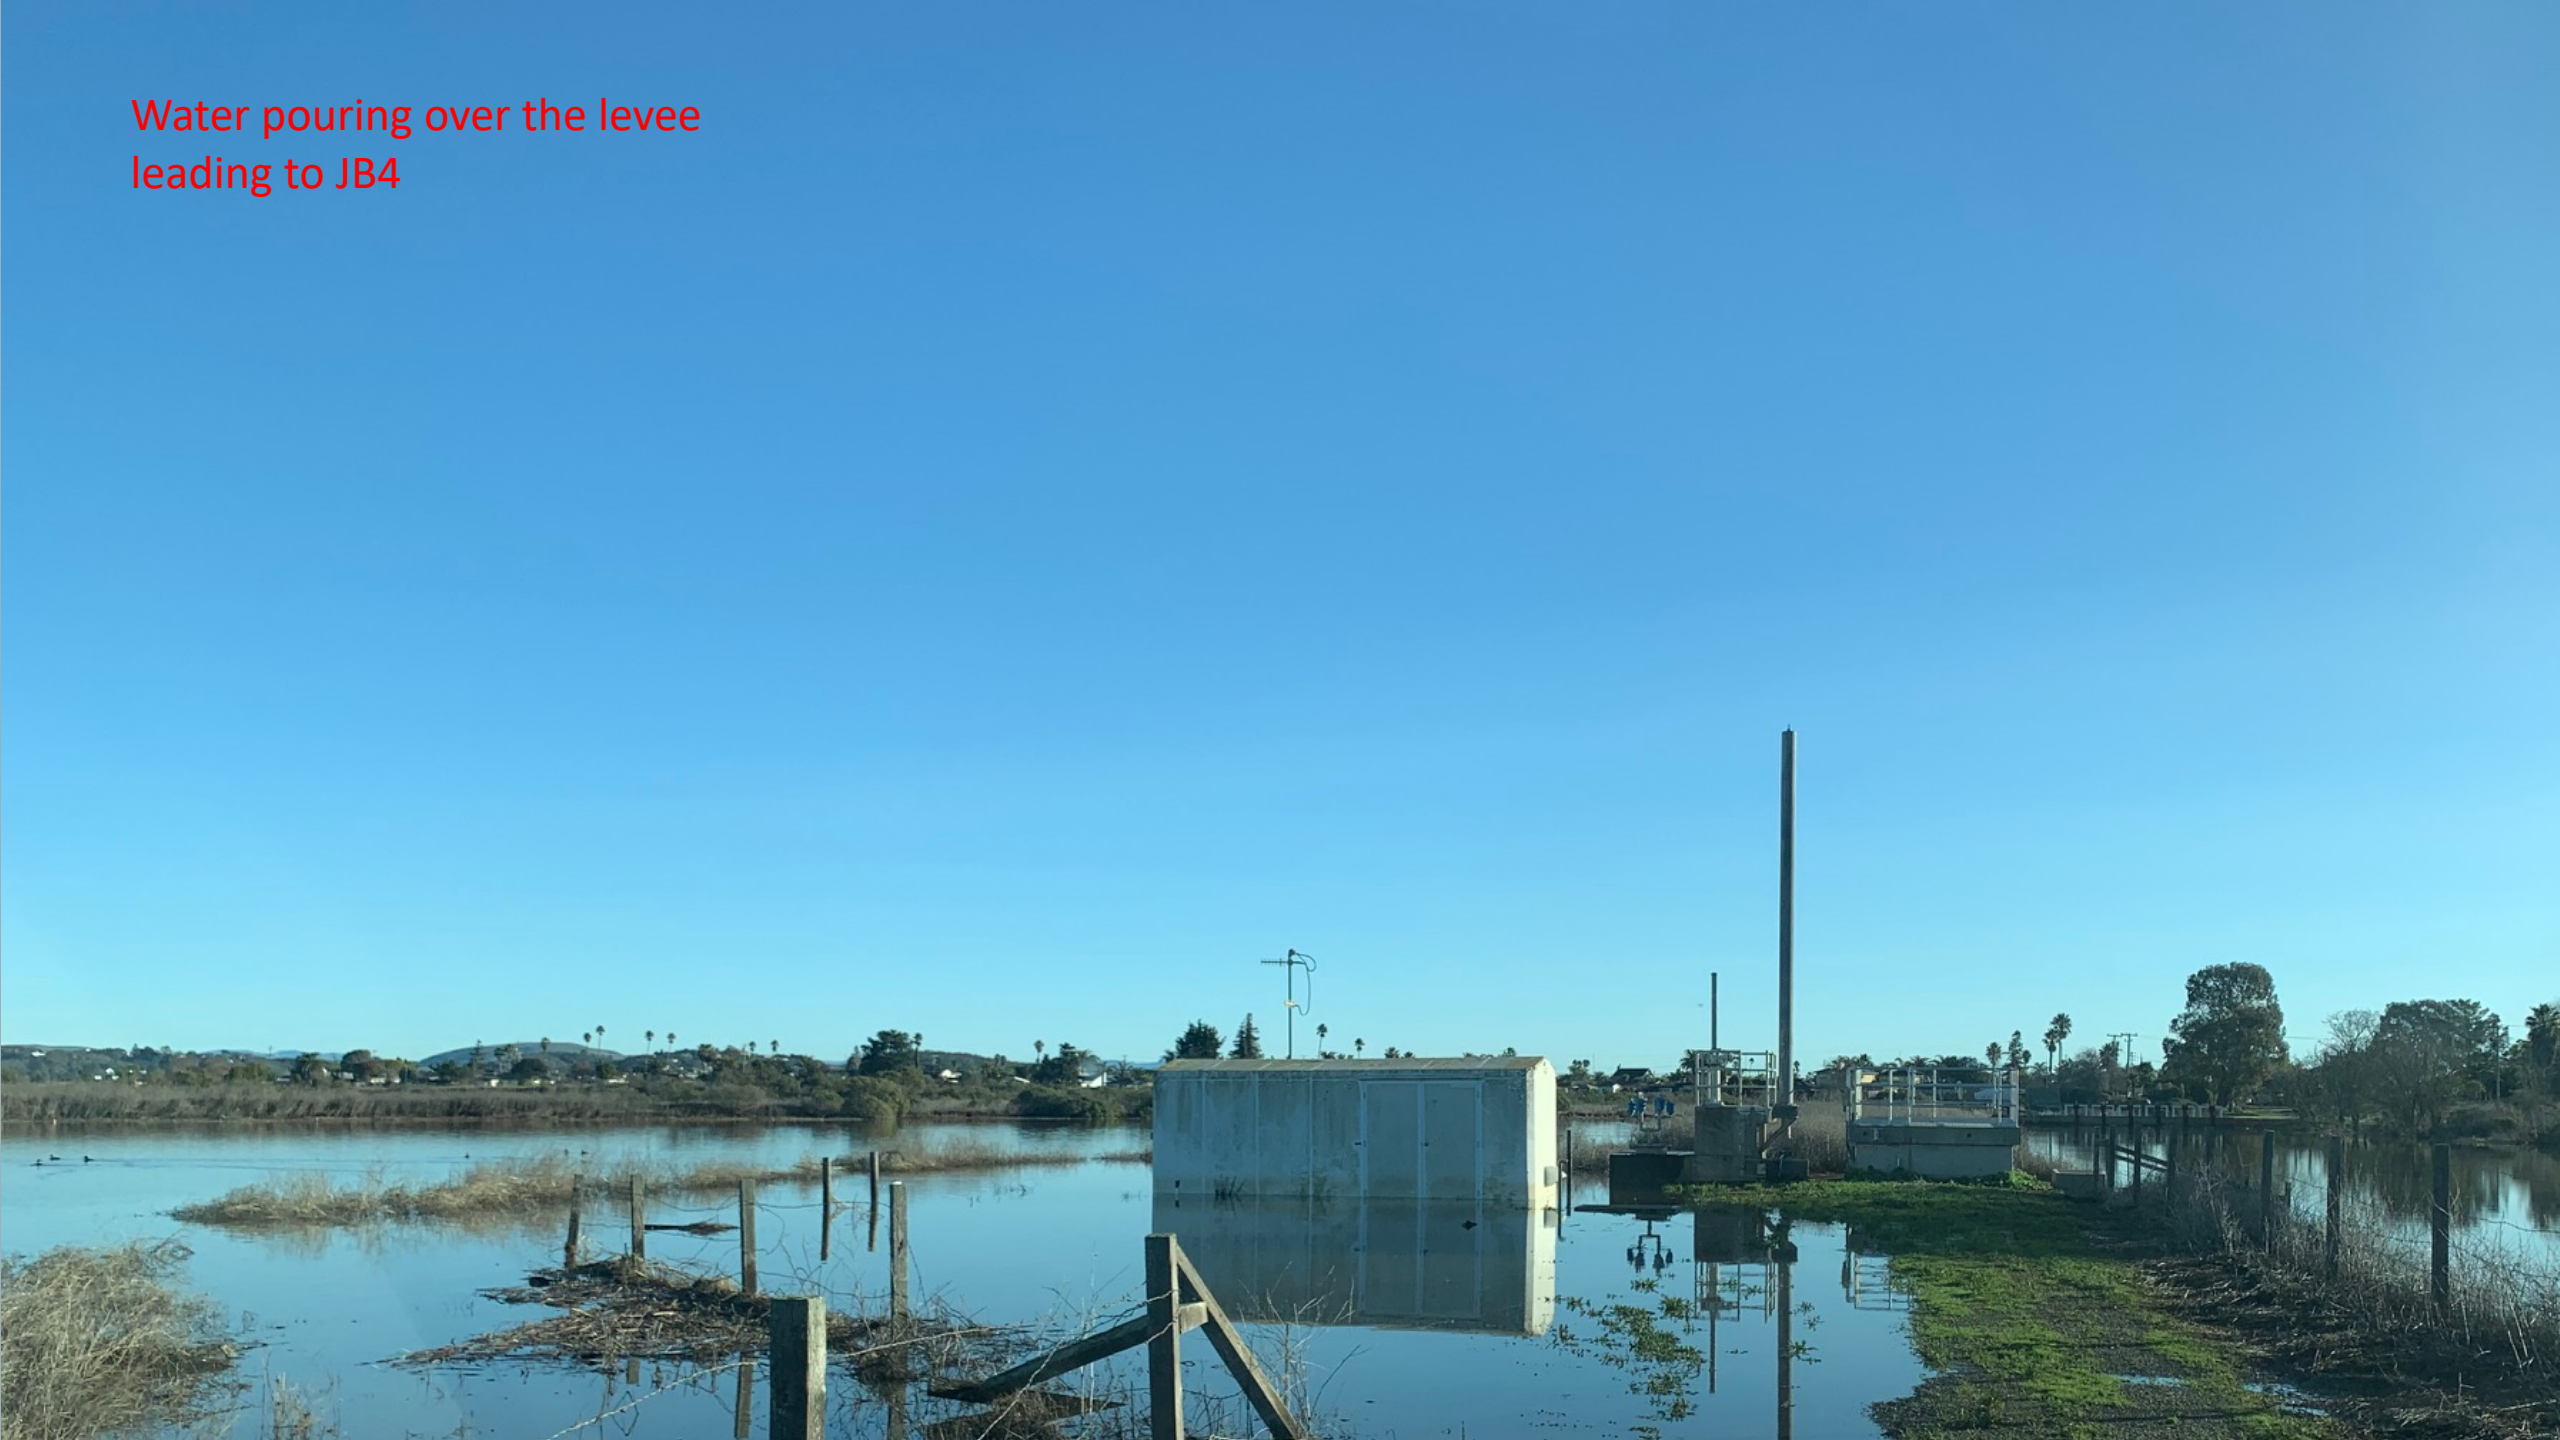
Water pouring over the levee
leading to JB4
