# Lessons Learned from Public-Facing Large Diameter CIPP Interceptor Rehabilitation

March PUG Meeting  
March 10, 2026

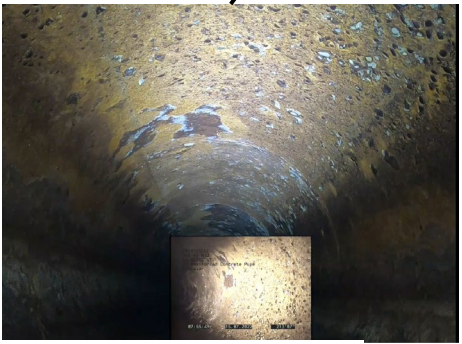
N31, 213' downstream

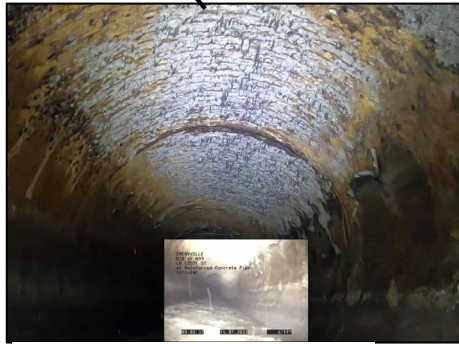
N32, 7' downstream

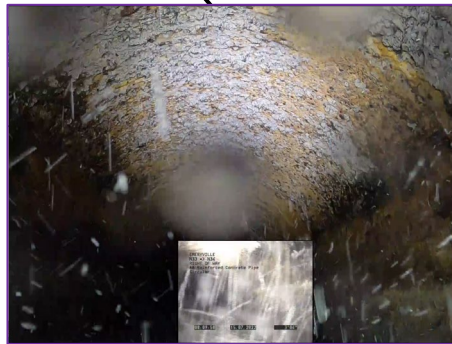
N33, 3' downstream

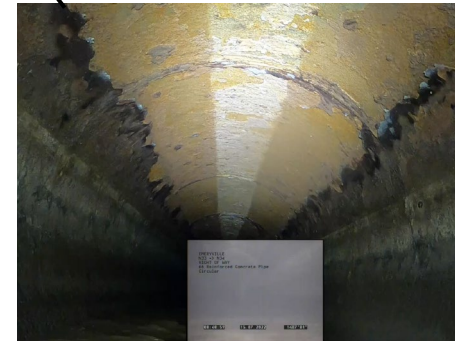
N33, 1487' downstream

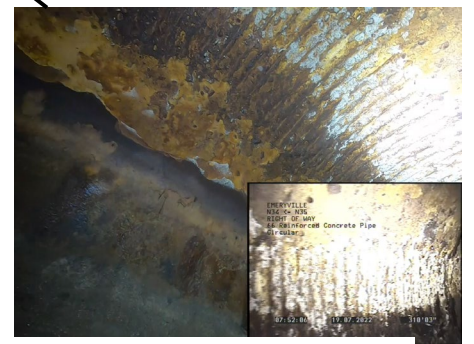
N34, 80' downstream

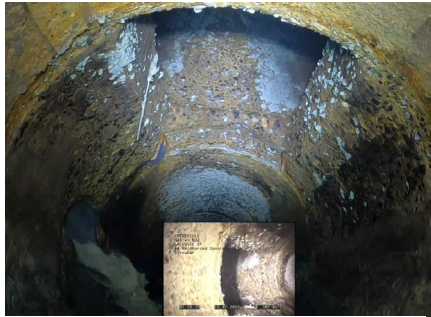
N32, from upstream view

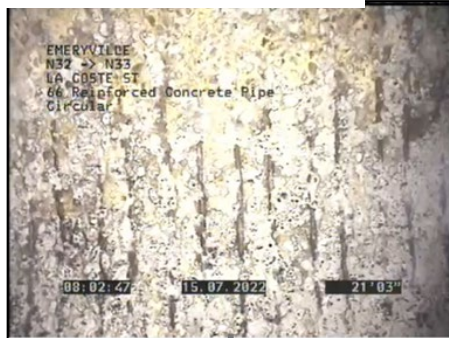
N32, 7' downstream

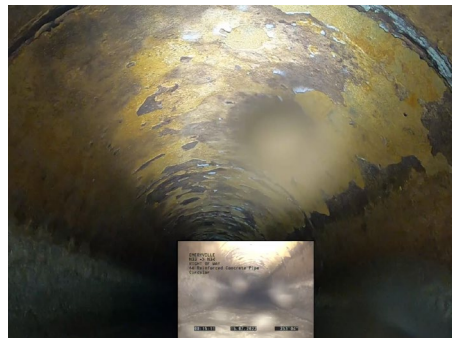
N33, 253' downstream

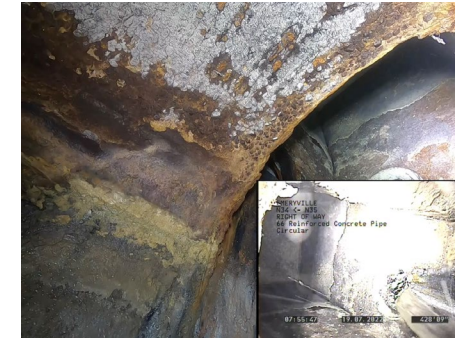
N34, downstream view

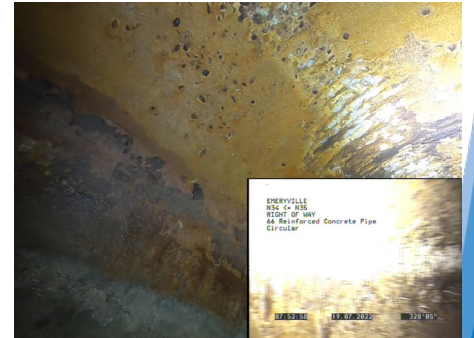
N34, 40' downstream

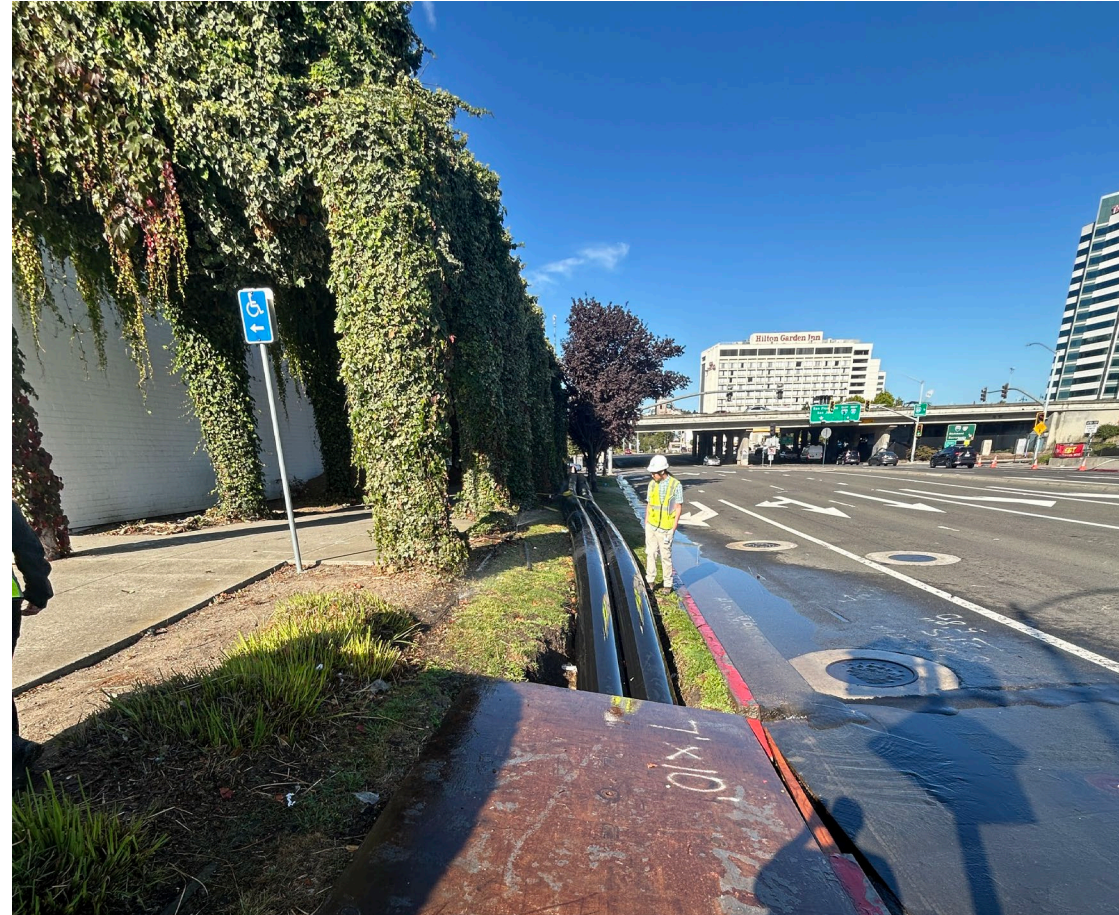
- Constant irrigation leaks onto Powell Street
- Repeated coordination with the City to address public concern
- Lessons learned: always request private property maintenance contact information

Powell Street Irrigation Leaks

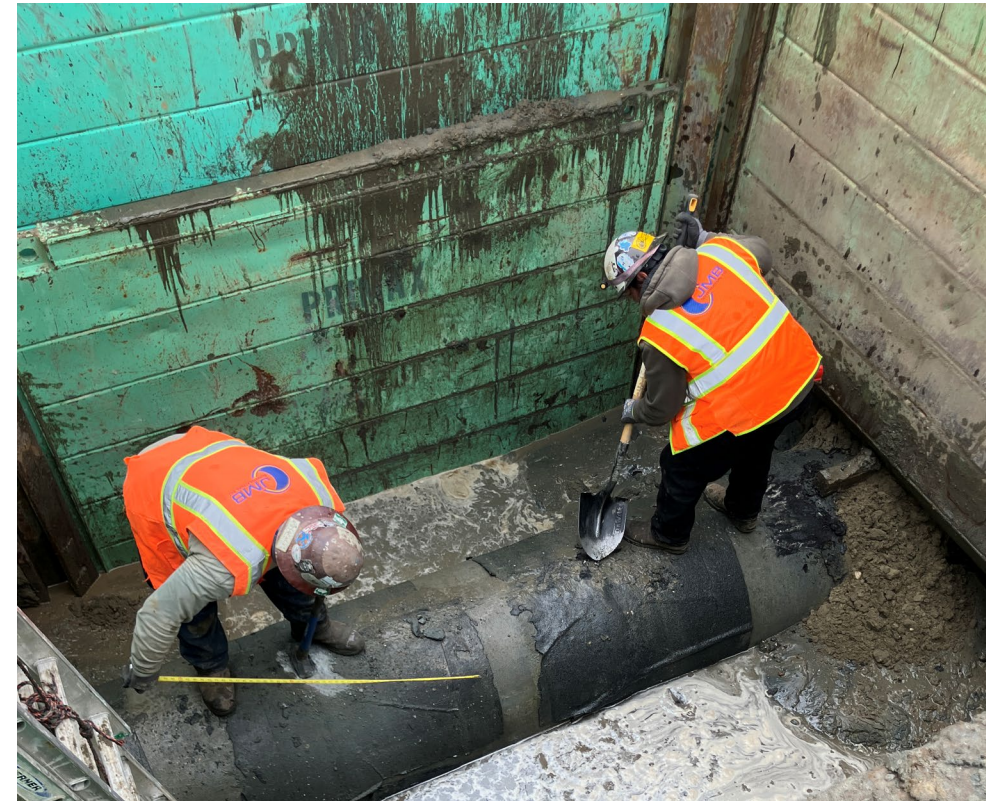
- Unforeseen 30" pipe discovered halfway in excavation
  - Not in as-builts or USA markings
- Project came to a stop
- Coordination with Caltrans for temporary removal and replacement

30" Storm Drain at Insertion Pit

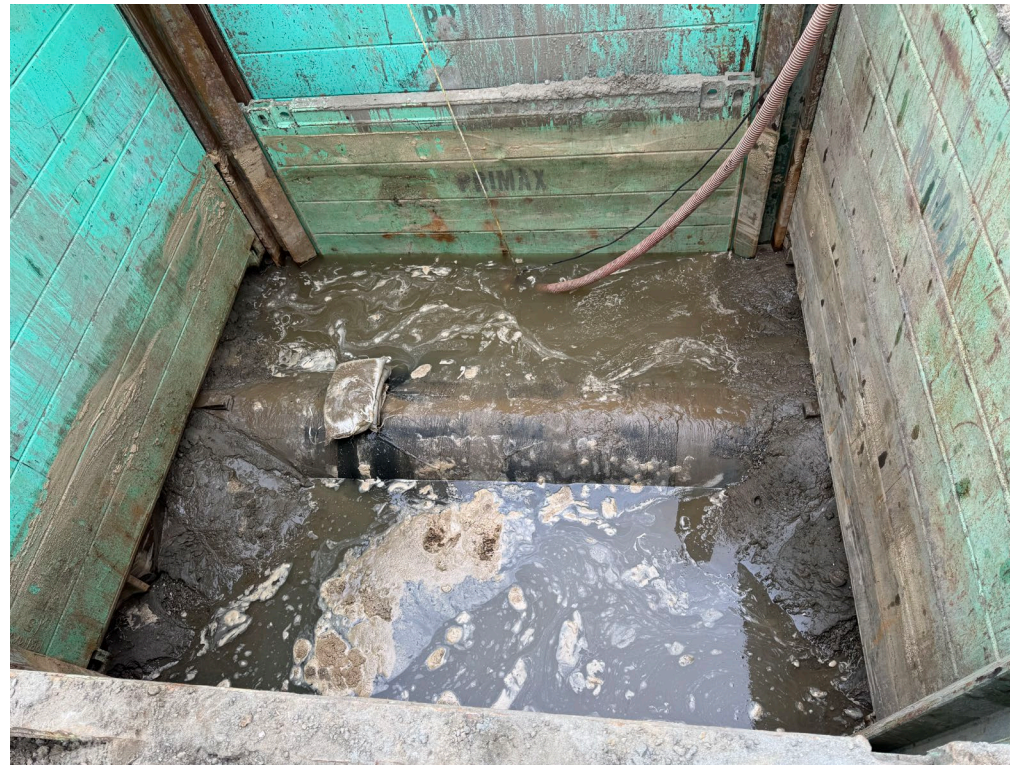
- Silt issues
- Tidal flows
- Removal
- New problems discovered

Tidal Flows

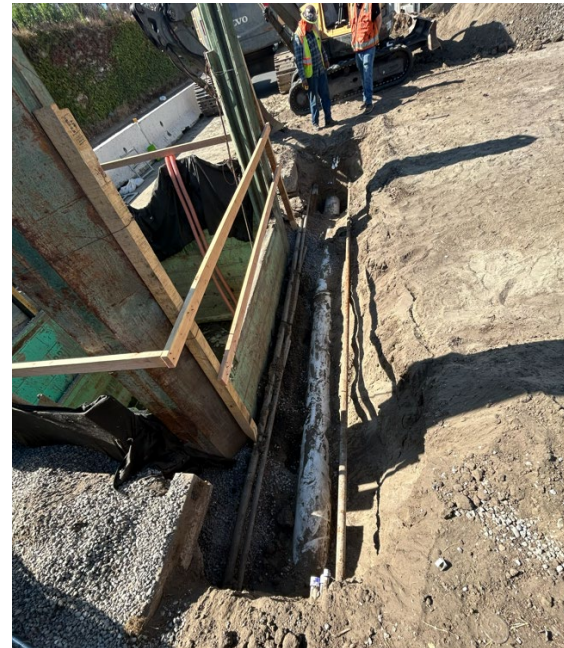
- 9 utilities
  - 6 abandoned
  - 3 active utilities
- Extend Shoring
  - Considerations
  - Shoring re-review

Utility Conflicts

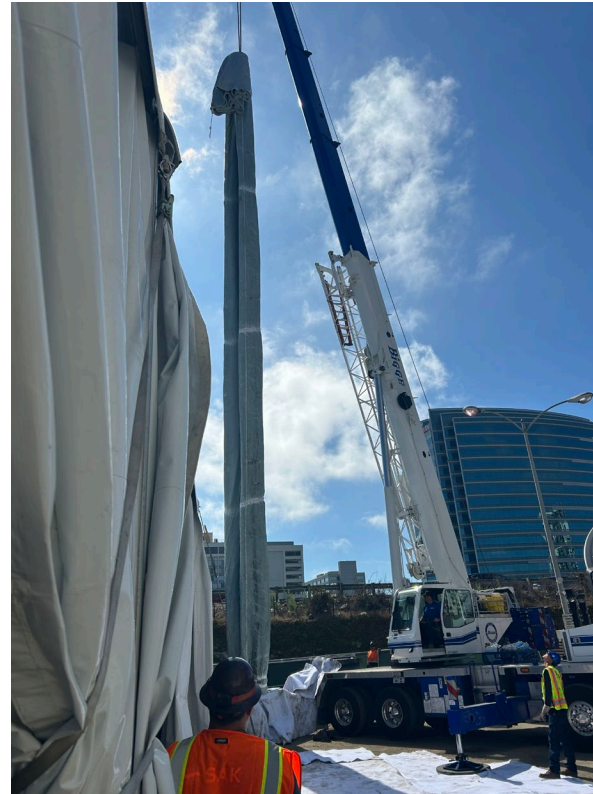
- Liner failed on Shot 1
- Liner removed into workable pieces for curing
- Failed liner staged at unoccupied building

Failed Liner

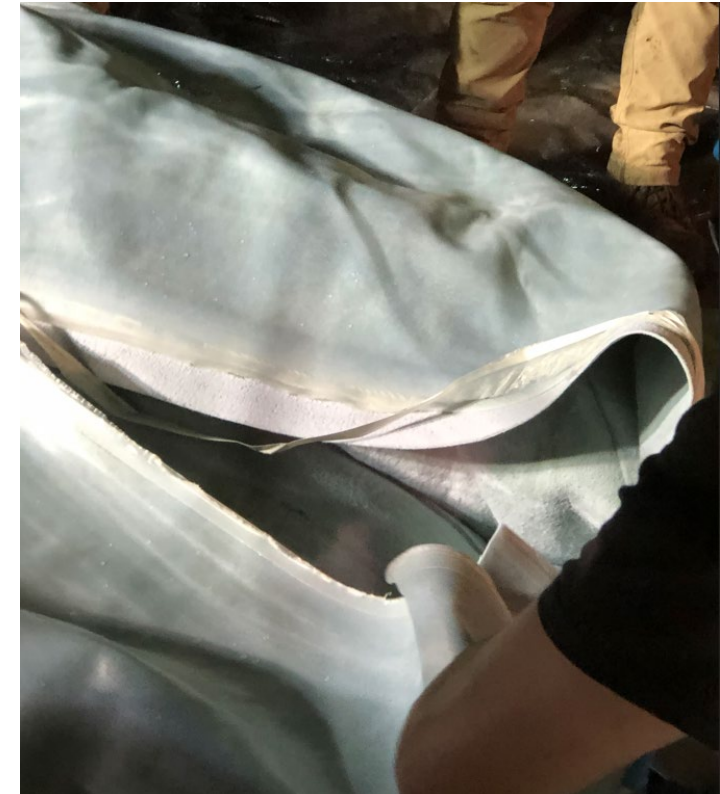
Seam Tear

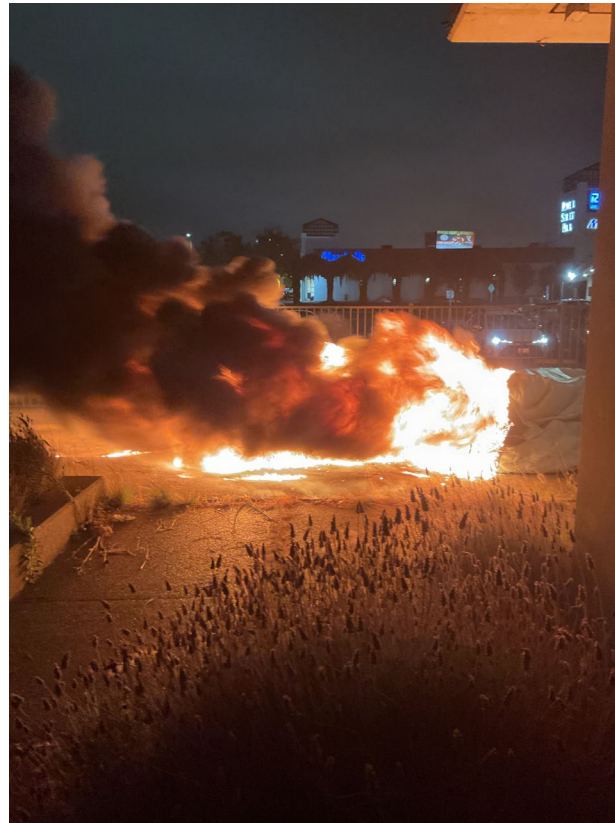
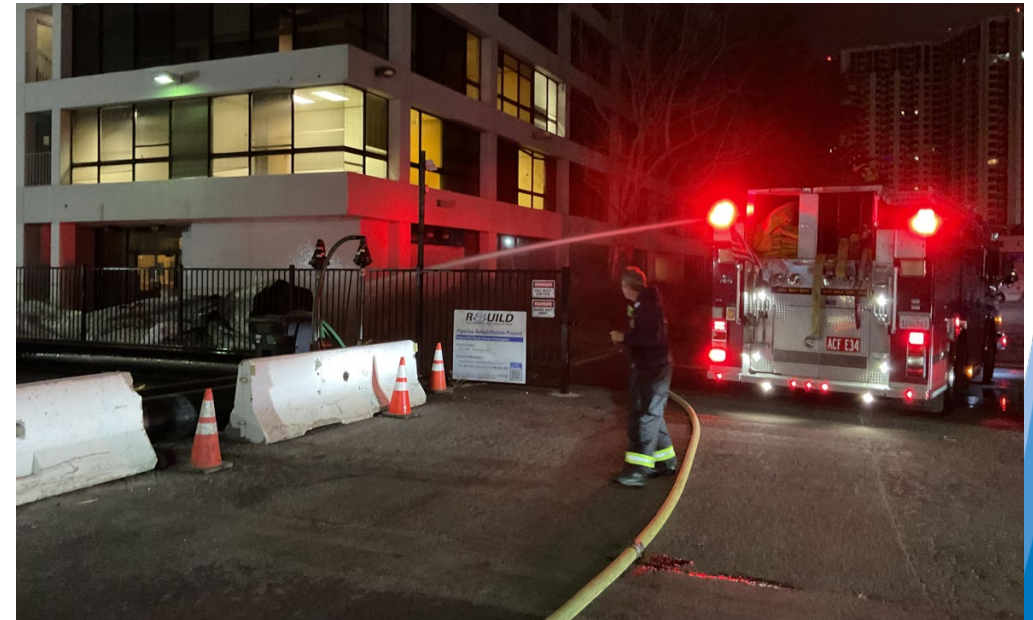
- Liner self-ignited
- Reason
- Public Impact
- Next steps?

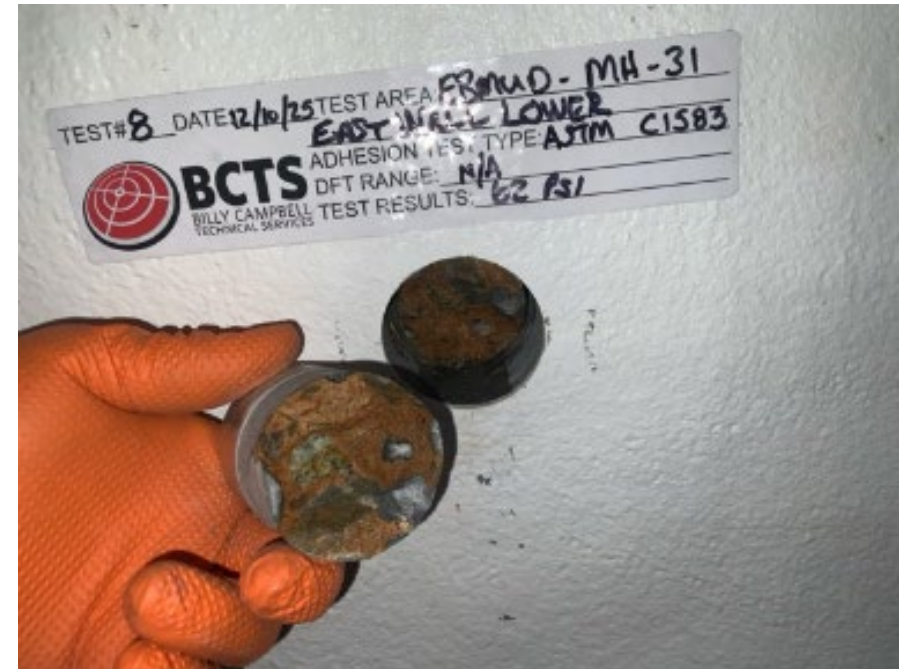
- Composite mortar-epoxy lining
- Specification requirements
- Pull test results
- Issue
  - Inadequate prep
  - or
  - Existing manhole issue

Pull Test Results

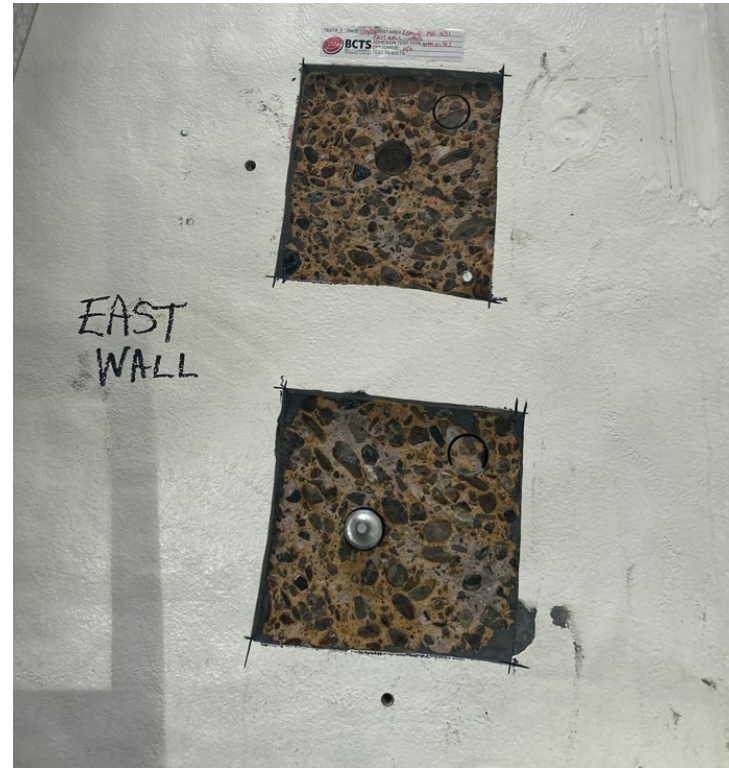
Retesting

- Cut “windows” into restored manhole
- Re-prepped areas with more rigorous QC and holdpoints
- Retest results
- Conclusion

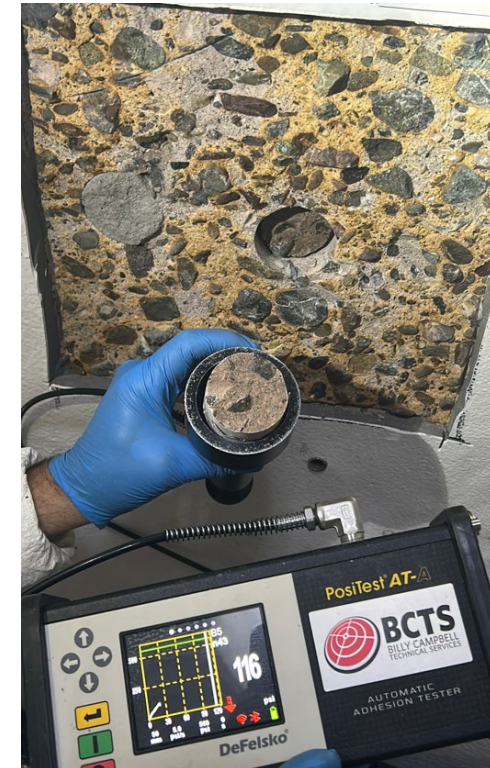
Retest Results

INITIAL RESULTS (PSI)	RETEST (PSI)	SPEC REQUIREMENT (PSI)
TEST 1	50	138	200
TEST 2	126	116	200
TEST 3	82	177	200
TEST 4	59	54	200
TEST 5	145	212	200
TEST 6	190	121	200
TEST 7	112	123	200
TEST 8	62	97	200

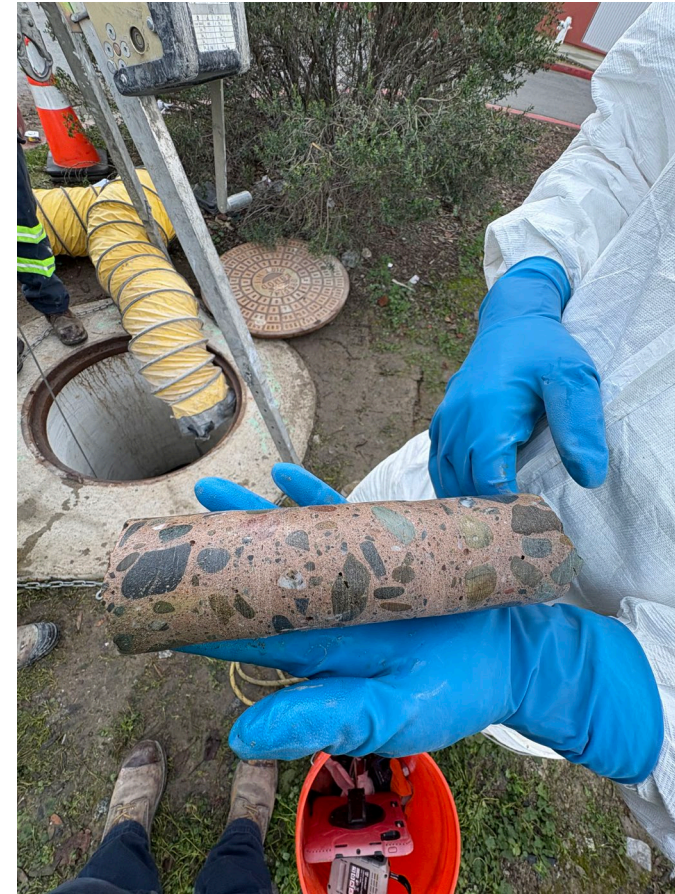
MANHOLE CORE
