The Northern California Pipe User's Group  
25th Annual Sharing Technologies Seminar

Berkeley, CA  
February 23, 2017

## AMERICAN CANYON REHABILITATES AGING STEEL TRANSMISSION LINE BY PIPE BURSTING

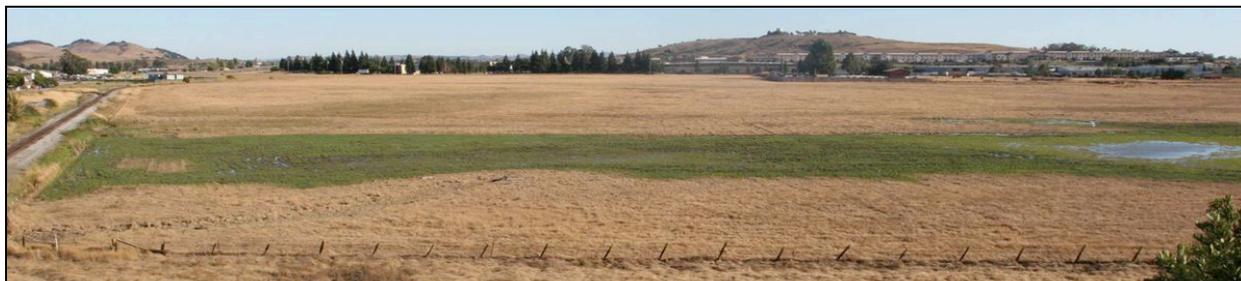
(AFY) of unaccounted water. One AFY equates to 325,900 gallons per year so, at its worst, approximately 98 million gallons of water were lost each year, or 10% of the city's total water demand. The 70-year-old transmission main was located along a roadside ditch with a few swales that detoured into vacant fields. The leaks along the line would fill these ditches with potable water that would then migrate through the swales to open fields, resulting in bright patches of green grass scattered along the alignment in the midst of the drought (see Figure 2).

Figure 2. Wet patch in a typically dry cattle field, a result of run-off from the leaking water main.

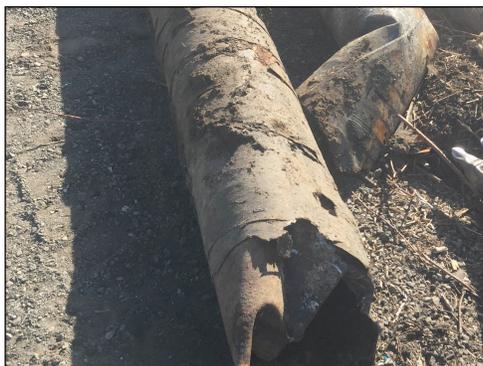
In the past few decades, a 7,400-foot segment of the 14-inch steel line had formed numerous leaks. Over 200 spot repairs had been performed along the main as leaks arose, yet it was still hemorrhaging between 100 to 200 gallons of potable water per minute (gpm), resulting in 200 to 300 acre-feet per year

Figure 3. Existing 14-inch steel transmission main installed in the 1940s.

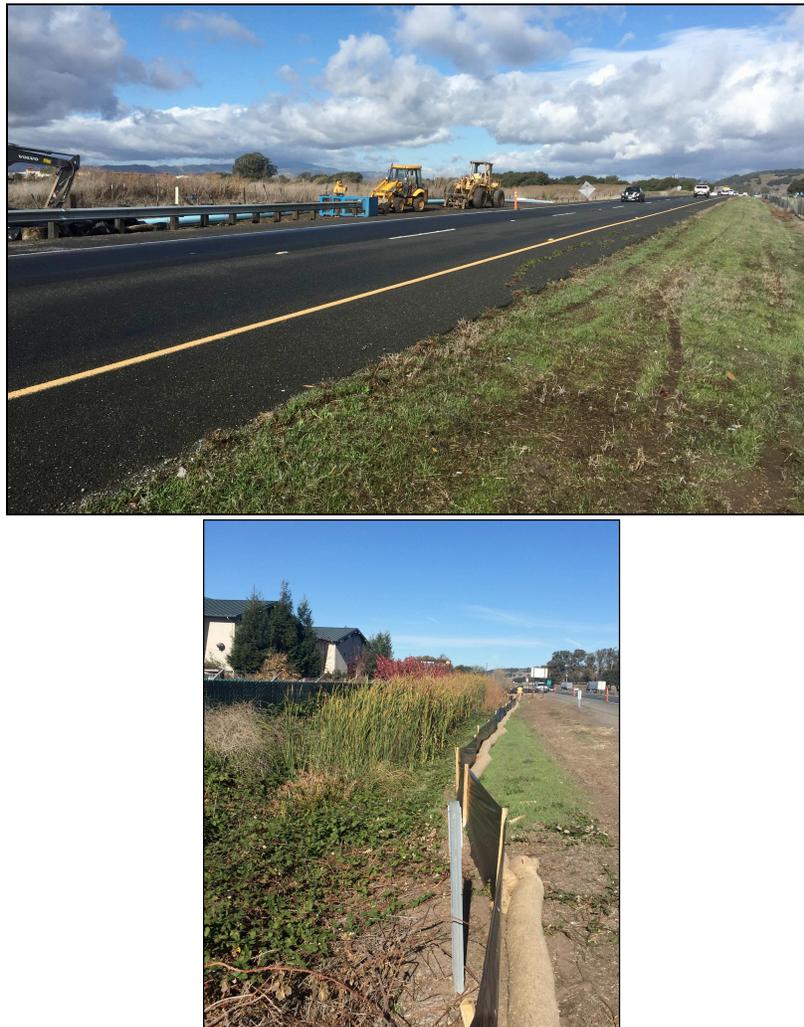
The existing 14-inch steel pipe laid at the bottom of the roadside ditch along CSR 29 with a minimum cover of three feet. There was only 5 to 10 feet from the ditch to the southbound lane of the highway, without any barriers between them. CSR 29 consists of two southbound and two northbound lanes with a posted speed limit of 65 miles per hour and approximately 50,000 vehicles travelling the route daily (see Figure 4). Other traits of the alignment included a creek crossing and ditch “habitats” that had formed in the over-saturated land above the leaking water line (see Figure 4). A mixture of potable chlorinated water from the steel line and storm water run-off into the ditch developed into a habitat with green vegetation, tules (typically found in marshlands), and a potential for red-legged frogs. The design needed to consider the impact of construction on highway traffic and the environment. A single lane closure would severely hinder residents’ daily commute and damage to these habitats and their wildlife would go against the city’s preservation efforts.

Figure 4. Environment near existing steel pipe [southbound lanes of CSR 29 (left); ditch “habitat” (right)].

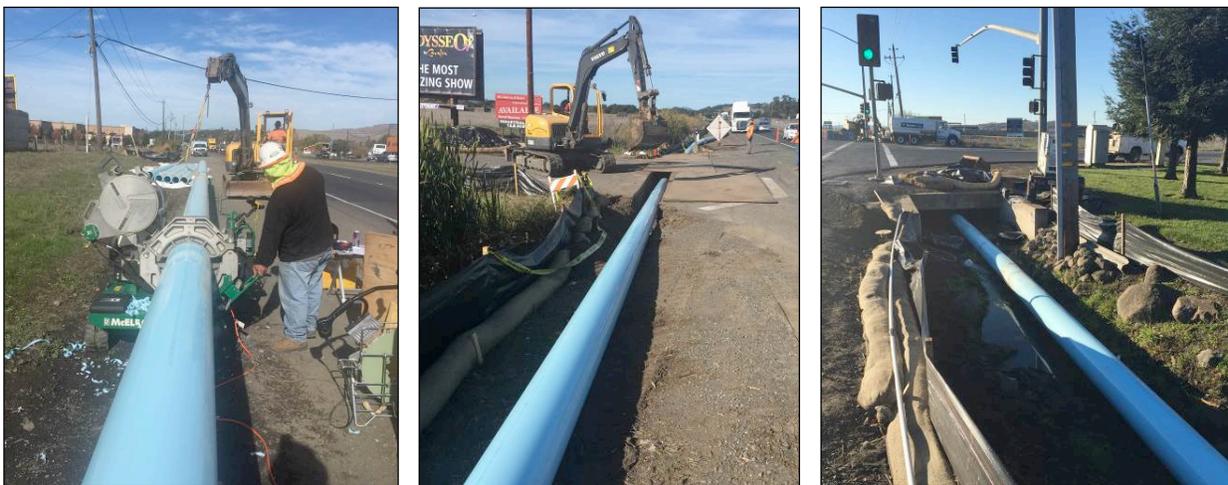
Fusion of 12-inch FPVCP began on November 4, 2015 for the first pipe burst run of the project. Fusion equipment was set up along the western shoulder of CSR 29 where fused pipe could be strung out to the total length needed for each pipe burst run (see Figure 7). Traffic control was minimal since all lanes of the highway were kept open for the duration of the project. However, several side streets and businesses were accessed off CSR 29. Access to the side streets had to be maintained at all times and driveways needed to be open to the public at least during business hours. The long pipe strings would occasionally cross one of these paths and, instead of attempting a tricky aerial layout or blocking access entirely, shallow trenches were excavated across the road and then covered with steel plates to maintain vehicular access and allow constant access for the pipe to cross (see Figure 7). At some crossings, the contractor was able to use existing drainage culverts to pull a fused pipe length under a road (see Figure 7). Both crossing methods allowed the pipe to be fused to the full length required for each run without need of intermediate fusion joints.

Figure 7. Pipe fusion and layout [fusion (left); layout under road (center); layout through culvert (right)].

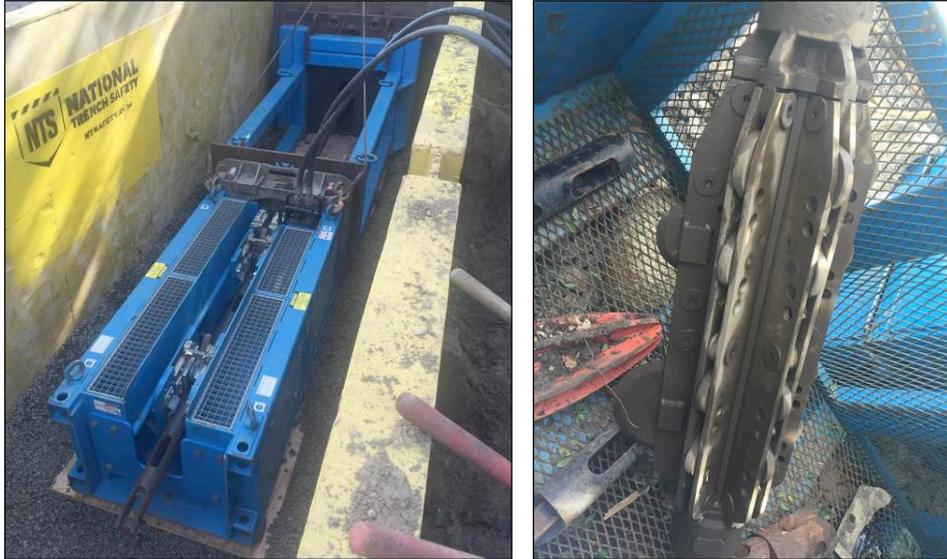
The pipe bursting equipment and pits were set up away from any driveways or intersections to avoid conflict. JMB used a static pipe burst unit from TT Technologies to install each of the pipe burst runs (see Figure 8). The unit used “Quickloc” bursting rods that allowed the contractor to add or remove rods much

faster than standard threaded rods and a rolling blade cutting rod (see Figure 8) to slice the steel before it met the expander head.

Figure 8. Static pipe burst equipment [static pipe burst unit in exit pit (left); roller cutters (right)]. Initially in design, 11 pipe burst runs or “locations” were anticipated; however, once on-site, JMB determined that much longer runs could be completed at lengths up to 1,200 feet. This revised plan increased productivity and minimized the number of entrance and exit pits and the associated excavation and assembly time, lessening the impact to traffic and businesses on the alignment. Fewer pits also reduced the risk of disrupting the environment along the pipeline; several lengths of the alignment were considered to have a habitat with potential for special status species (the red-legged frog) and required a biologist to be on-site to monitor construction.

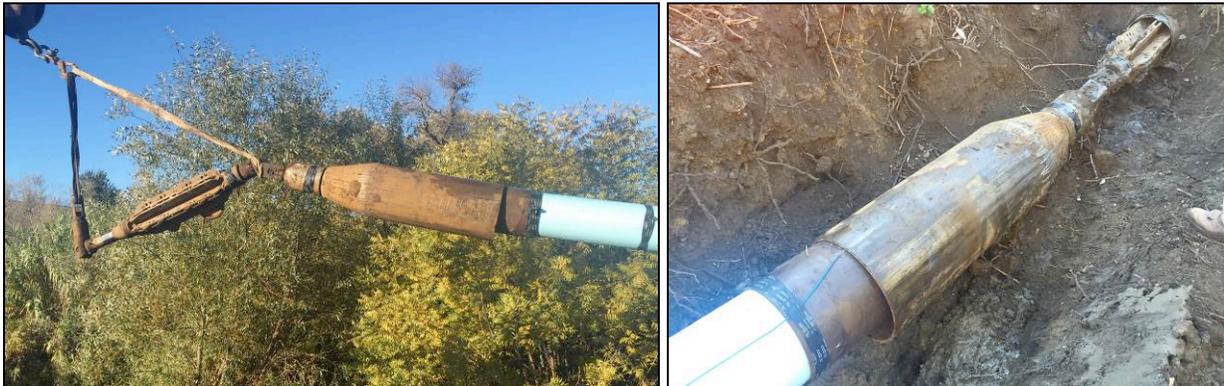
The number of pipe burst lengths was reduced to six. For each run, JMB set up the bursting unit in the exit pit and then fed the bursting rods through the existing steel line to the entrance pit. On the entrance pit side, a roller cutter and expander head were attached to the new 12-inch pipe and connected to the bursting rods (see Figure 9). At that point the assembly was pulled back through the existing line (see Figure 9), cutting and bursting open the 14-inch steel and pulling the 12-inch FPVCP into place behind it all the way to the exit pit (see Figure 10). Because the existing pipe alignment was under the drainage ditch, the pipe strings laid out through the drainage culverts and along the shoulder of the freeway could be pulled into the entrance pit with little to no adjustments. For four of the six runs, pulling the new pipe string into place did not obstruct access to any facilities, which allowed them to be installed during the day. The other two runs, however, would cross and block off several driveways during installation. These could not be installed during business hours, requiring night work. The pipe was strung elsewhere prior to installation and then pulled into place when the run was ready for pull back.

Figure 9. Installation from entrance pit [cutter and expander assembly (left); pull into existing steel (right)].

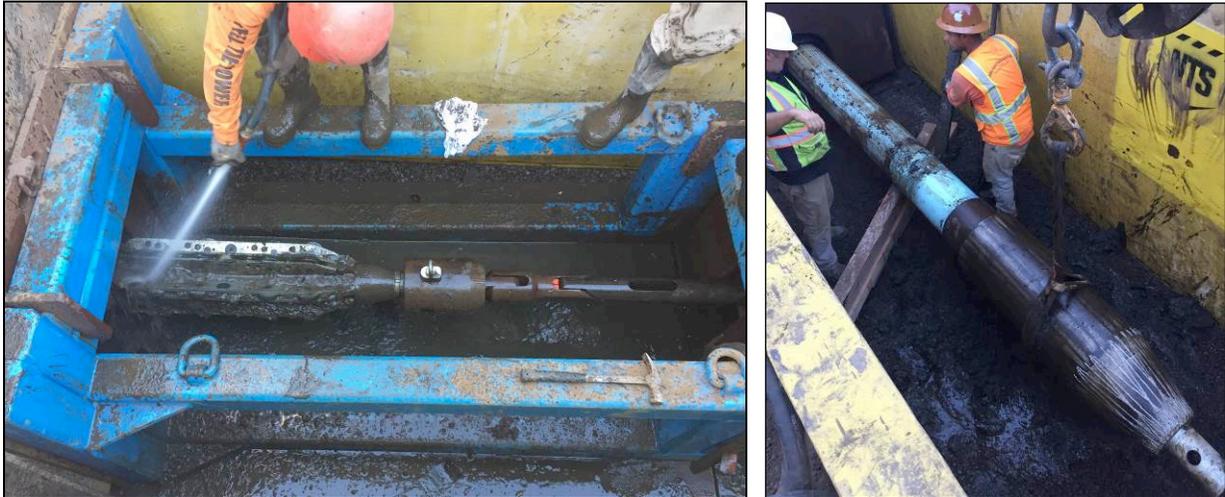
Figure 10. Installation from exit pit [roller cutter pulled through (left); pipe pulled through (right)].
