INSTALLATION OF A COMPOSITE BONDED LINER FOR CORROSION PROTECTION AND REHABILITATION OF EBMUD 105” INTERCEPTOR SYSTEM

**TWENTY-FOURTH ANNUAL SHARING
TECHNOLOGIES SEMINAR**

PUG 2016

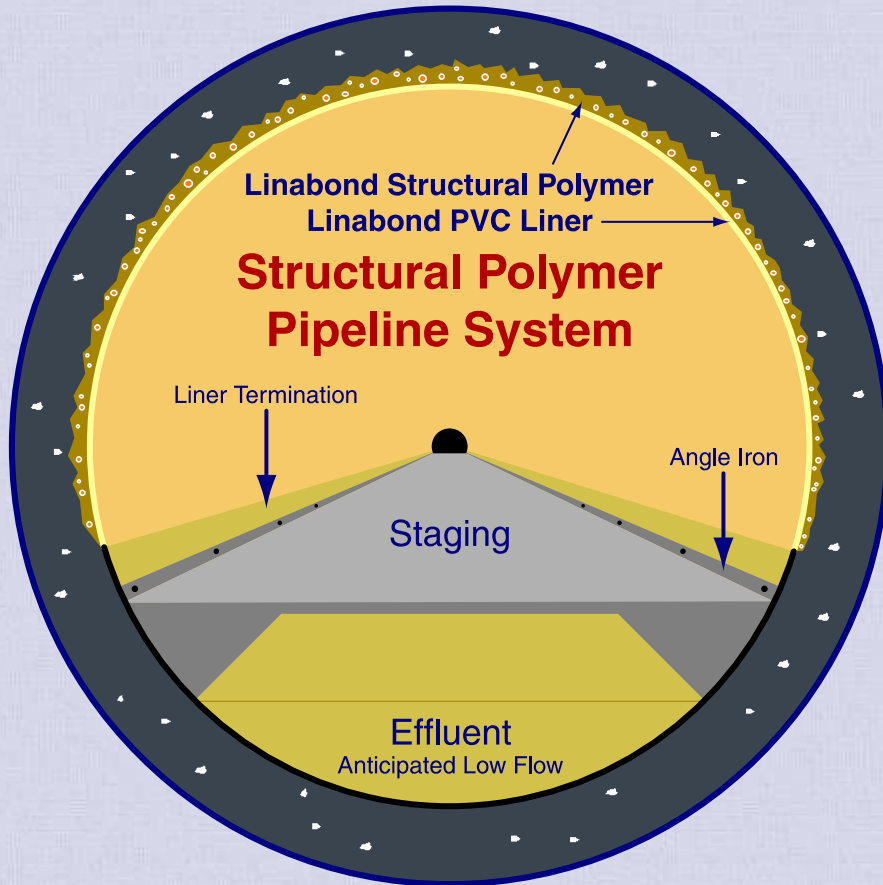
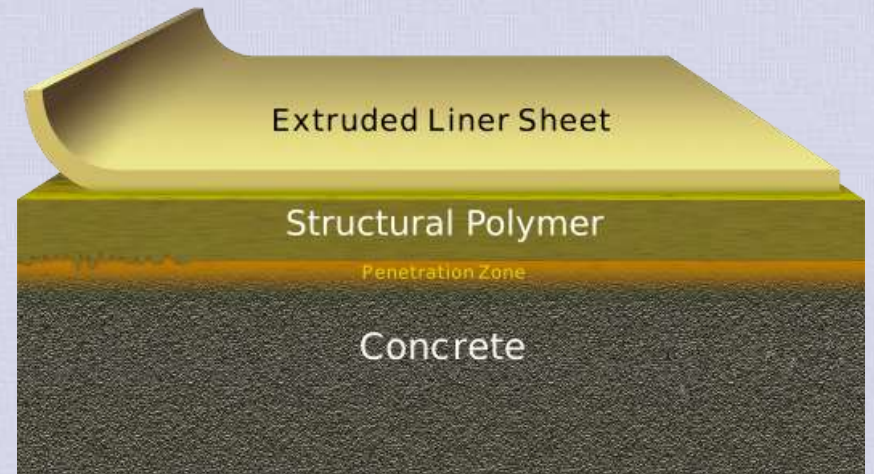
STRUCTURAL POLYMER SYSTEM

- Danby: semi-rigid partial ribbed liner grouted in place
- T-Hab: grouted in place ribbed liner with portable support forms
- Linabond Structural Polymer System: composite bonded liner.
