The Northern California Pipe User's Group  
22nd Annual Sharing Technologies Seminar

## Asbestos Cement Pipelines – Sampling, Testing, and Condition Assessment

The East Bay Municipal Utility District (EBMUD) is a major metropolitan water district located near San Francisco, California, with over 4,100 miles of distribution mains including 1,100 miles of asbestos cement (AC) pipe with an average age of 50 years. A surge in AC pipe failures led to a first phase of collection and testing that showed that AC mains were deteriorating from both inner and outer wall corrosion. A second phase of collection and testing, using state-of-the-art sampling, testing, and condition assessment methods using acoustic technology, is currently underway in collaboration with Water Research Foundation (WRF). Results from both studies will be used to complete statistical analyses and remaining service life predictions, to assess the need for water quality changes to reduce the rate of inner AC wall deterioration and to implement a model that can be used to develop a cost-effective program to replace or rehabilitate AC pipes.

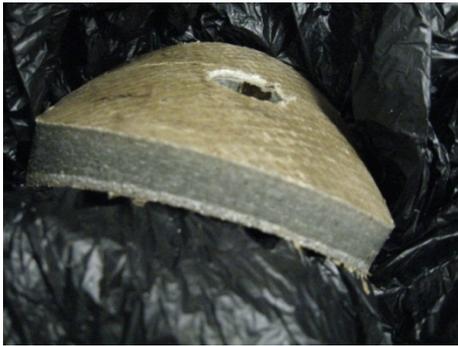
**Figure 2.11 – Coupon Sample**

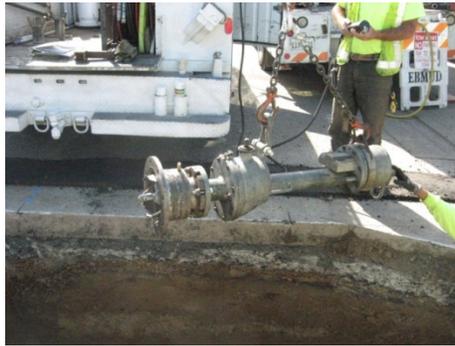
**Figure 2.12 – Pipe Tap Machine**

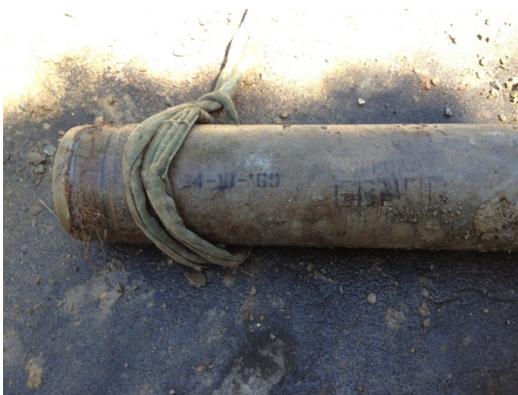
**Figure 2.13 – AC Pipe Sample**

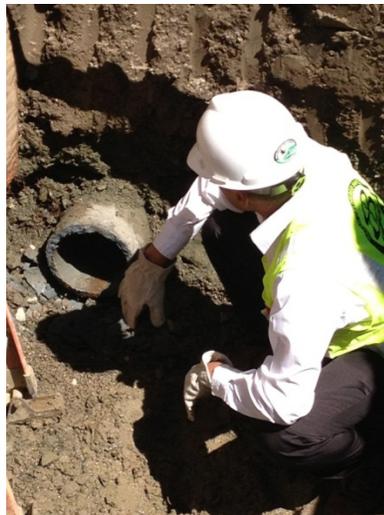
**Figure 2.14 – AC Pipe Excavation**

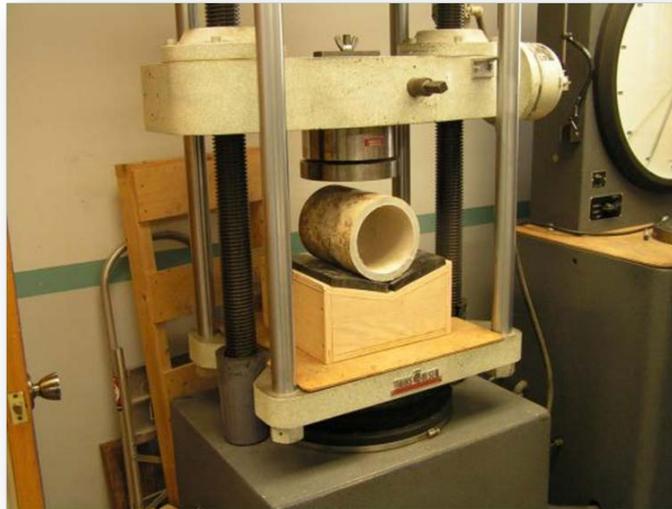
The crush strength tests conducted on the pipe samples indicated that all of the test samples met the requirement of as-manufactured (new) pipe for Class 150 AC pipe.

**Figure 2.23 – Crush Strength Test**

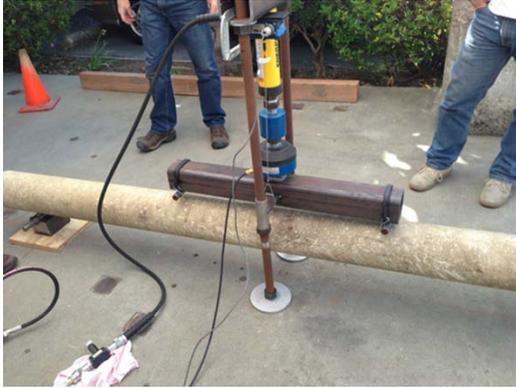
Flexural testing was performed on two samples, each requiring a minimum length of 9-feet. The flexure test results indicated that the samples met the requirement for new Class 150 AC pipe.

**Figure 2.24 – Flexural Test**

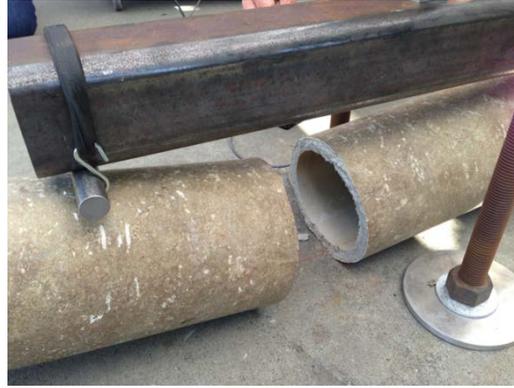
**Figure 2.25 – Flexural Test**
