## The Northern California Pipe User's Group 28th Annual Sharing Technologies Seminar

Concord, CA  
February 20, 2020

### **EBMUD 3<sup>rd</sup> St. Interceptor Rehabilitation Phase 2**

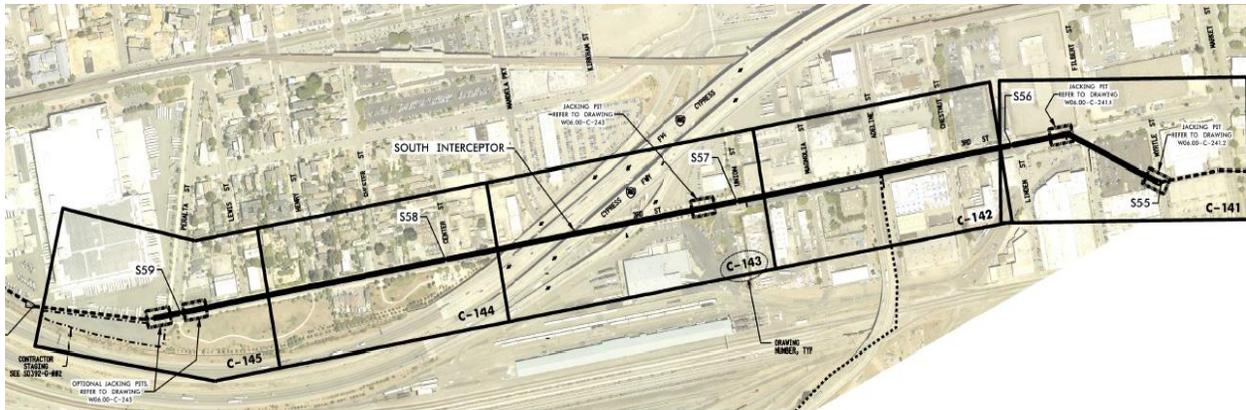
Up to five sliplining pits were planned for this project, and were strategically located at interceptor bends or midpoints of long reaches. Community impacts, construction staging, traffic and underground utility conflicts were also considered when locating the pits. Extensive underground utility searches were completed by utility locating, ground penetration radar, and potholing during the design phase to identify these potential conflicts. The locations of the five potential pits are shown in Figure 4. Contractors were to assume these five pre-defined pits were utility-free and were allowed to use as many or as few as they wanted.

Figure 4. Locations of the five planned sliplining pits

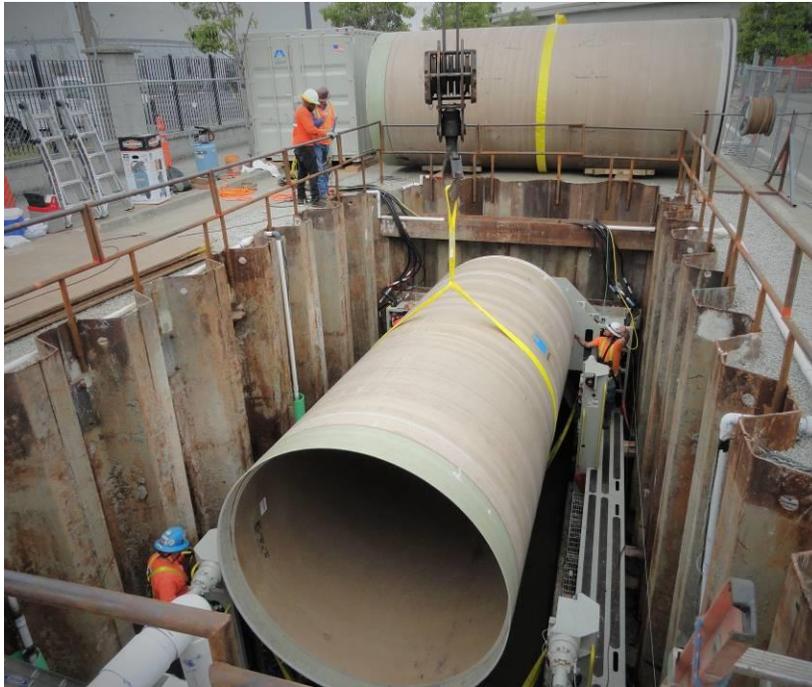
Sliplining can be advantageous because pipe can be installed much faster than other technologies for large-diameter applications. An inherent challenge is being able to ship pipe to the project site fast enough to keep up with the installation rate. It is difficult to stockpile pipe in the congested work area due to amount of space each 20-foot piece of pipe occupies. To balance the pipe installation and shipping rates, the Contractor had to accurately forecast how much pipe would be needed three days in advance so that the pipe manufacturer could ship pipe accordingly. Ultimately, the sliplining portion of the work required approximately 20 working days for a majority of the 4,700-foot reach of the project. A photo of the pipe being lowered into the pit is shown in Figure 6.

Figure 6. New pipe being lowered into pit, and next pipe ready to be lowered

The contractor procured a high-capacity pipe pushing machine specifically for the Project to allow them to push longer reaches of pipe, which eliminated the need for two extra sliplining pits. Pushing longer reaches has its challenges due to the amount of force required with each additional pipe that is installed; each 20-foot section of pipe weighed 11,250 pounds. In order to overcome the frictional force to push the new pipe, the contractor made the new pipe more buoyant by diverting more flow outside of the new pipe, which effectively increases the upward force on the new pipe. This approach allowed the contractor to push 2,500 feet of 96-inch diameter pipe in a single reach.
