The Northern California Pipe User's Group
28th Annual Sharing Technologies Seminar

City of San Diego Programmatic Water Transmission Pipelines Condition Assessment Project

Clinton McAdams, P.E.¹ Daniel Rodriguez, P.E.²

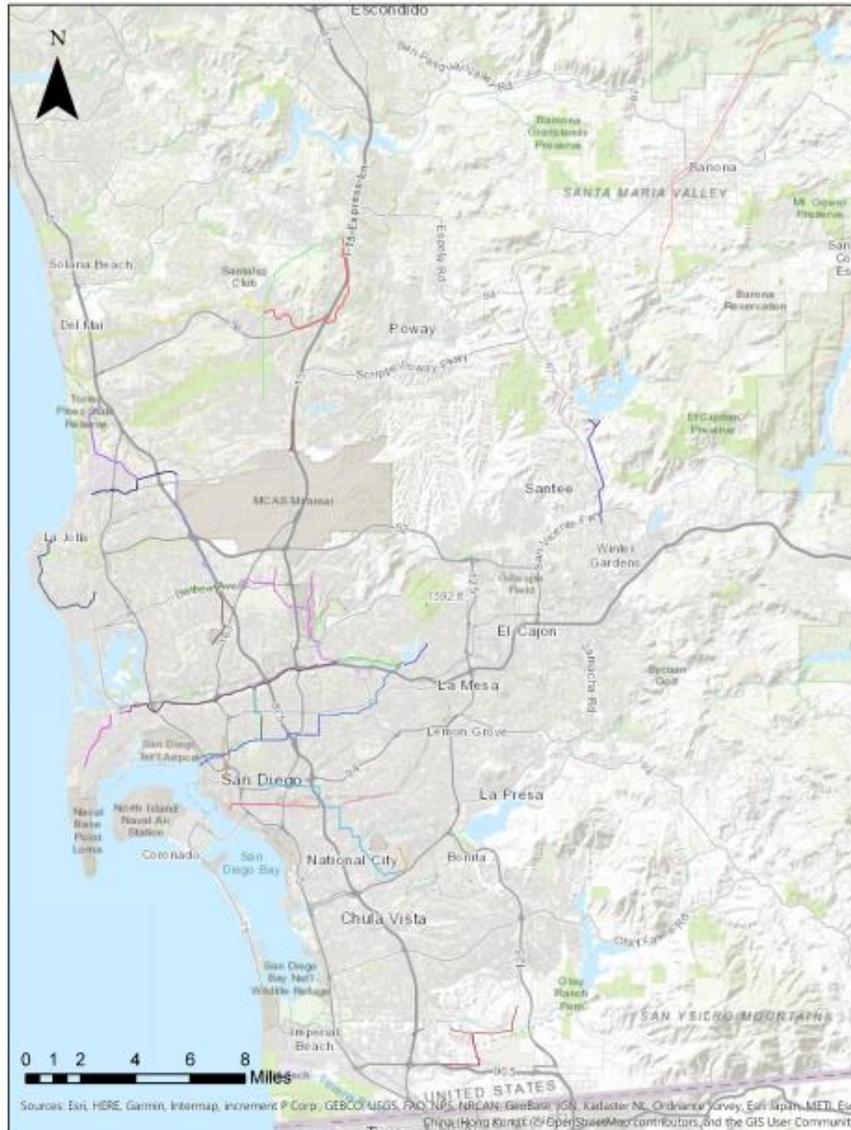
The transmission pipelines shown in Figure 1 have been in service for 40 or more years and vary in size from 20-inch to 54-inch in diameter. Pipeline materials are primarily reinforced concrete steel cylinder (RCSC) pipe, steel cylinder rod wrapped (SCRW) pipe, and cement mortar lined and coated steel (CML&C) pipe. Of the 34 pipelines, three convey raw water and 31 convey potable water.

Figure 1. Map of assessed pipelines

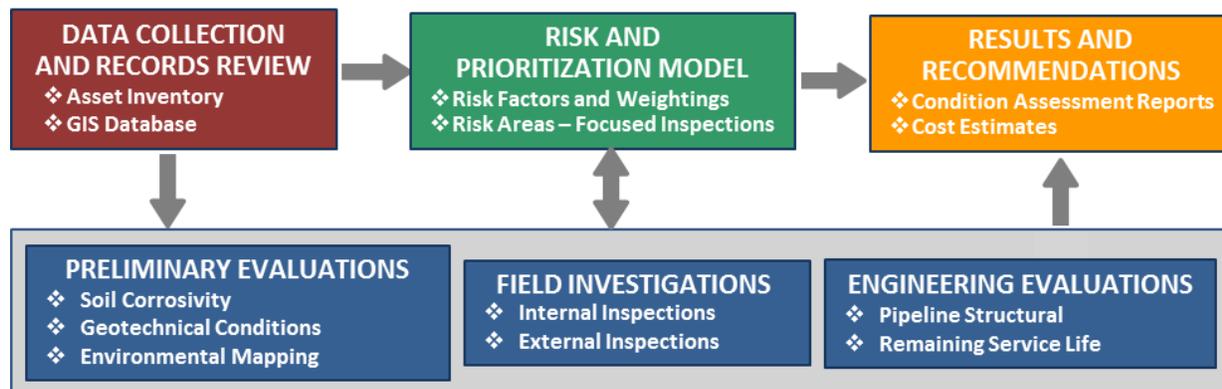
Black & Veatch developed a six-step work flow process for conducting the assessments with each step of the process building on the results and findings from the previous step, as shown in Figure 2. While keeping most of the pipelines in service, Black & Veatch conducted internal leak detection, video inspections, non-destructive testing (ultrasonic testing, slab impulse response, and mortar sample testing), visual inspections, soil corrosivity testing, and a geotechnical evaluation of each pipeline alignment in order to document the liner integrity, structural integrity, and other localized defects that will affect the reliability or serviceability of the pipelines either now or in the future. As an example, Figure 3 shows the various inspection methods that were used, and their coverage, for the Elliot potable water pipeline. The Project also included a field evaluation and assessment of over 200 valves and appurtenances on the potable water pipelines, including inline valves, isolation valves to branch transmission lines, air vacuum and air relief valves, and blow-off valves. The in-service condition assessment inspections yielded comprehensive information with the least impact on water operations.

Figure 2. Project approach

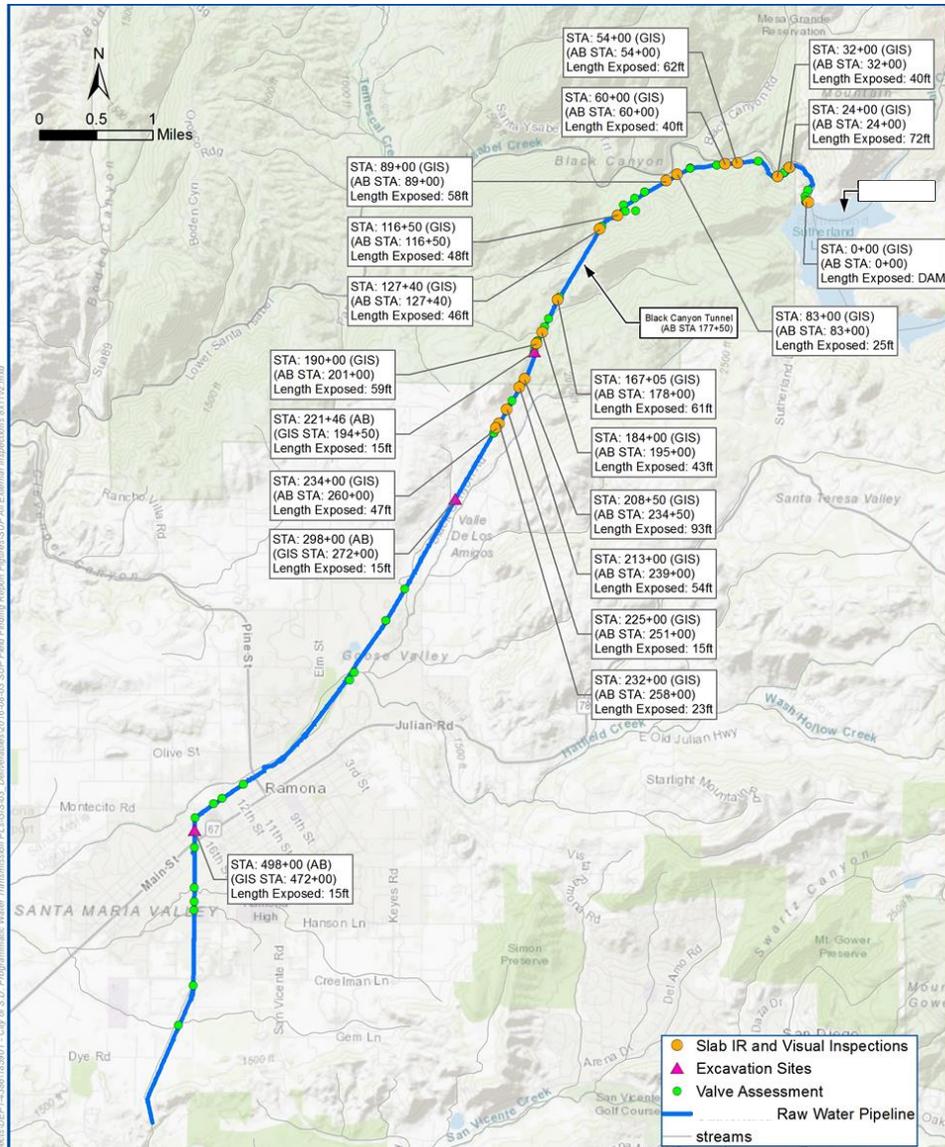
The raw water pipelines were inspected first to set a precedent for the potable water pipeline inspections. The raw water pipelines are some of the highest risk pipelines in the transmission system yet were easier to take offline and inspect than the potable pipelines because of system redundancy and downstream reservoir capacity. Originally, manned-entry inspections had been planned to supplement the CCTV inspections for the raw water transmission pipelines. However, some pipelines required the addition of new access manways for CCTV equipment insertion. Additionally, CCTV results justified an increased scope for manned-entry inspections. Along with the relative importance of the raw water pipeline system, a revised plan for internal inspections relying predominantly on physical manned entry was proposed by Black & Veatch. The revised plan provided a substantial increase in the inspection coverage, as shown in Figure 3, and contributed to the discovery of several areas of damage.

Figure 3. Example inspection methods and coverage for raw water pipeline

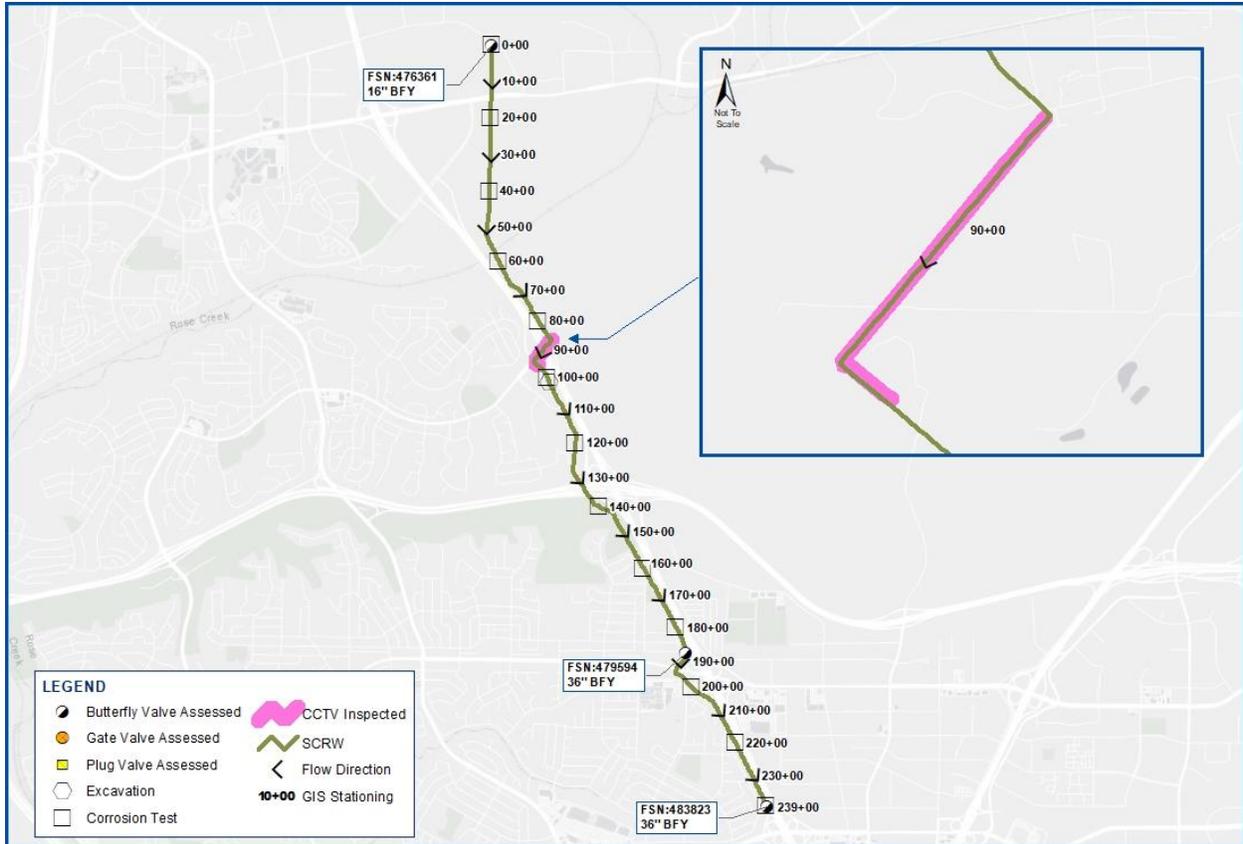
The potable water pipeline inspections were conducted in two phases. Black & Veatch performed a preliminary risk analysis based on the background data and records review and preliminary investigation results. This categorized the potable water pipelines according to overall risk and established groups of pipelines as high, medium, and low priorities for Phase 1 inspection. The Phase 2 inspections were intended to verify concerns identified during the preliminary investigation and Phase 1 inspections. Potable water pipelines tended to be smaller diameters than raw water pipelines which resulted in different inspection approaches, as shown in Table 1. The City also preferred to keep these pipelines in service, so manned-entry inspection could not be performed. An example of inspection methods and coverage for a potable water pipeline is presented in Figure 4.

Figure 4. Example inspection methods and coverage for potable water pipeline

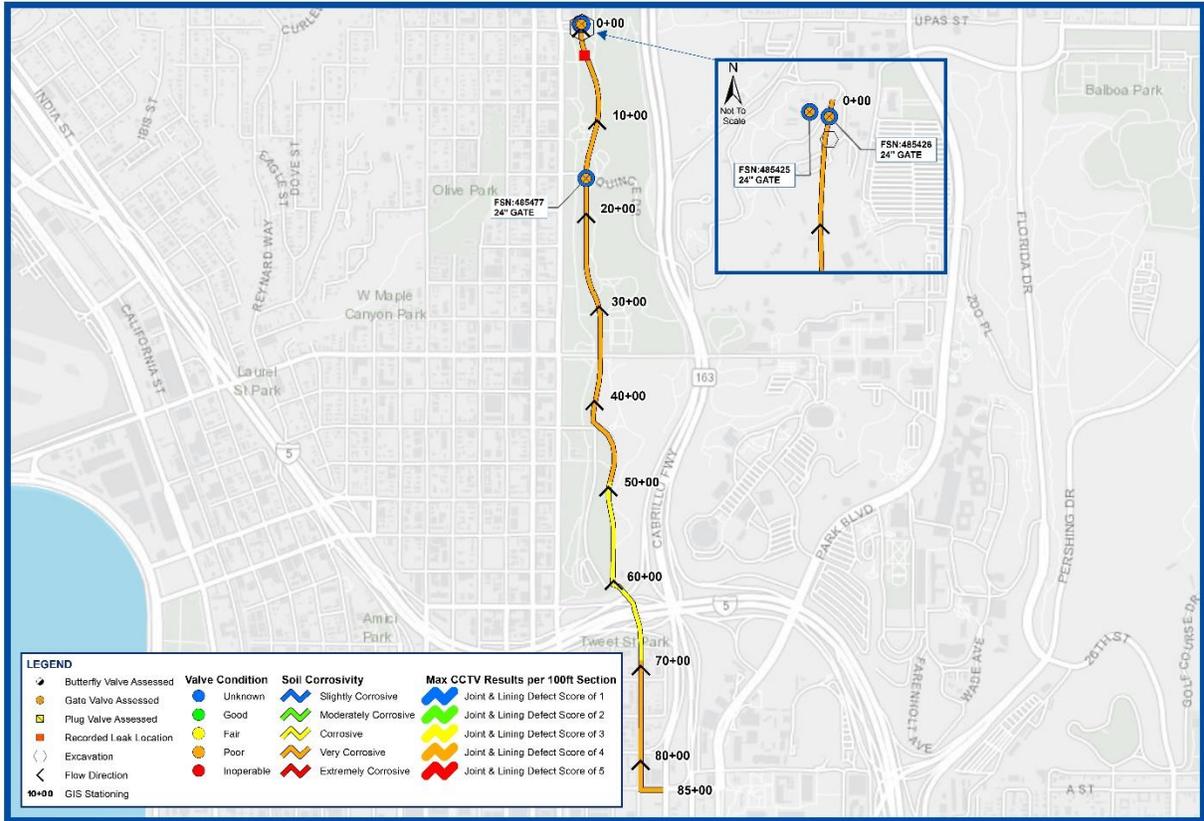
The Project has been successful in identifying high-risk pipeline segments and performing emergency rehabilitation at areas that have failed or are at risk of imminent failure. Pipeline condition was determined by correlating as-built information, historical performance records, field investigations, and phase 1 and/or phase 2 inspections. Figure 5 shows an example correlating the condition assessment results for a potable water pipeline. A rating system based on a 1 through 5 scale was used to score pipe segments.

Figure 5. Example inspection results for potable water pipeline

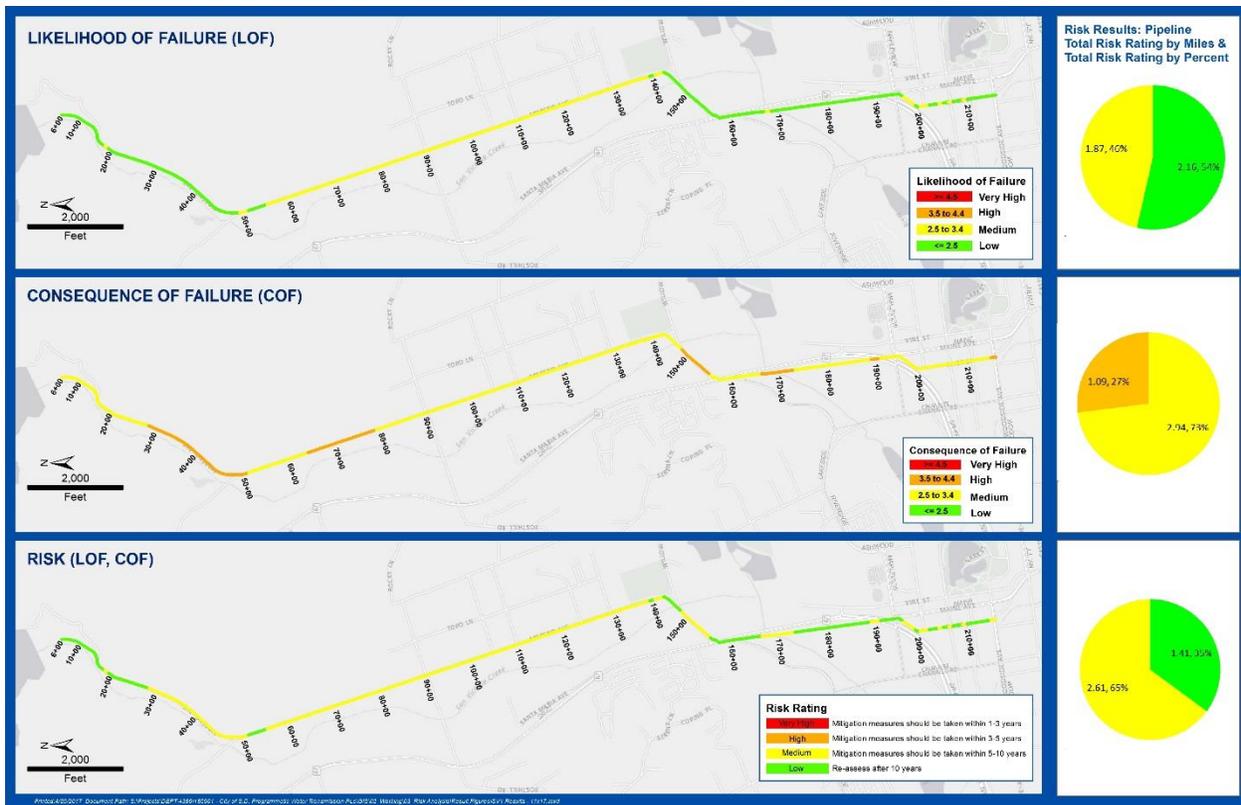
This assessment of pipeline conditions was bolstered by a risk analysis of each pipeline, along with a review of remaining useful life. The likelihood and consequence of failure factors used in the risk analysis were calibrated using field inspection data and Black & Veatch’s knowledge and experience with similar condition assessment projects. The model was used to predict the rate of deterioration and forecast when the pipeline may be no longer cost effective to maintain. Examples of the risk analysis results are presented in Figure 6 and Figure 7.

Figure 5. Example risk analysis results for raw water pipeline

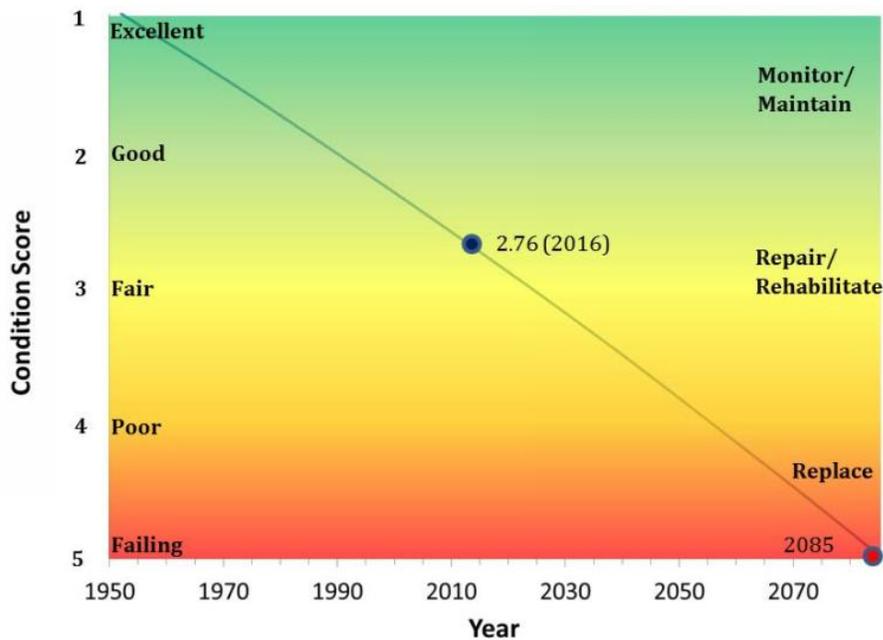
Figure 6. Example condition curve for raw water pipeline

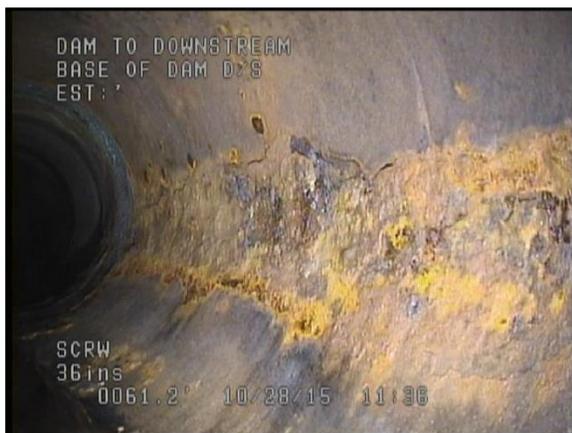
- Manned-entry of a raw water pipeline that was already taken offline lent itself well to being rehabilitated during the shutdown that was already in effect. An example defect that was rehabilitated as part of the manned-entry raw water pipeline inspection is shown in Photo 1 below.

Photo 1. Example internal inspection on raw water pipeline

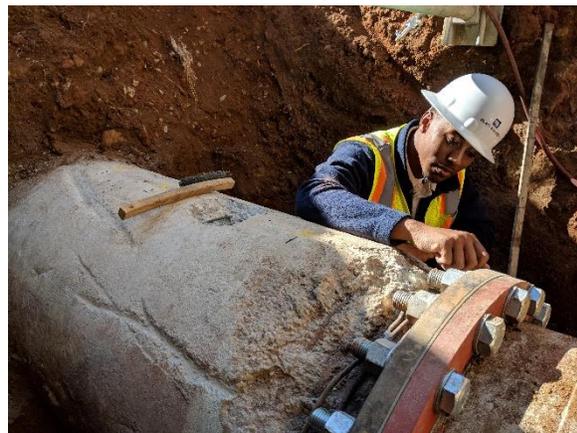
- There is no silver bullet—all inspection results were used in conjunction to identify potential trends and root causes. Photo 2 shows an example of Phase 2 external inspection confirming preliminary investigation and Phase 1 internal inspection results.

Photo 2. Example external inspection on potable water pipeline

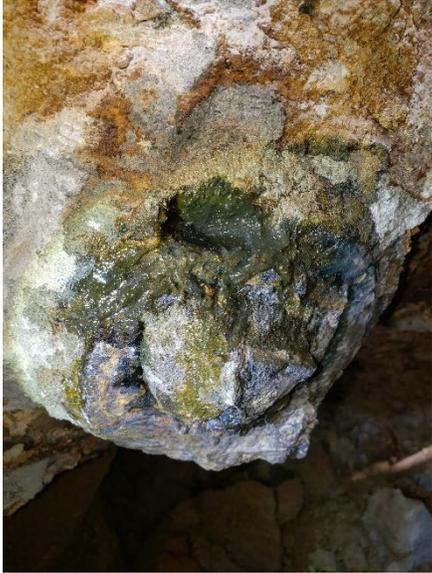
Photo 3. Example leak identified by inspections and repaired on potable water pipeline
