HOW A SUCCESSFUL PROJECT WOUND UP IN COURT (A CASE STUDY OF THE MAGNOLIA FORCE MAINS RELOCATION PROJECT)

Presented at the Northern California Pipe Users
Group

February 13, 2025

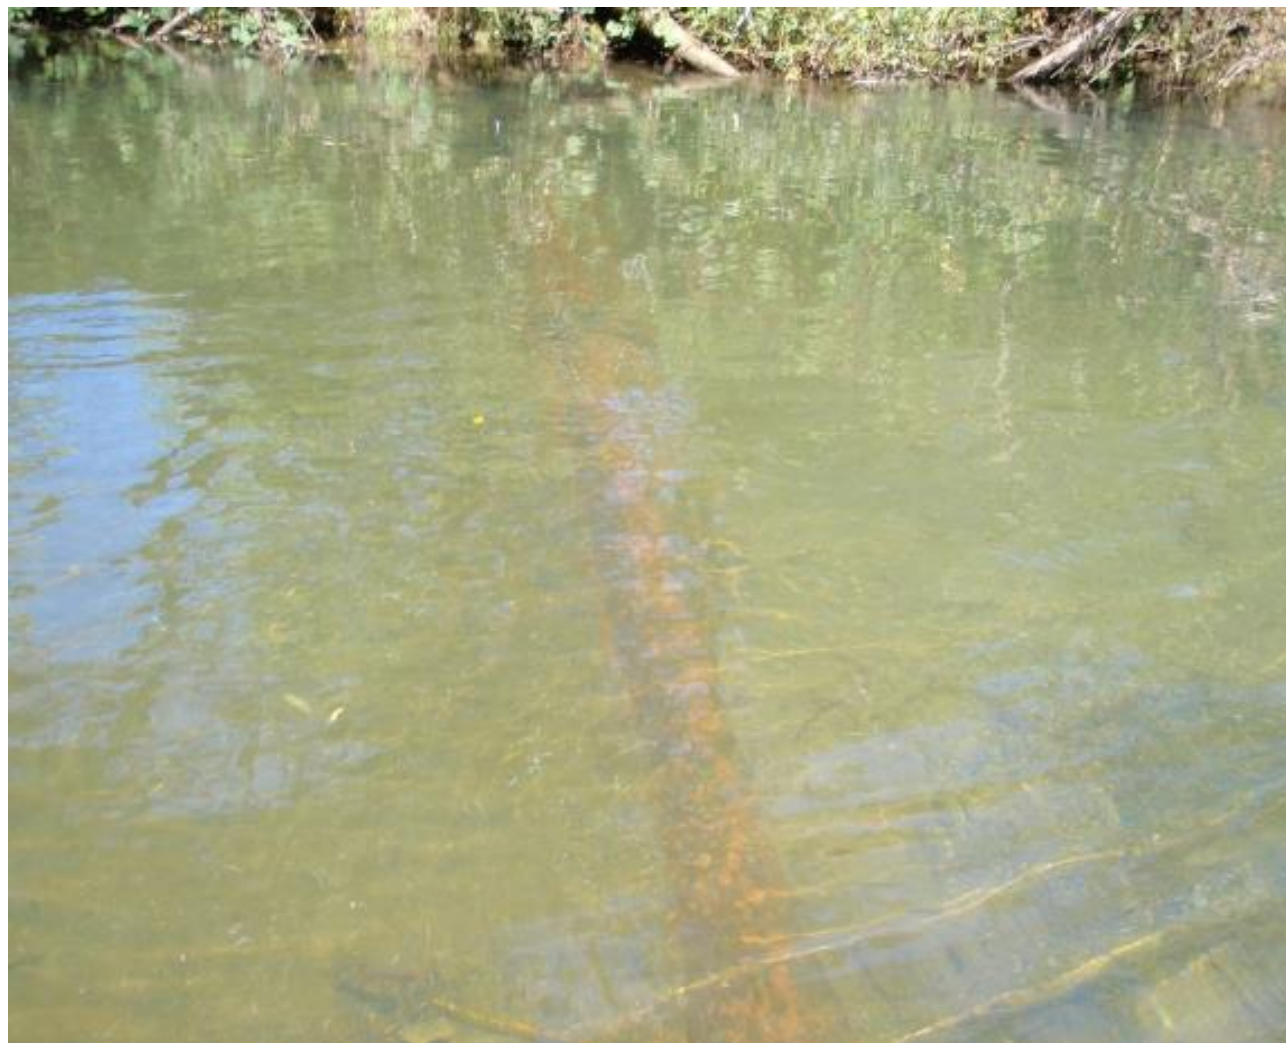
- The original FMs were open-cut constructed prior to Warm Springs Dam.
- During RW bridge construction in 2014, one of the force mains was observed to be exposed.

Exposed pipeline at streambed is vulnerable to damage and corrosion.

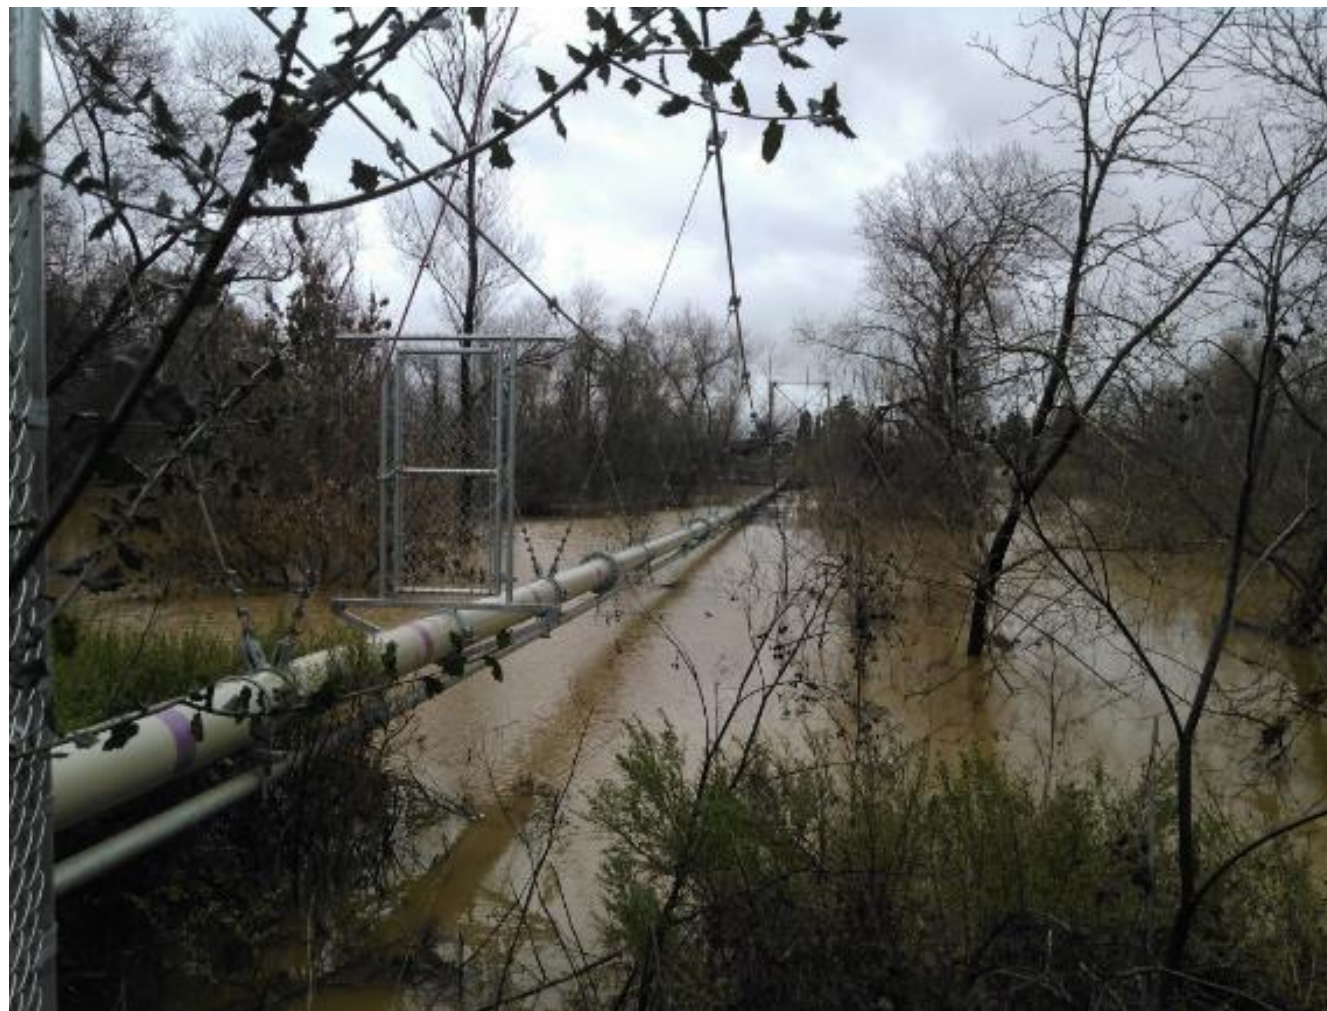
- Reconstructing the force main using open-cut is not possible because of flow year round
- Bridge crossing over the creek is possible with new bridge, but has on-going maintenance and reliability issues

Dry Creek level rises routinely making an aerial crossing vulnerable to damage from floating debris

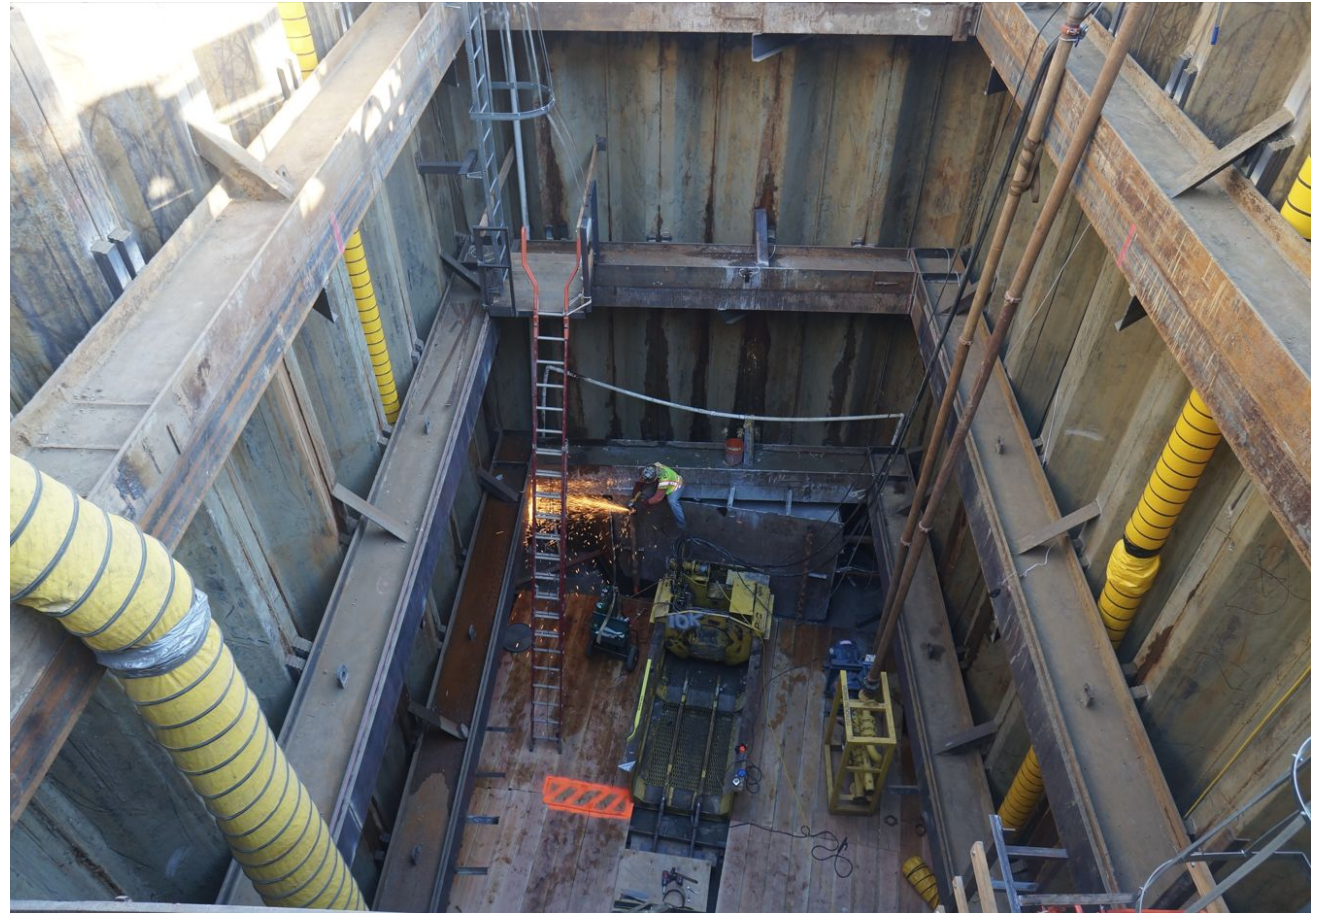
Microtunnel jacking pit

- Watertight shoring using interlocking sheet piles and internal bracing
- Ground improvement at MTBM launch and retrieval areas using compaction grouting techniques

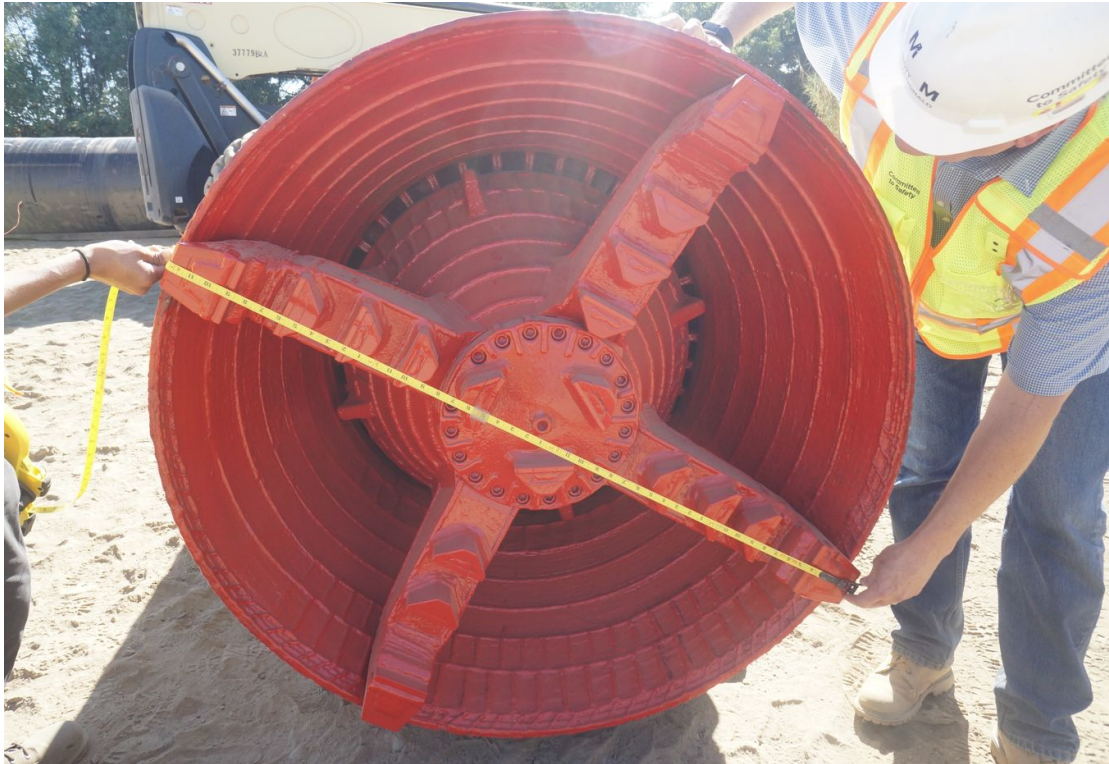
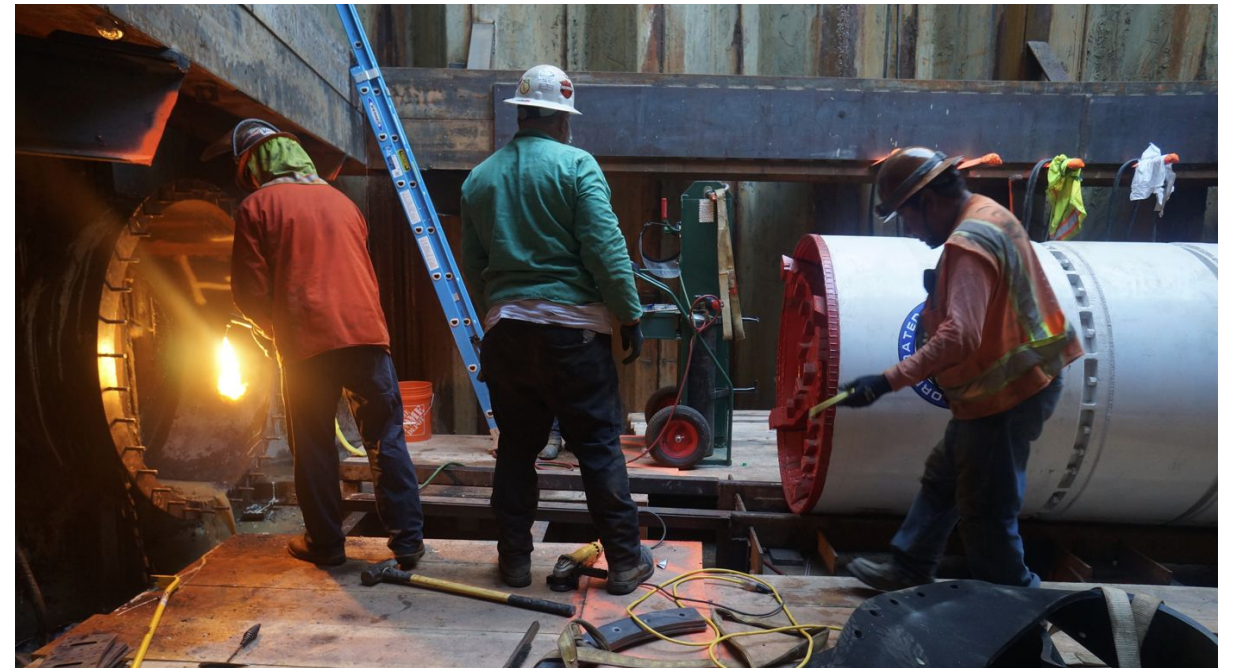
- Ø48" Iseki Unclemole TCC 1000
- No automated recordkeeping (spec variance)

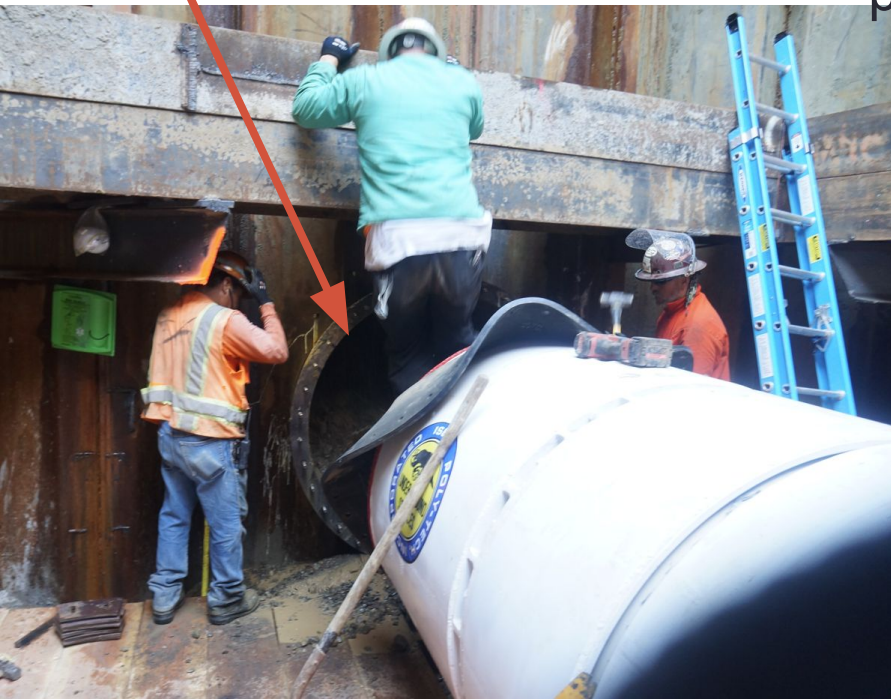
Removing sheet pile at entry

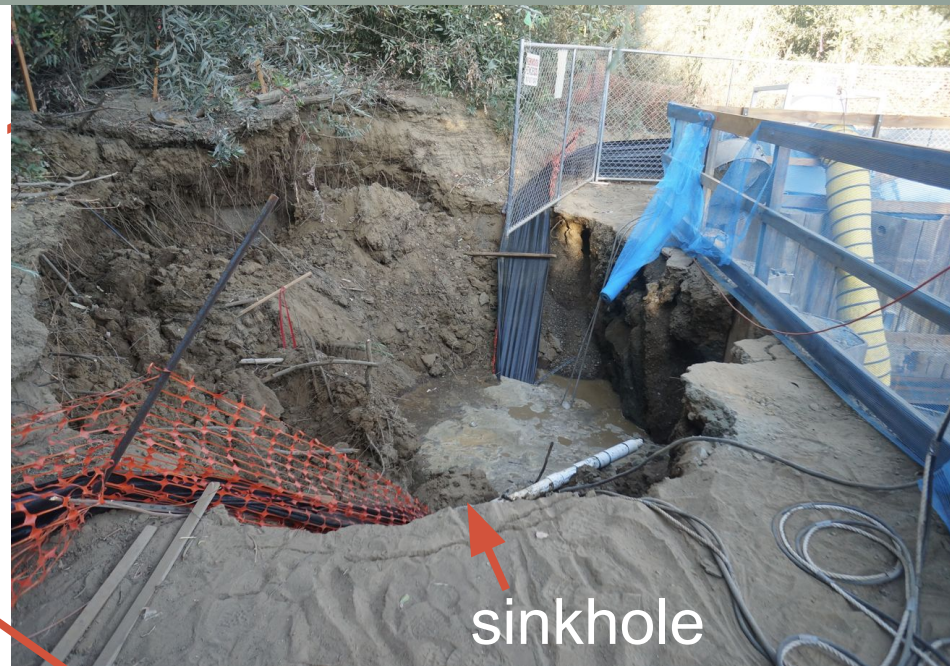
~60 cy of wet gravel enters entry point

sinkhole

- Ground-pre-treatment determined ineffective
- 13 days lost

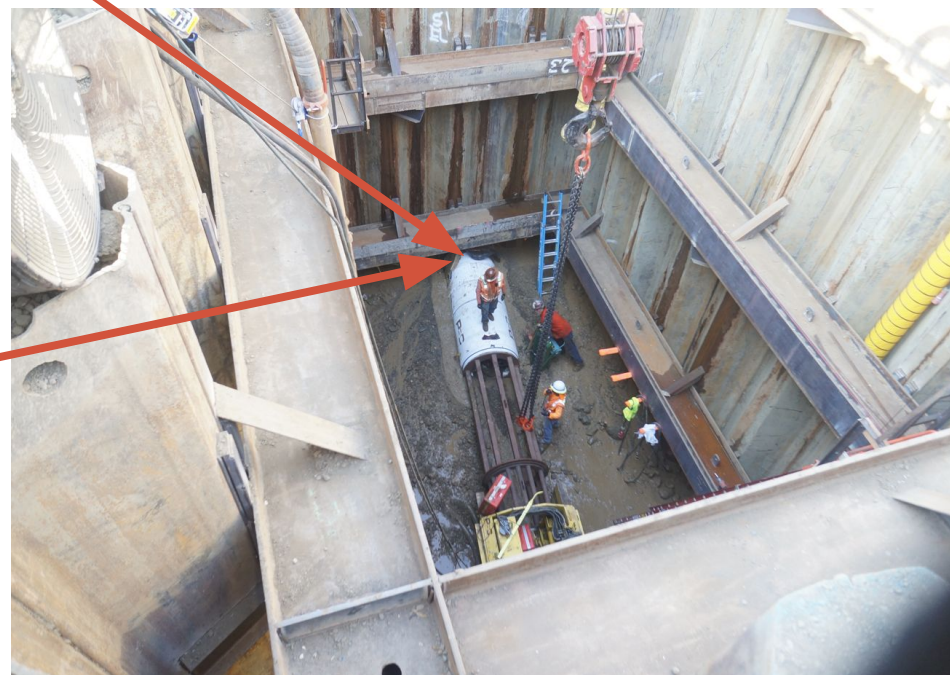
MTBM thrust into opening

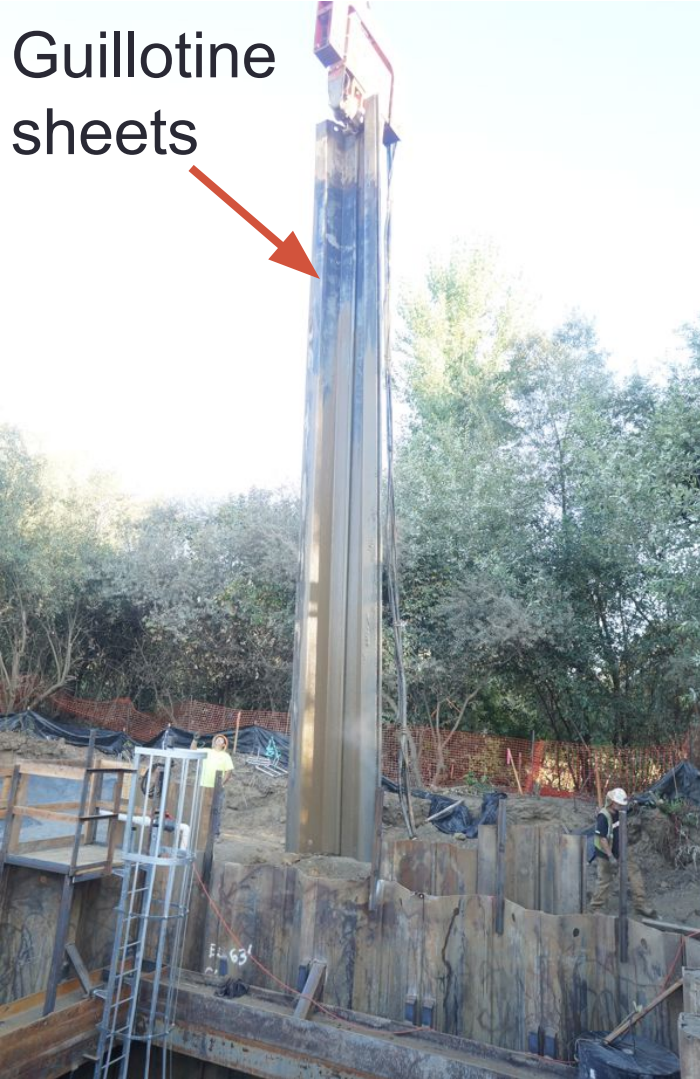
Guillotine
sheets

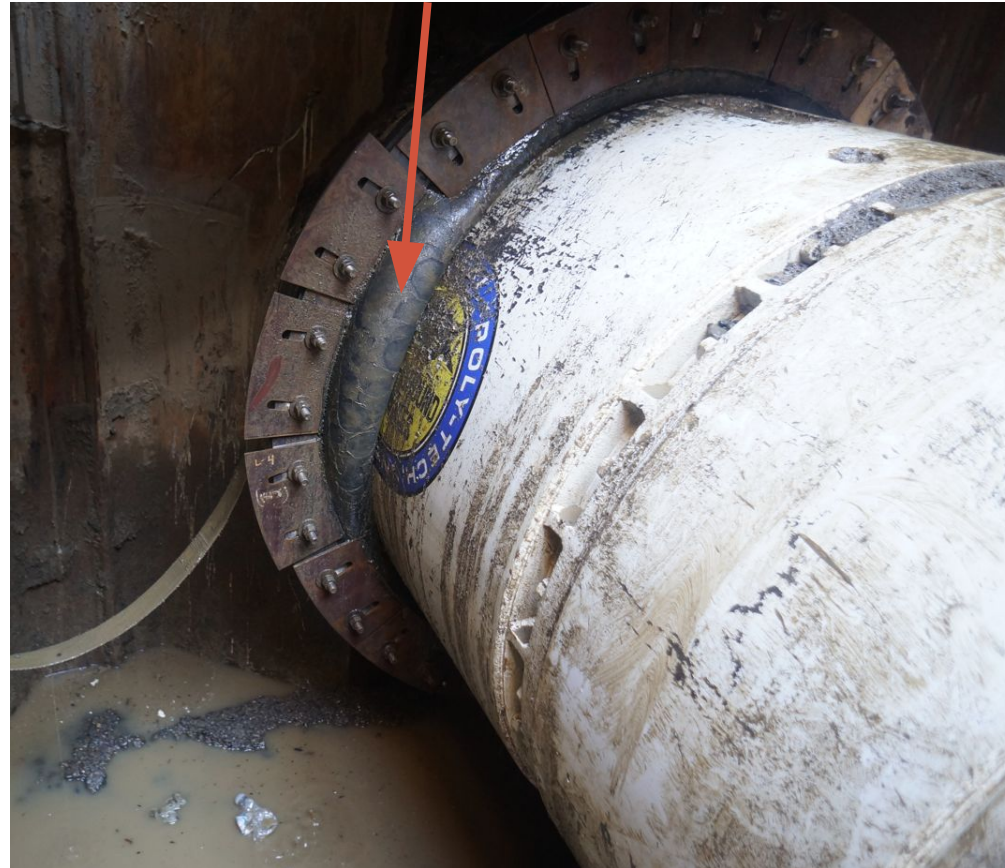
However, seal leakage issues
and water sprays MTBM
components

- MTBM advances 5 feet then stops because of motor issues.
- Motor rewound and reinstalled
- 8 days lost

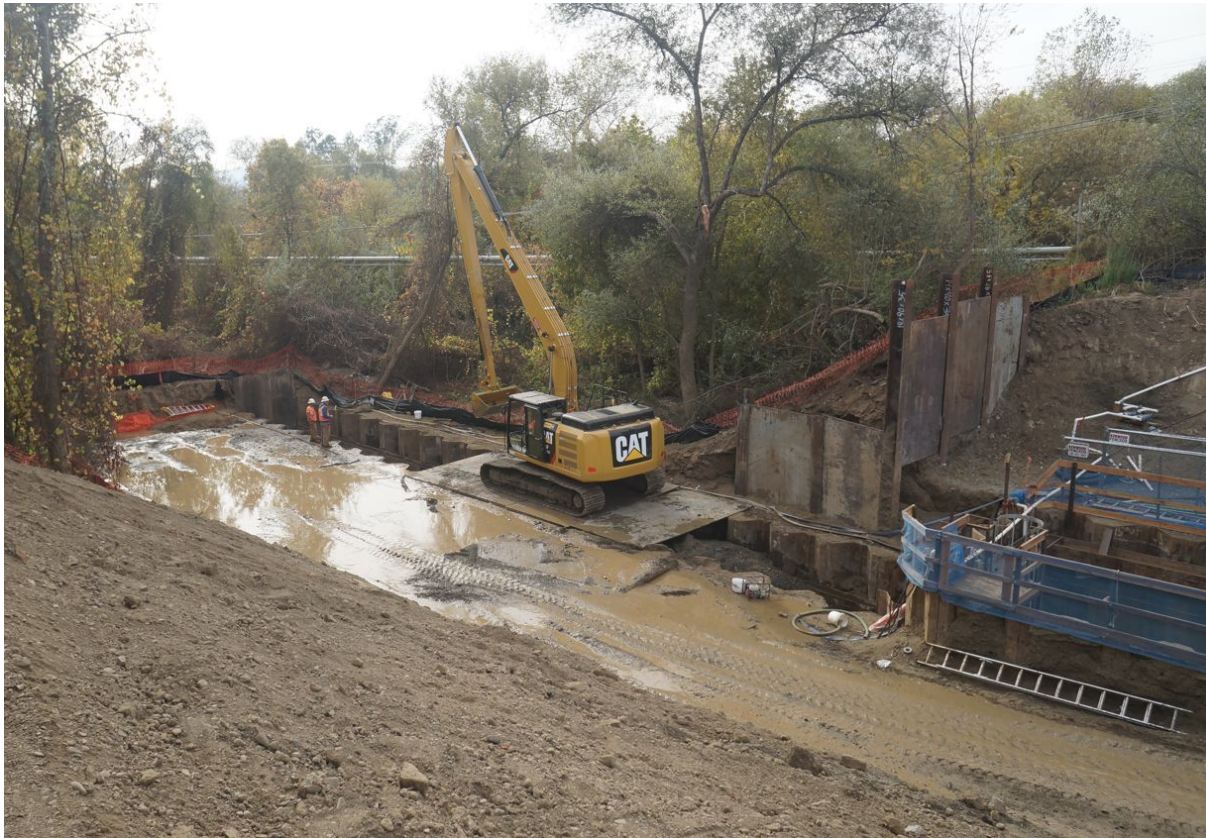
- A rescue trench was constructed and the MTBM pushed under water to the receiving shaft.

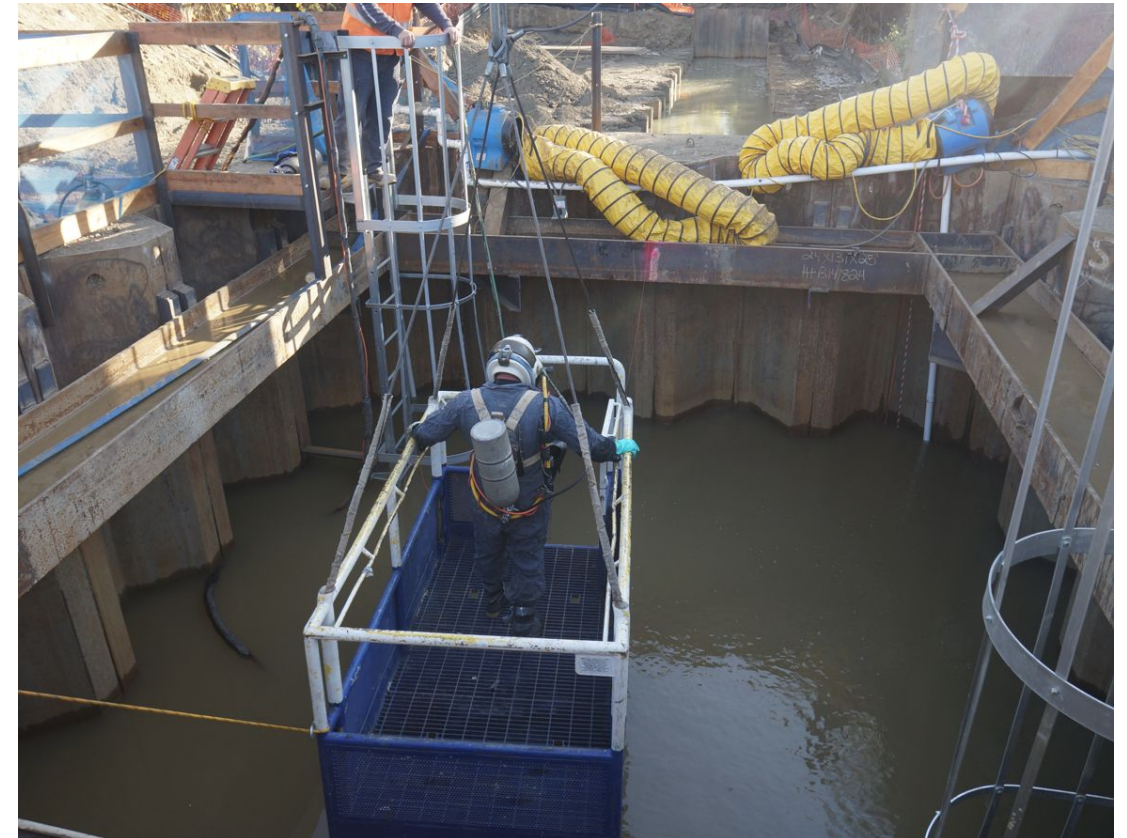
- Retrieval of the machine in the wet (diver work).

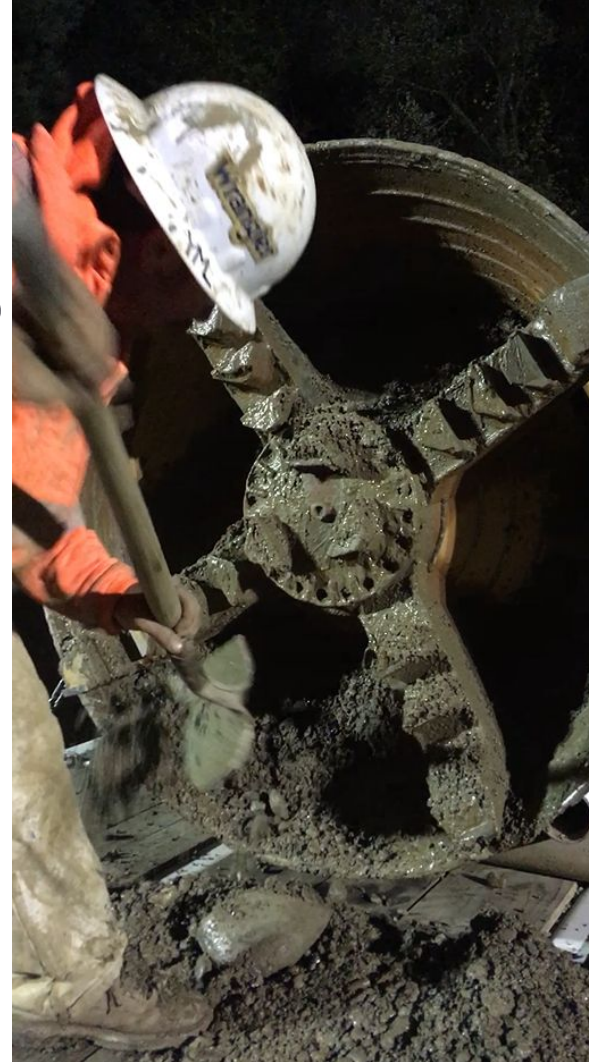
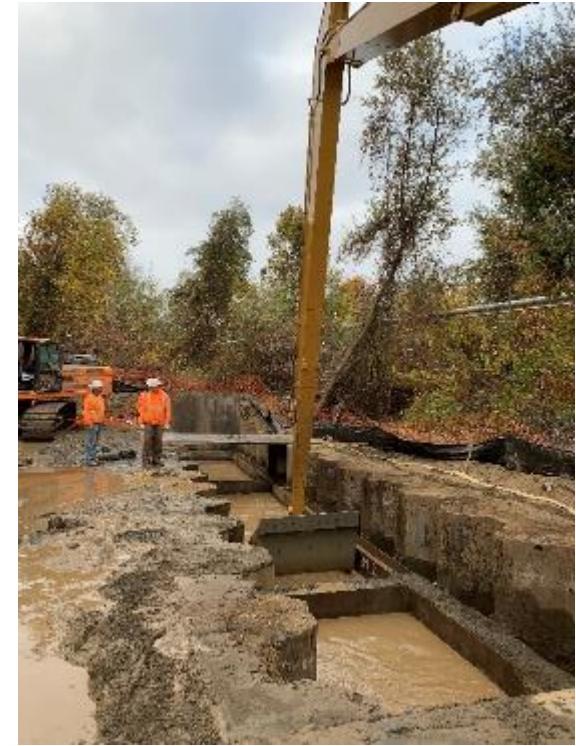
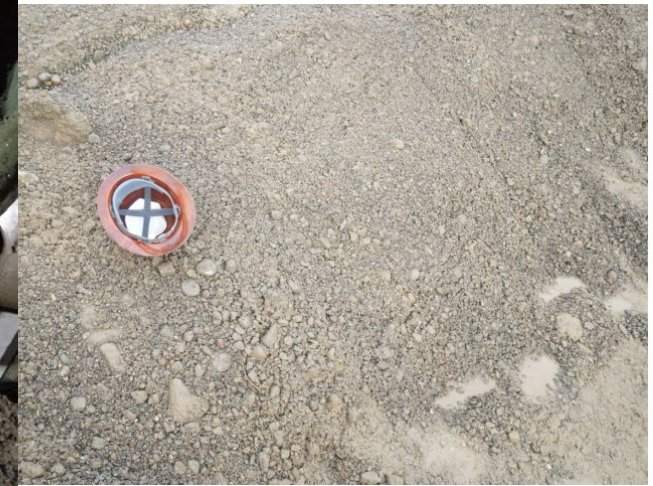
- While there is evidence of the MTBM being damaged, there is no evidence of when the damaged occurred (it was all internal damage), no evidence as to what caused the damage, and no evidence that the damage caused the stoppage.
- No metal parts were pulled from the rescue trench
- No foreign metal was found in the crushing chamber

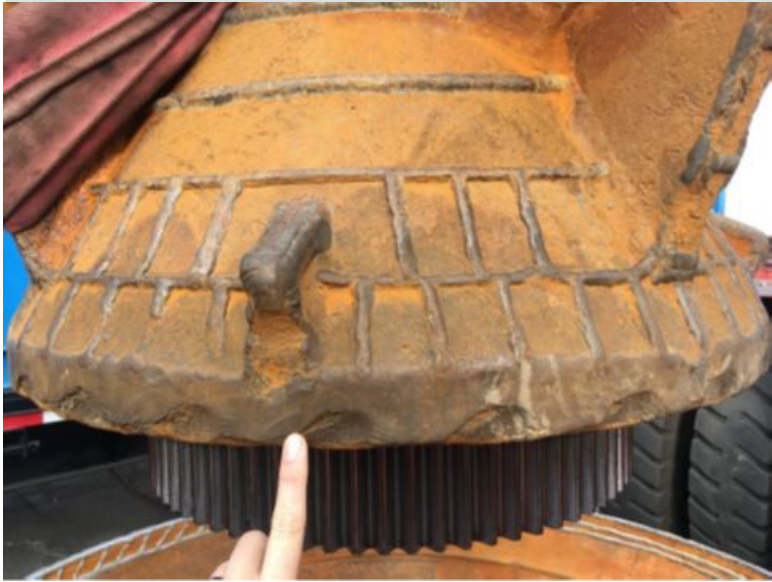
The machine was stopped by metal object(s)

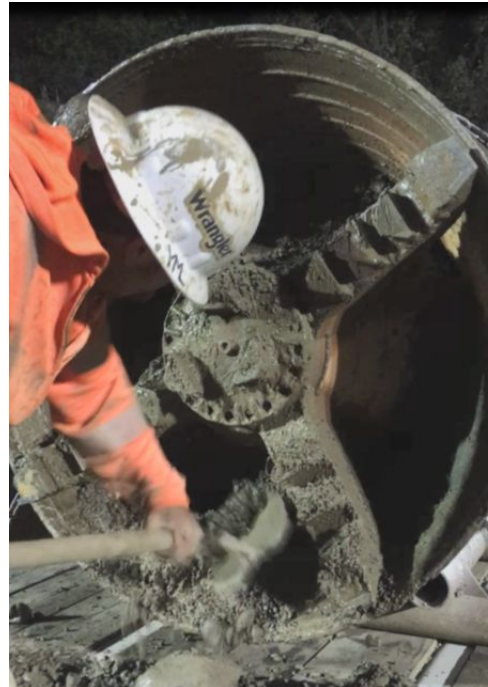
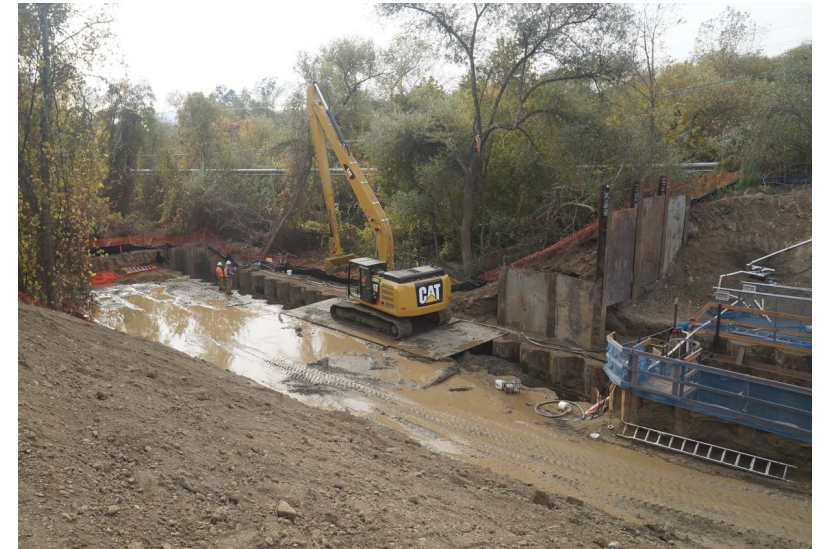
No object was found
