**Silicon Valley
Mid-Summer Emergency:
Santa Clara Addresses Peak-Demand
Repair of 96-inch Pipeline**

Mike Larsen

Anna Pridmore, PhD, PE

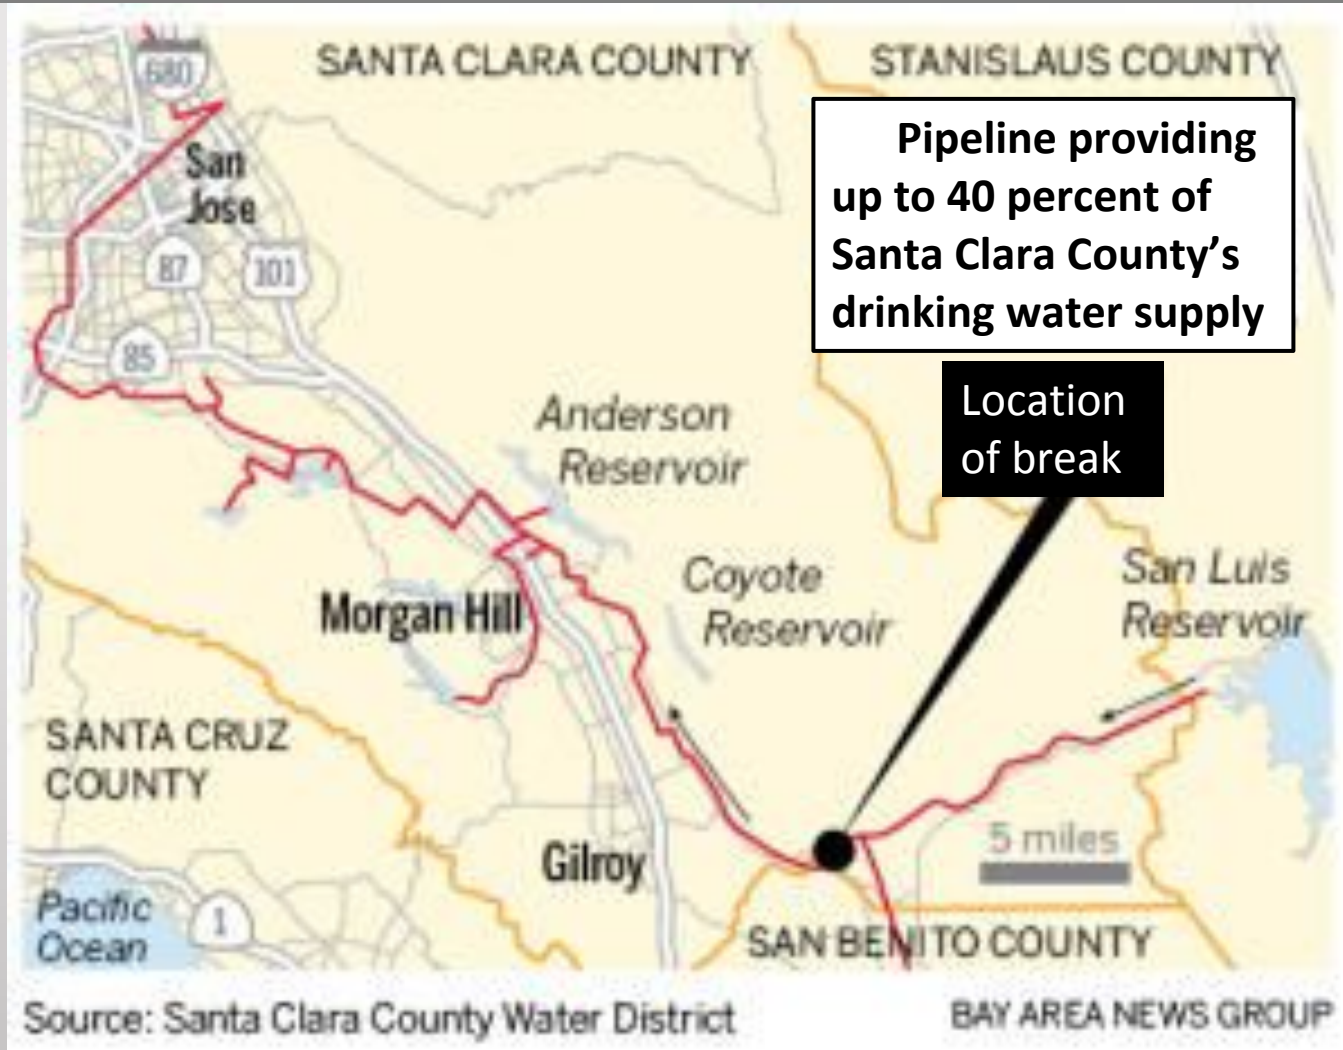
PIPE RUPTURE LOCATION & AREA IMPACTED

- ~6:30 AM August 1, 2015
- Drastic pressure loss along Santa Clara Conduit
- Investigation determined location
- Rupture occurred during a power outage
- **20 million gallons** of water lost due to rupture
