The Northern California Pipe User's Group
26th Annual Sharing Technologies Seminar

HIGHLIGHTING INNOVATION AND SUSTAINABILITY BY RENEWING AC PIPELINES WITH CURED-IN-PLACE PIPE

Tara Sweet and David Katzev

East Bay Municipal Utility District, Oakland, CA

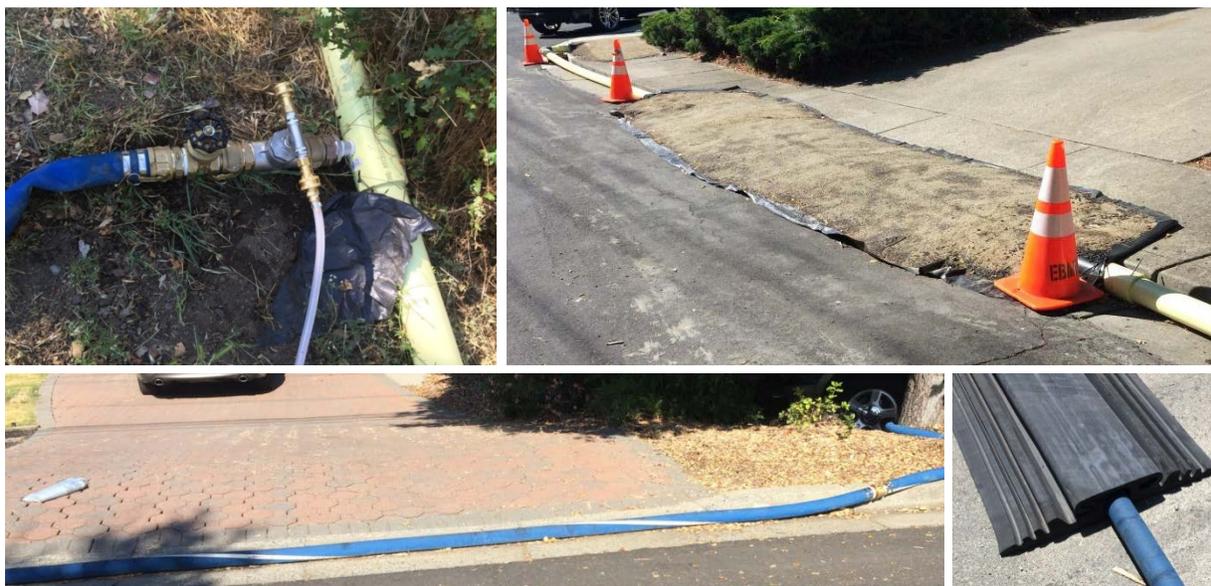
Figure 3. Temporary main materials and setup

to customers with larger irrigation demands. Figure 3 shows examples of the temporary main and ramp materials.

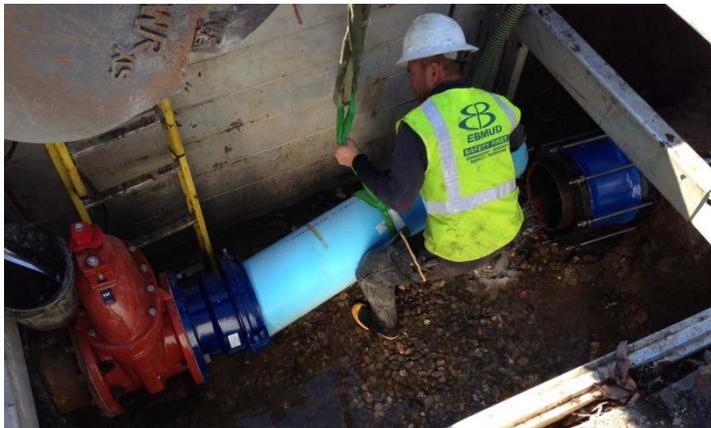
Figure 8. New valve and reconnect in access pit

Connections were constructed of PVC or steel, and attached to the Aqua-Pipe-lined AC pipe with flexible couplings (Figure 8). The thick-walled AC pipe had a very large outside diameter compared to steel or PVC of the same nominal diameter. Standard couplings did not have a wide enough range to fit all of the connections, so some reducing couplings were used, which were not in EBMUD's standard warehouse supply.
