The Northern California Pipe User's Group
25th Annual Sharing Technologies Seminar

THE HILLS HAVE PIPES...AND THEY NEED TO BE REPLACED! – A TALE OF A WATER MAIN REPLACEMENT PROJECT IN A GEOHAZARD AREA IN BERKELEY AND OAKLAND

Krista Moita, P.E.¹

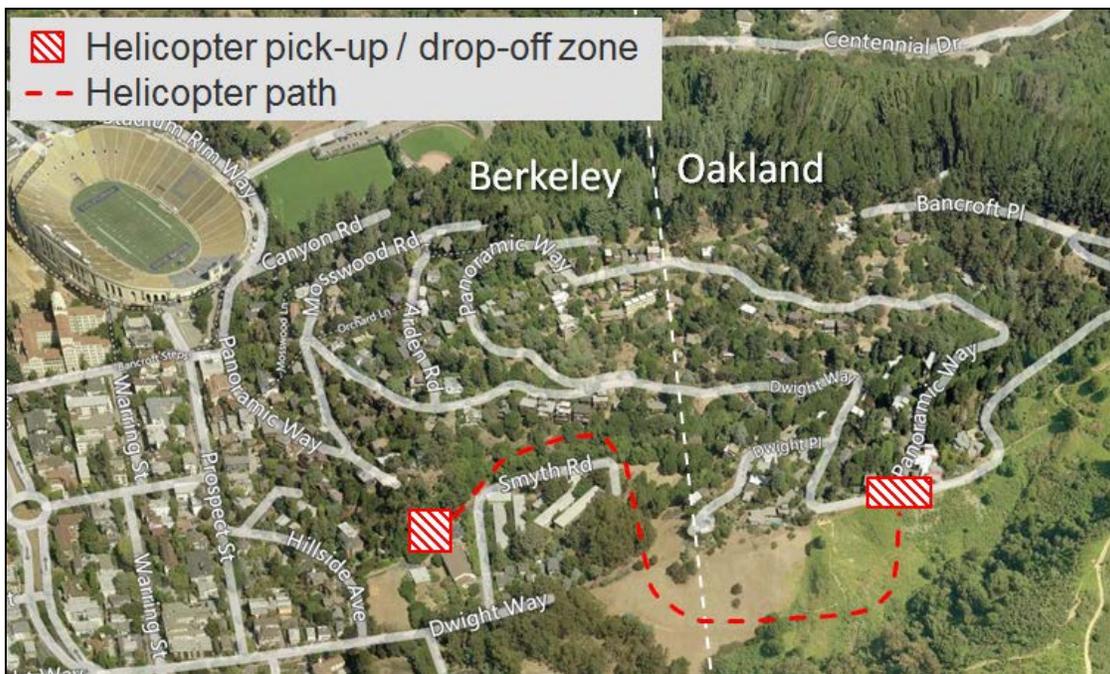
Figure 3. Helicopter Flight Path for Delivering Pipe to the Panoramic Hill Pipeline Replacement Project

The District then began exploring the idea to airlift pipe to the top of the hill. After extensive permitting and outreach efforts with City of Berkeley, City of Oakland, the Federal Aviation Administration, fire and police, and the Panoramic Hill neighborhood, the helicopter delivery plan was put into action. On Wednesday, September 21, 2016, District crews assisted a qualified contracted helicopter transport company to airlift 2,500 feet of HDPE pipe in 16 bundles to the top of the hill. The pipe was taken from below the hill at Fernwald Road to Panoramic Way at the edge of the canyon. Figure 3 shows the helicopter flight path described above. The helicopter transport of one of the 16 bundles is shown in Figure 4, and the delivery location on Panoramic Way is shown in Figure 5.

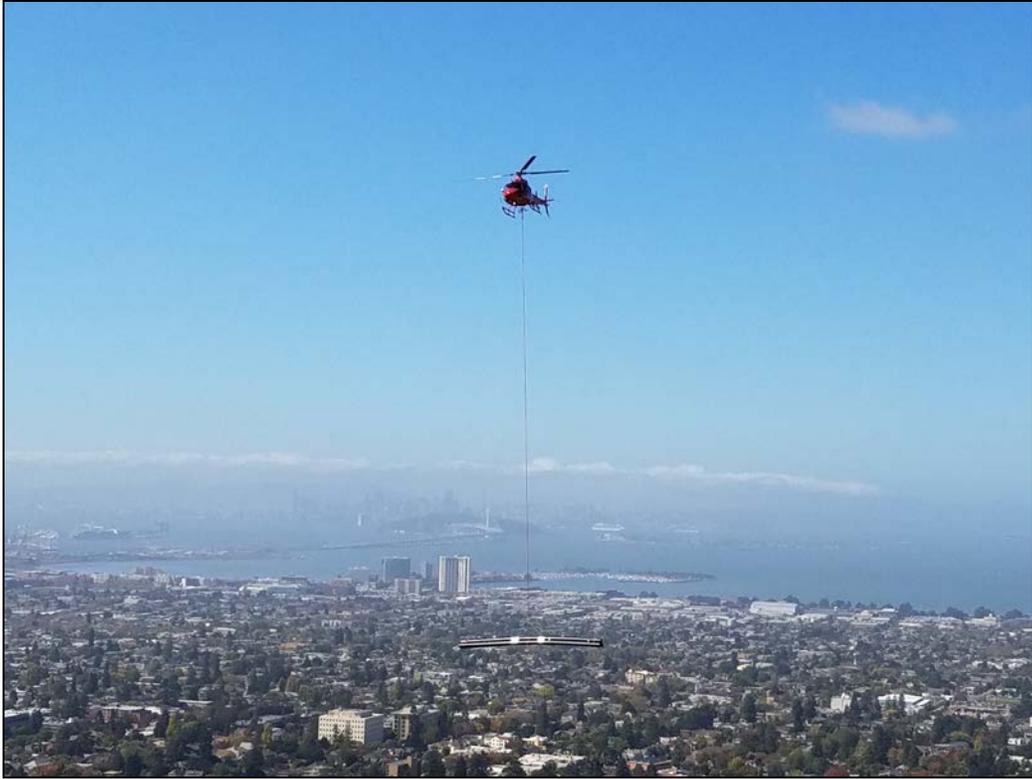
Figure 4. Helicopter Delivering Bundle of HDPE Pipe for the Panoramic Hill Pipeline Replacement Project

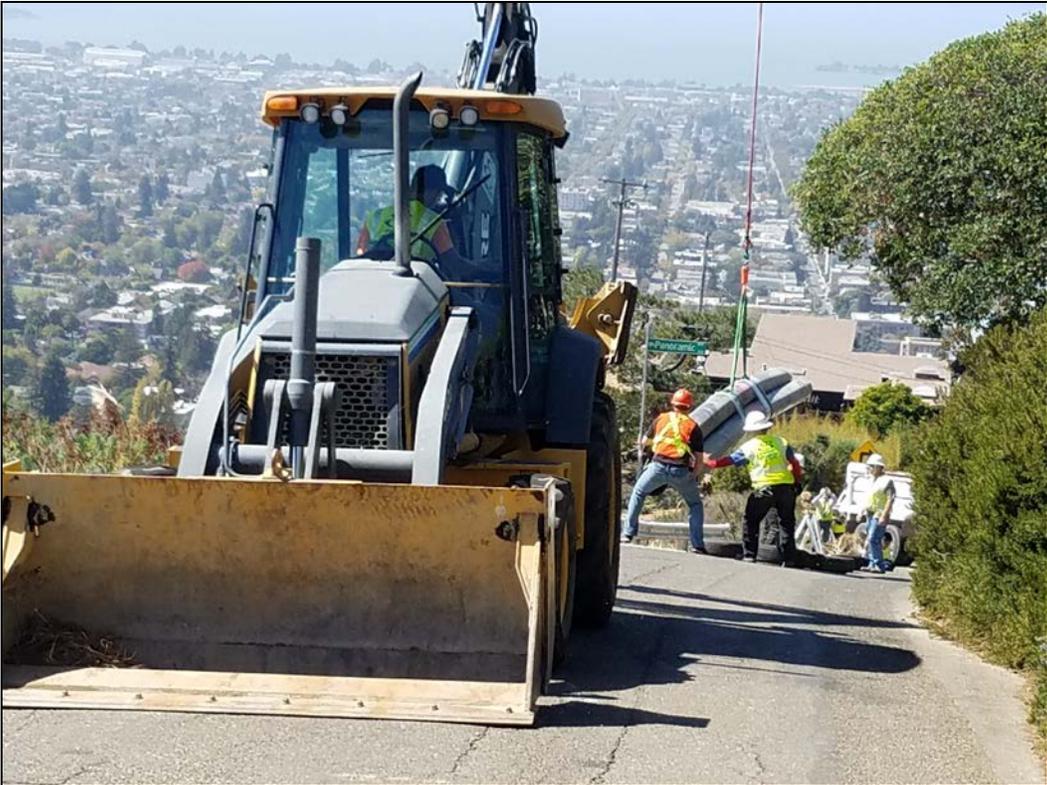
Figure 5. Airlift Delivery Location on Panoramic Way for the Panoramic Hill Pipeline Replacement Project
