The Northern California Pipe User's Group
29th Annual Sharing Technologies Seminar

Just Another Bore-ing Water Main Crossing: How Preliminary Exploration Helped Deliver a Successful Project

ABSTRACT: As part of the City of Mountain View's initiative to increase the accessibility and reliability of its water and sewer system, the Water Main Crossing US 101 from San Rafael Avenue to Macon Avenue Project was constructed to provide redundancy to one of the three aging utility pipelines that provide service to the City's North Bayshore area. Located under a six-lane California state highway with high traffic volumes, the water main project included 570 linear feet of 12-inch fusible PVC (FPVC) pipe installed via jack and bore, and 470 linear feet of 12-inch FPVC pipe installed via open trench methods.

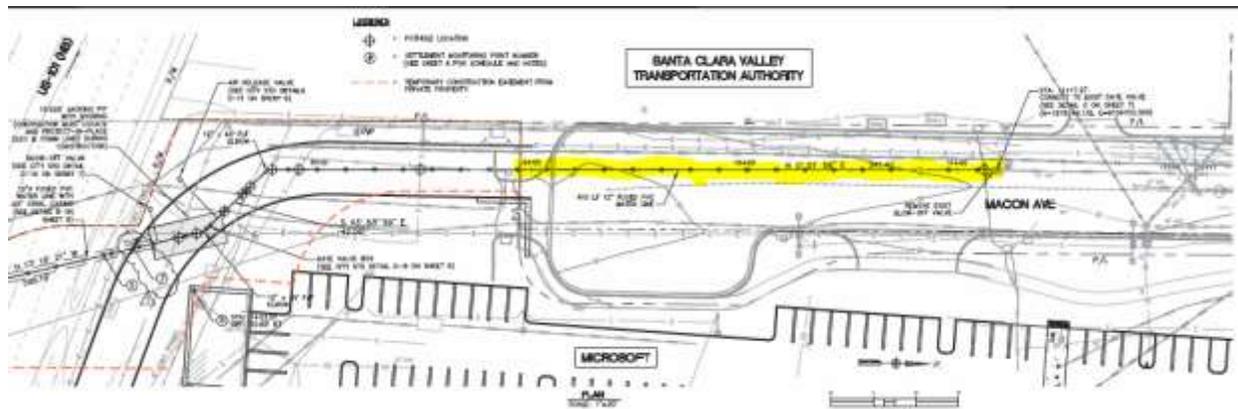
Figure 2. Cut and cover segment of water main segment on Macon Avenue its proximity to the Microsoft Campus.

Timely communication and coordination with the surrounding businesses was key to the project's success. In addition to obtaining the required easement through the Microsoft Campus, it was necessary for the project team to coordinate with the onsite construction that was to occur at the Microsoft Campus during the same timeframe as the water main installation. All stakeholders involved had a vested interest in ensuring that the project was completed on schedule. The City, Tanner Pacific, Inc. (Construction Management firm for the Project), and Microsoft representatives had regularly scheduled meetings to review project progress and coordinate construction activities. As seen in Figure 2 below, the construction deliveries to the Microsoft Campus required close coordination during the cut and cover segment along Macon Avenue because the work area restricted the turn radius of trucks.

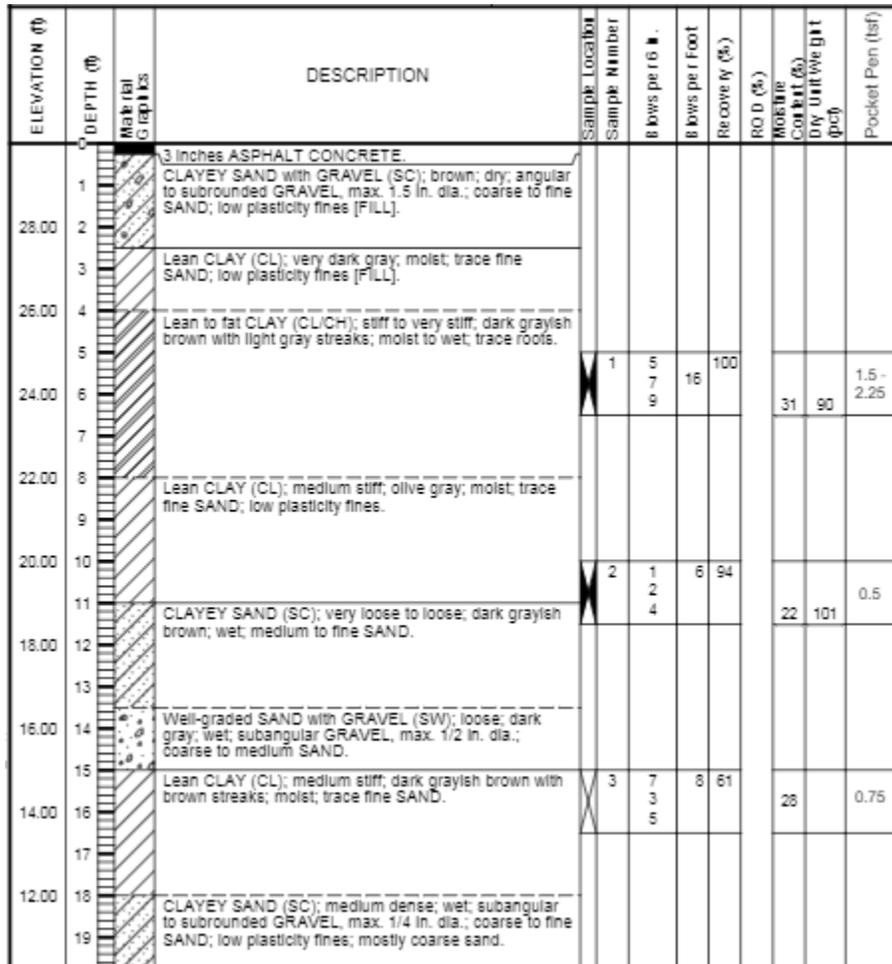
Figure 4. Boring Record for hole ID B-1 from the geotechnical report for this Project.

At the beginning of the project, the soil type and the groundwater level at the Project location were both identified as site conditions that would need to be addressed during construction. As shown in Figure 4, the geotechnical report for this project revealed the soils at the jacking and receiving pits were both sandy and clayey soils.

Even though these soils were identified as susceptible to settlement, the geotechnical report stated, "Archiving would be expected to occur in still soils such as those revealed in project and historic explorations such that voids which might be present around the pipe as a result of overcut would be unlikely to manifest as ground surface settlement. If settlement were to occur, it would be alleviated by the U.S. 101 pavement structural section." Based on this report, surface and subsurface settlement monitoring points were given to the Contractor and they monitored the points per the Designer's recommendation. The monitoring reports showed minor settlement occurred throughout the project, all within the limits set by the Designer.
