# CMP COMMON & UNCOMMON FAILURE MODES & REHABILITATION METHODS

2025 NORCAL PUG ANNUAL SHARING TECHNOLOGIES SEMINAR

Harris & Associates

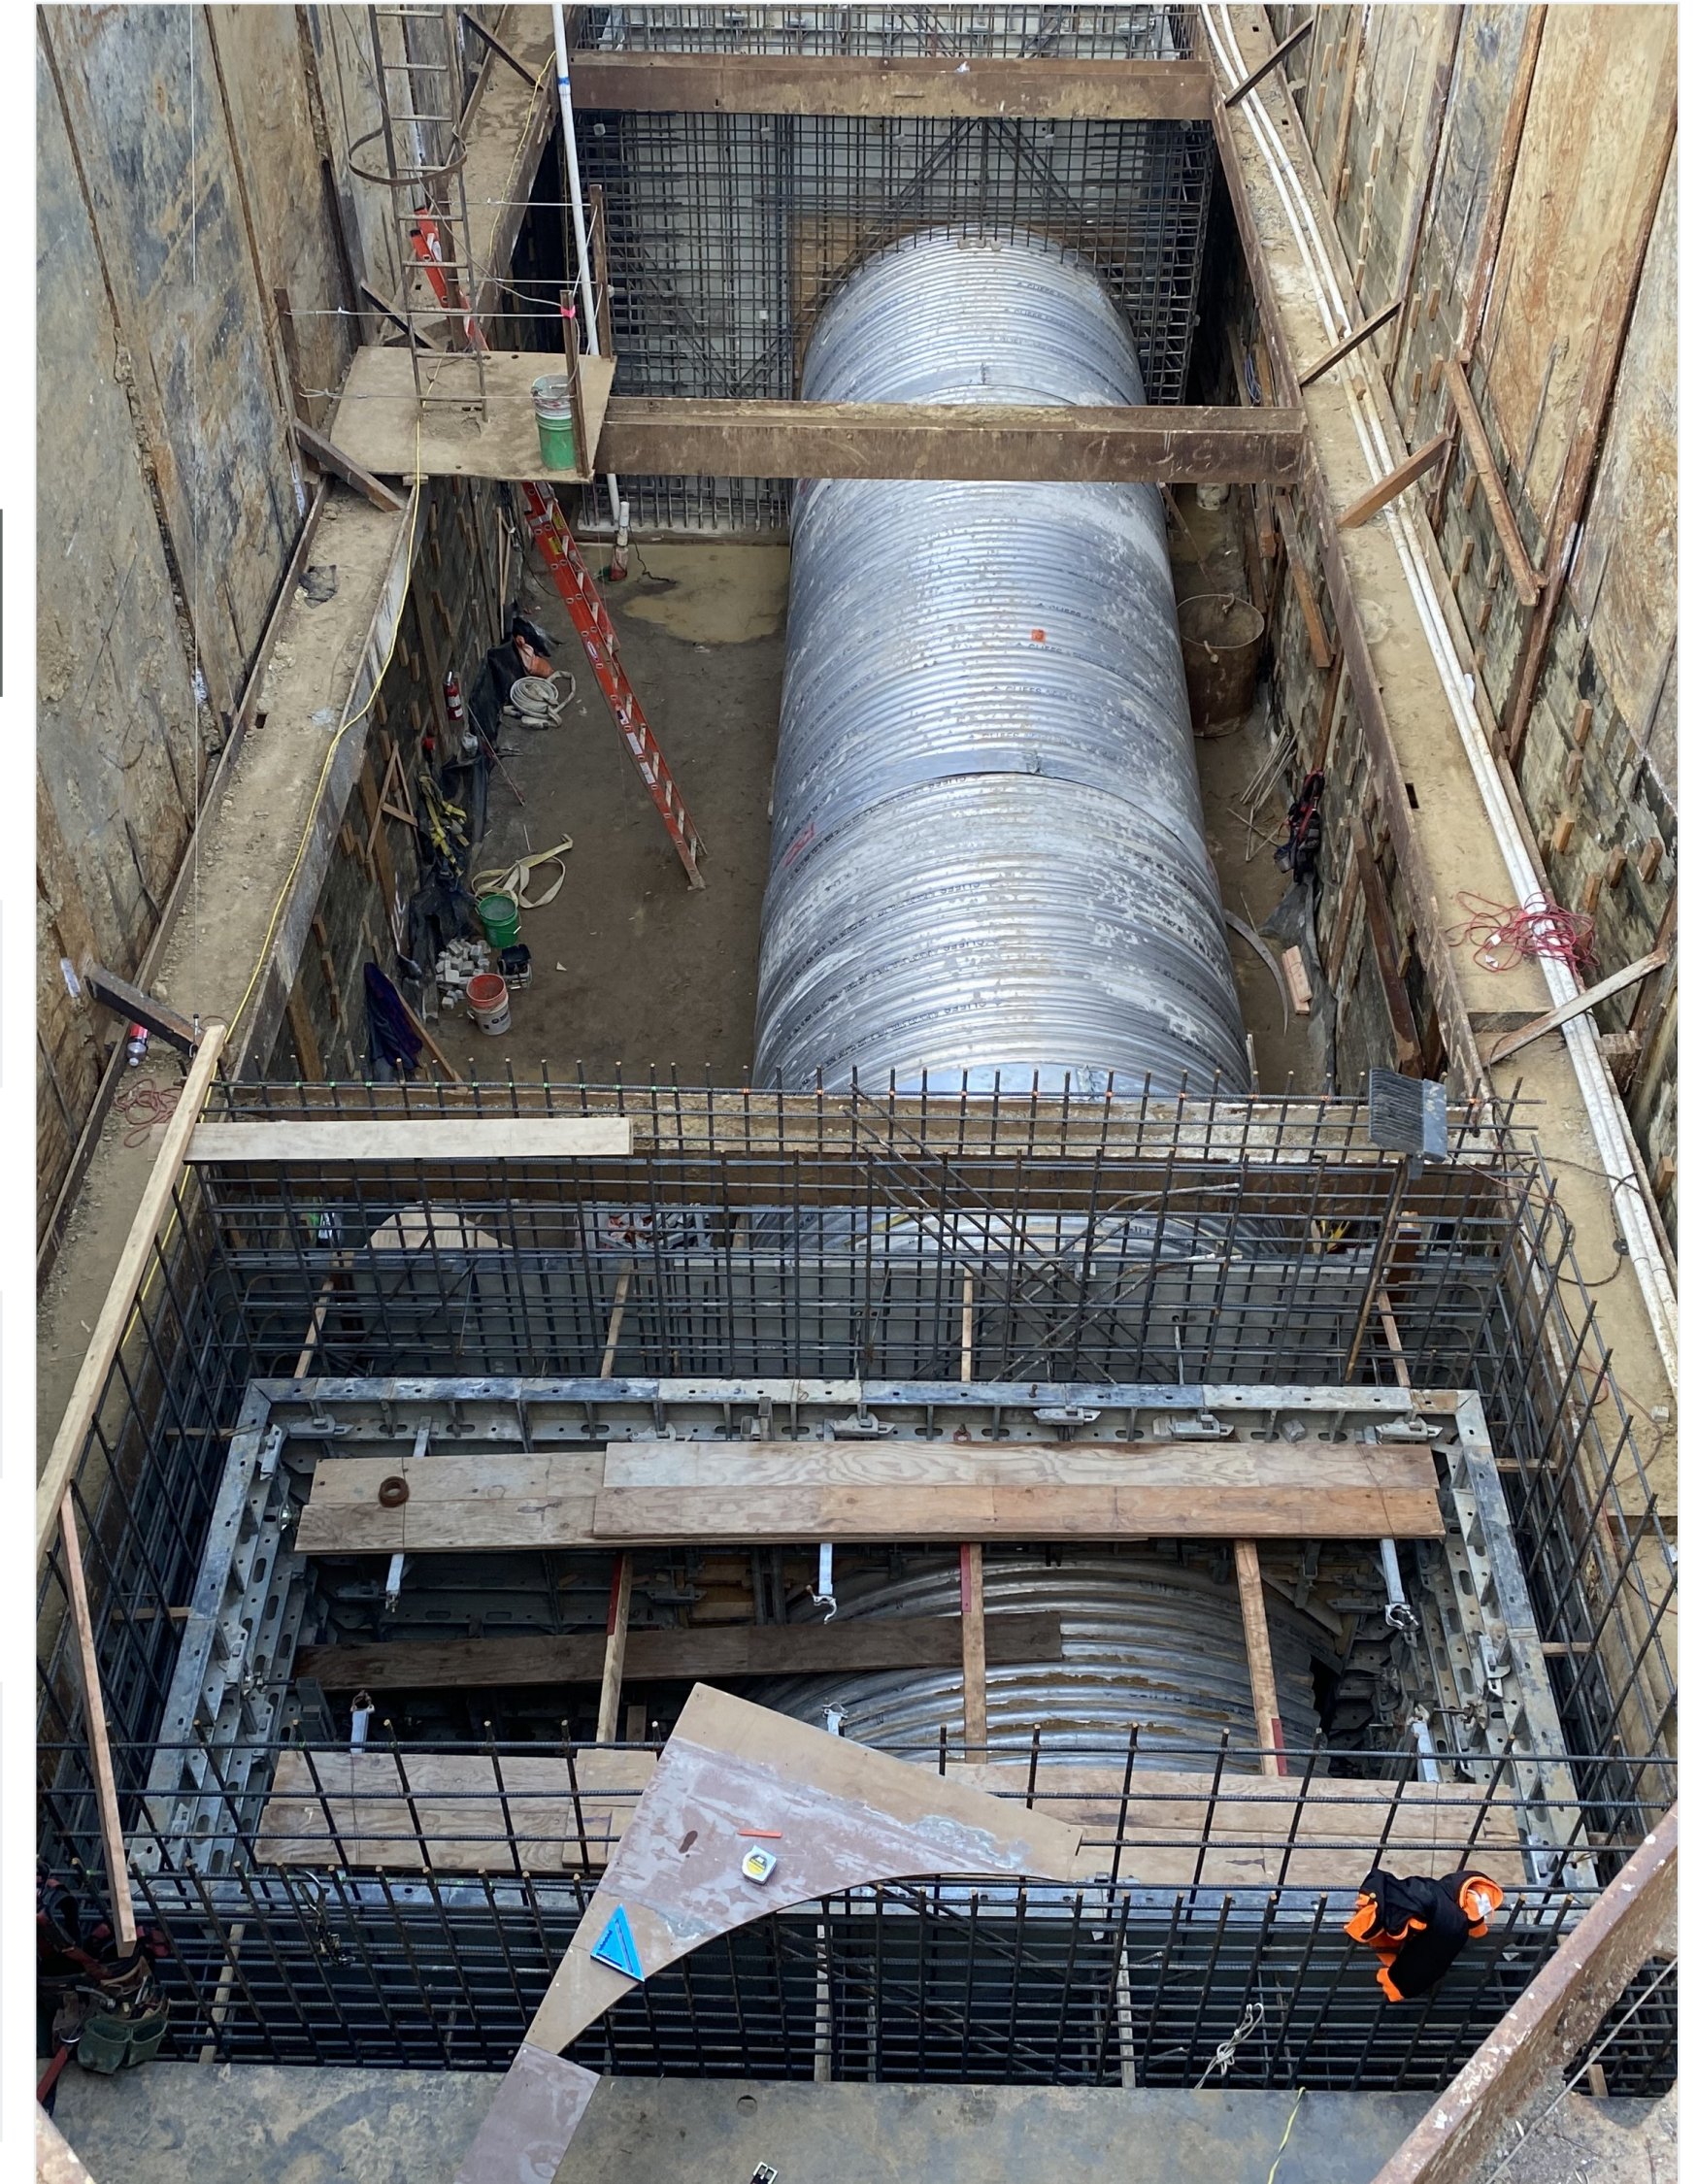
## CMP CHARACTERISTICS

Characteristic	Typical Options
<b>Sizing</b>	6-inch to 144-inch Diameter
<b>Pipe Shape</b>	Circular vs Arched
<b>Corrugation Pattern</b>	Circumferential (Annular) vs Helical (Spiral)
<b>Corrugation Dimensions</b>	Classified by Corrugation Depth & Spacing
<b>Steel Thickness</b>	18 – 8 Gage
<b>Coatings</b>	Galvanized Steel Aluminum Type 2 Polymer Coatings Asphalt

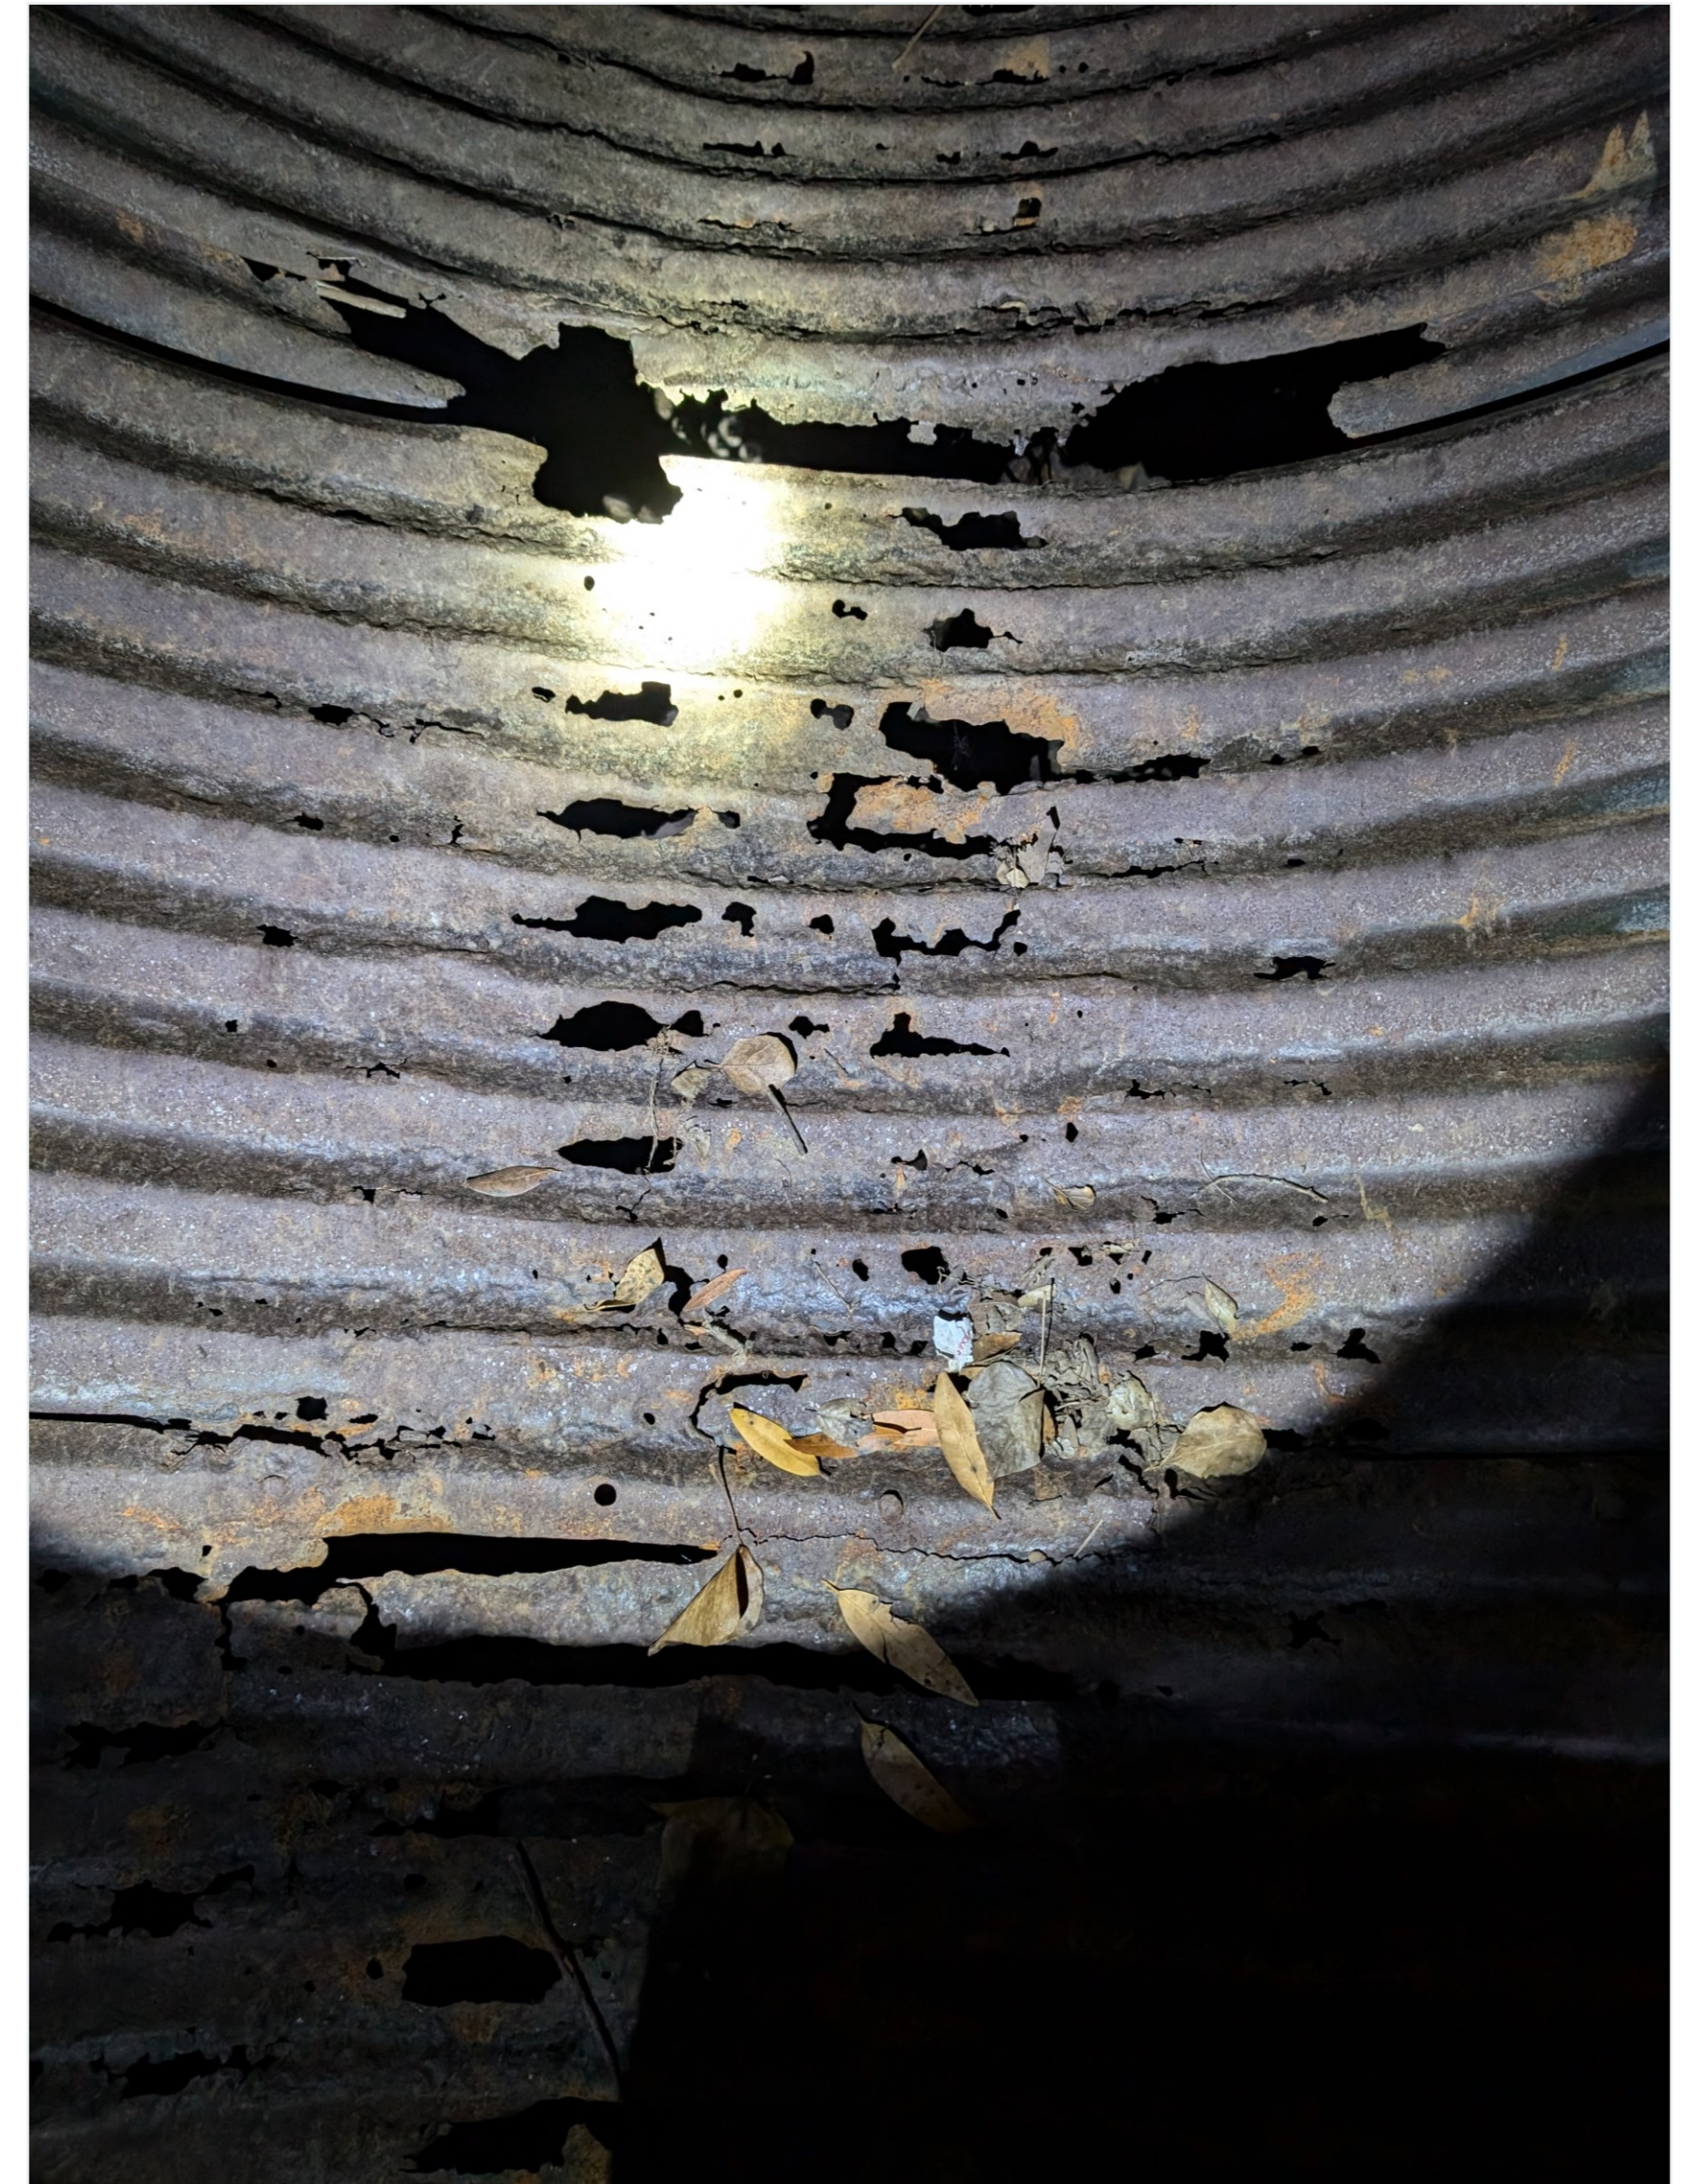
## DETERIORATED INVERTS (ABRASION & WEAR)

- Sediment and debris erodes the CMP invert
- Whether the CMP was coated or not, the CMP becomes susceptible to corrosion often resulting in the invert rusting out.
- **Prevention methods:**
  - Proper selection of CMP coating
  - Consideration of flow characteristics and quantities
  - Lining the CMP

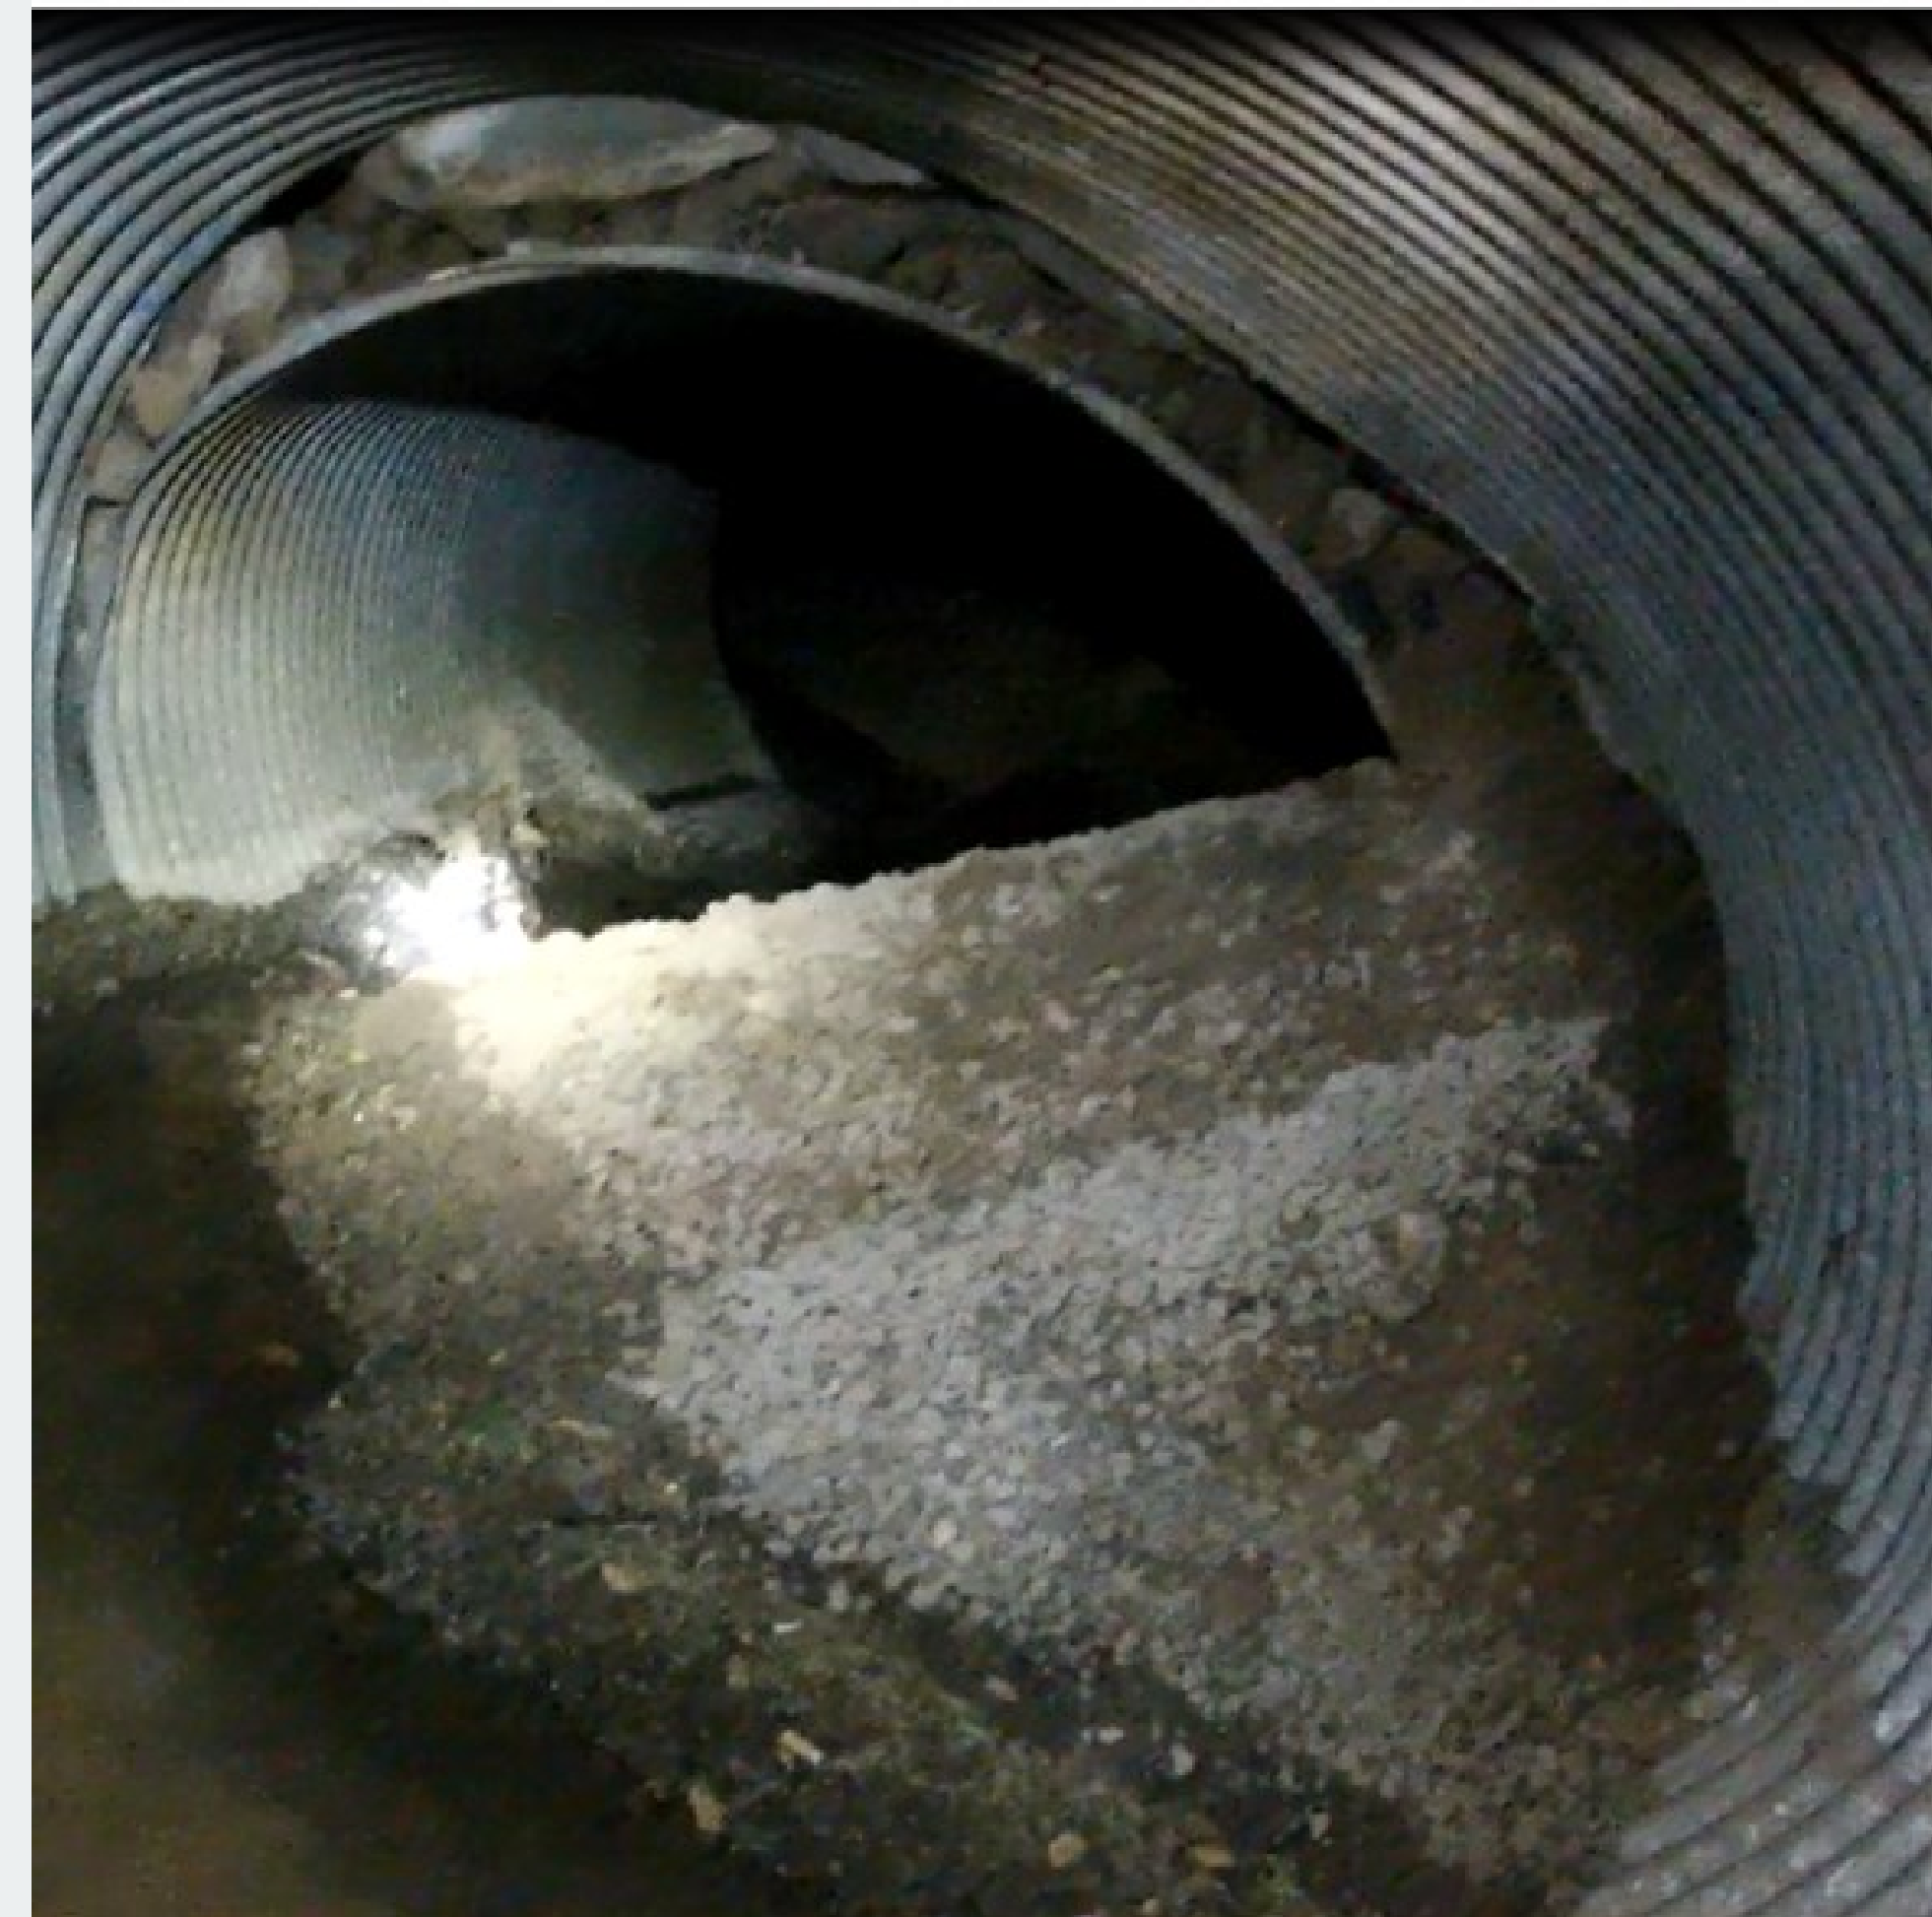
## OPEN/OFFSET JOINTS

- Joints between sticks of CMP are weak points
- Ovality in the pipe due to buckling can result in offset joints
- Open joints compromise the structural integrity of the pipe
- **Prevention methods:**
  - High quality gaskets
  - Proper installation of CMP connecting bands
  - Proper compaction of backfill material
  - Installation of expansion joints
  - Regular inspections to monitor integrity of invert

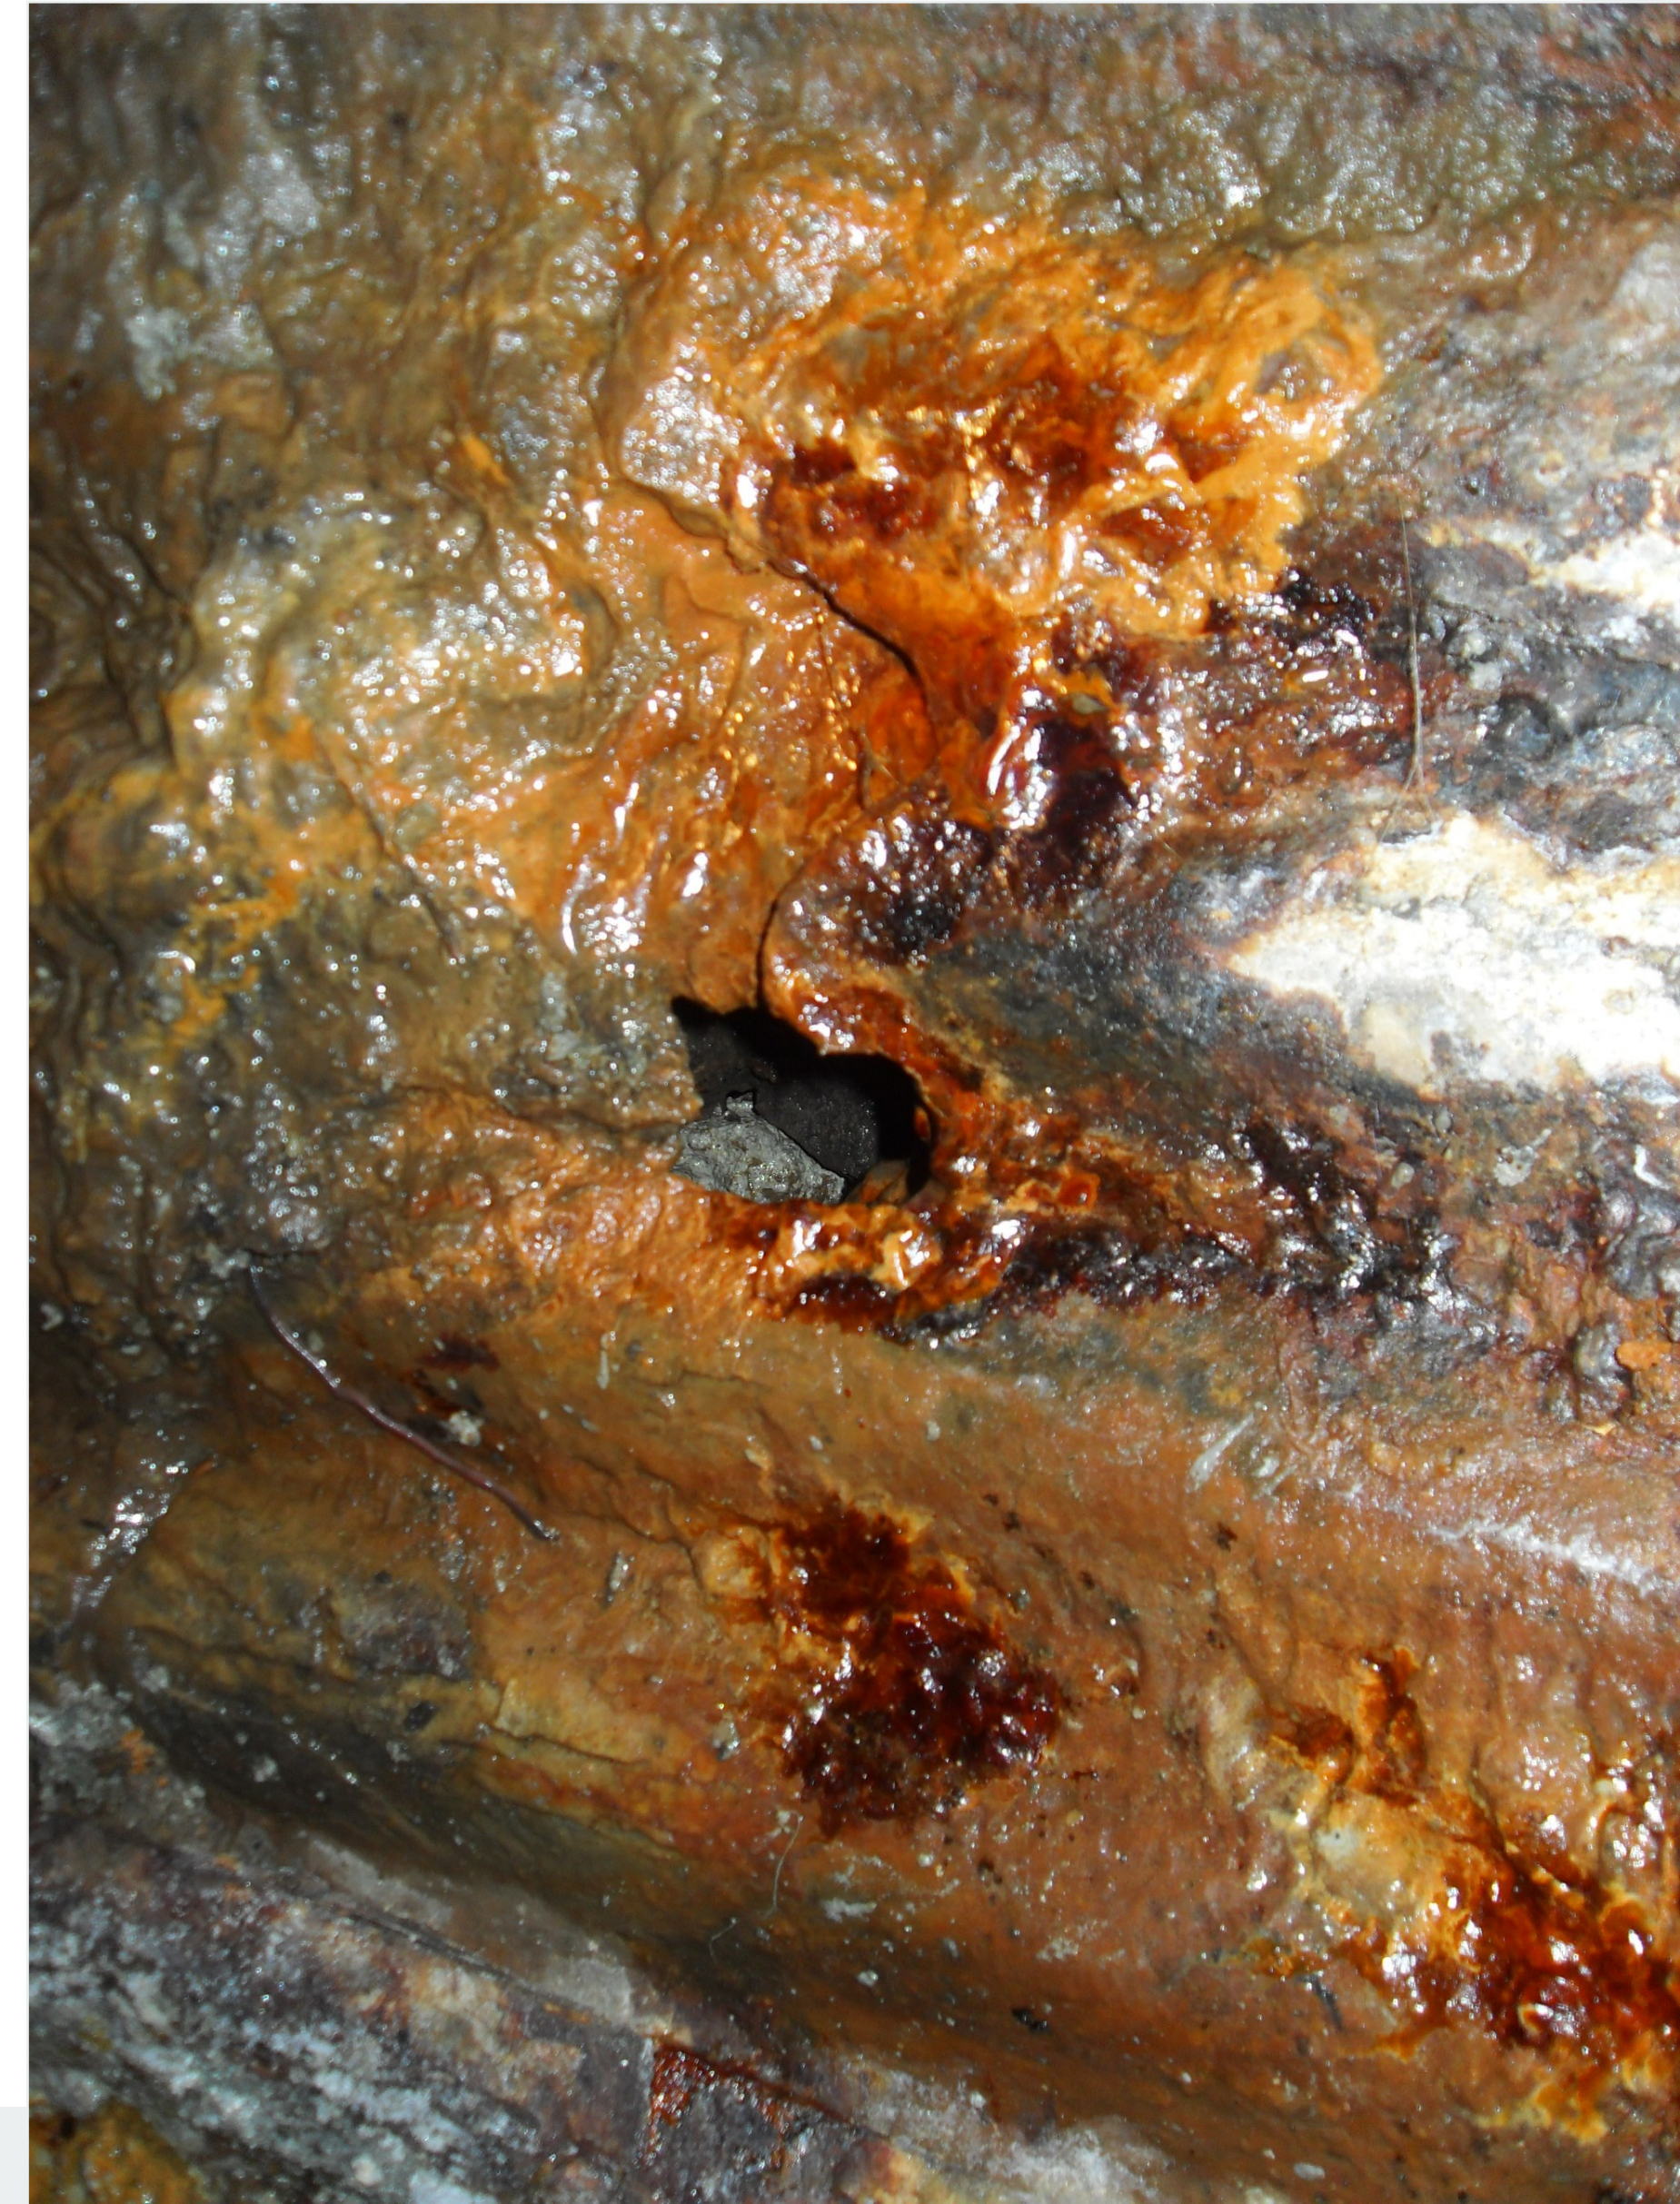
## VOIDS – BURIED PIPES RELY ON GOOD SOIL/PIPE CONTACT

- Separated/offset joints or holes in the CMP will allow water to flow outside of the pipe.
- The flow of water will scour the area behind the pipe, resulting in soil loss and a void.
- The pipe will begin to change shape

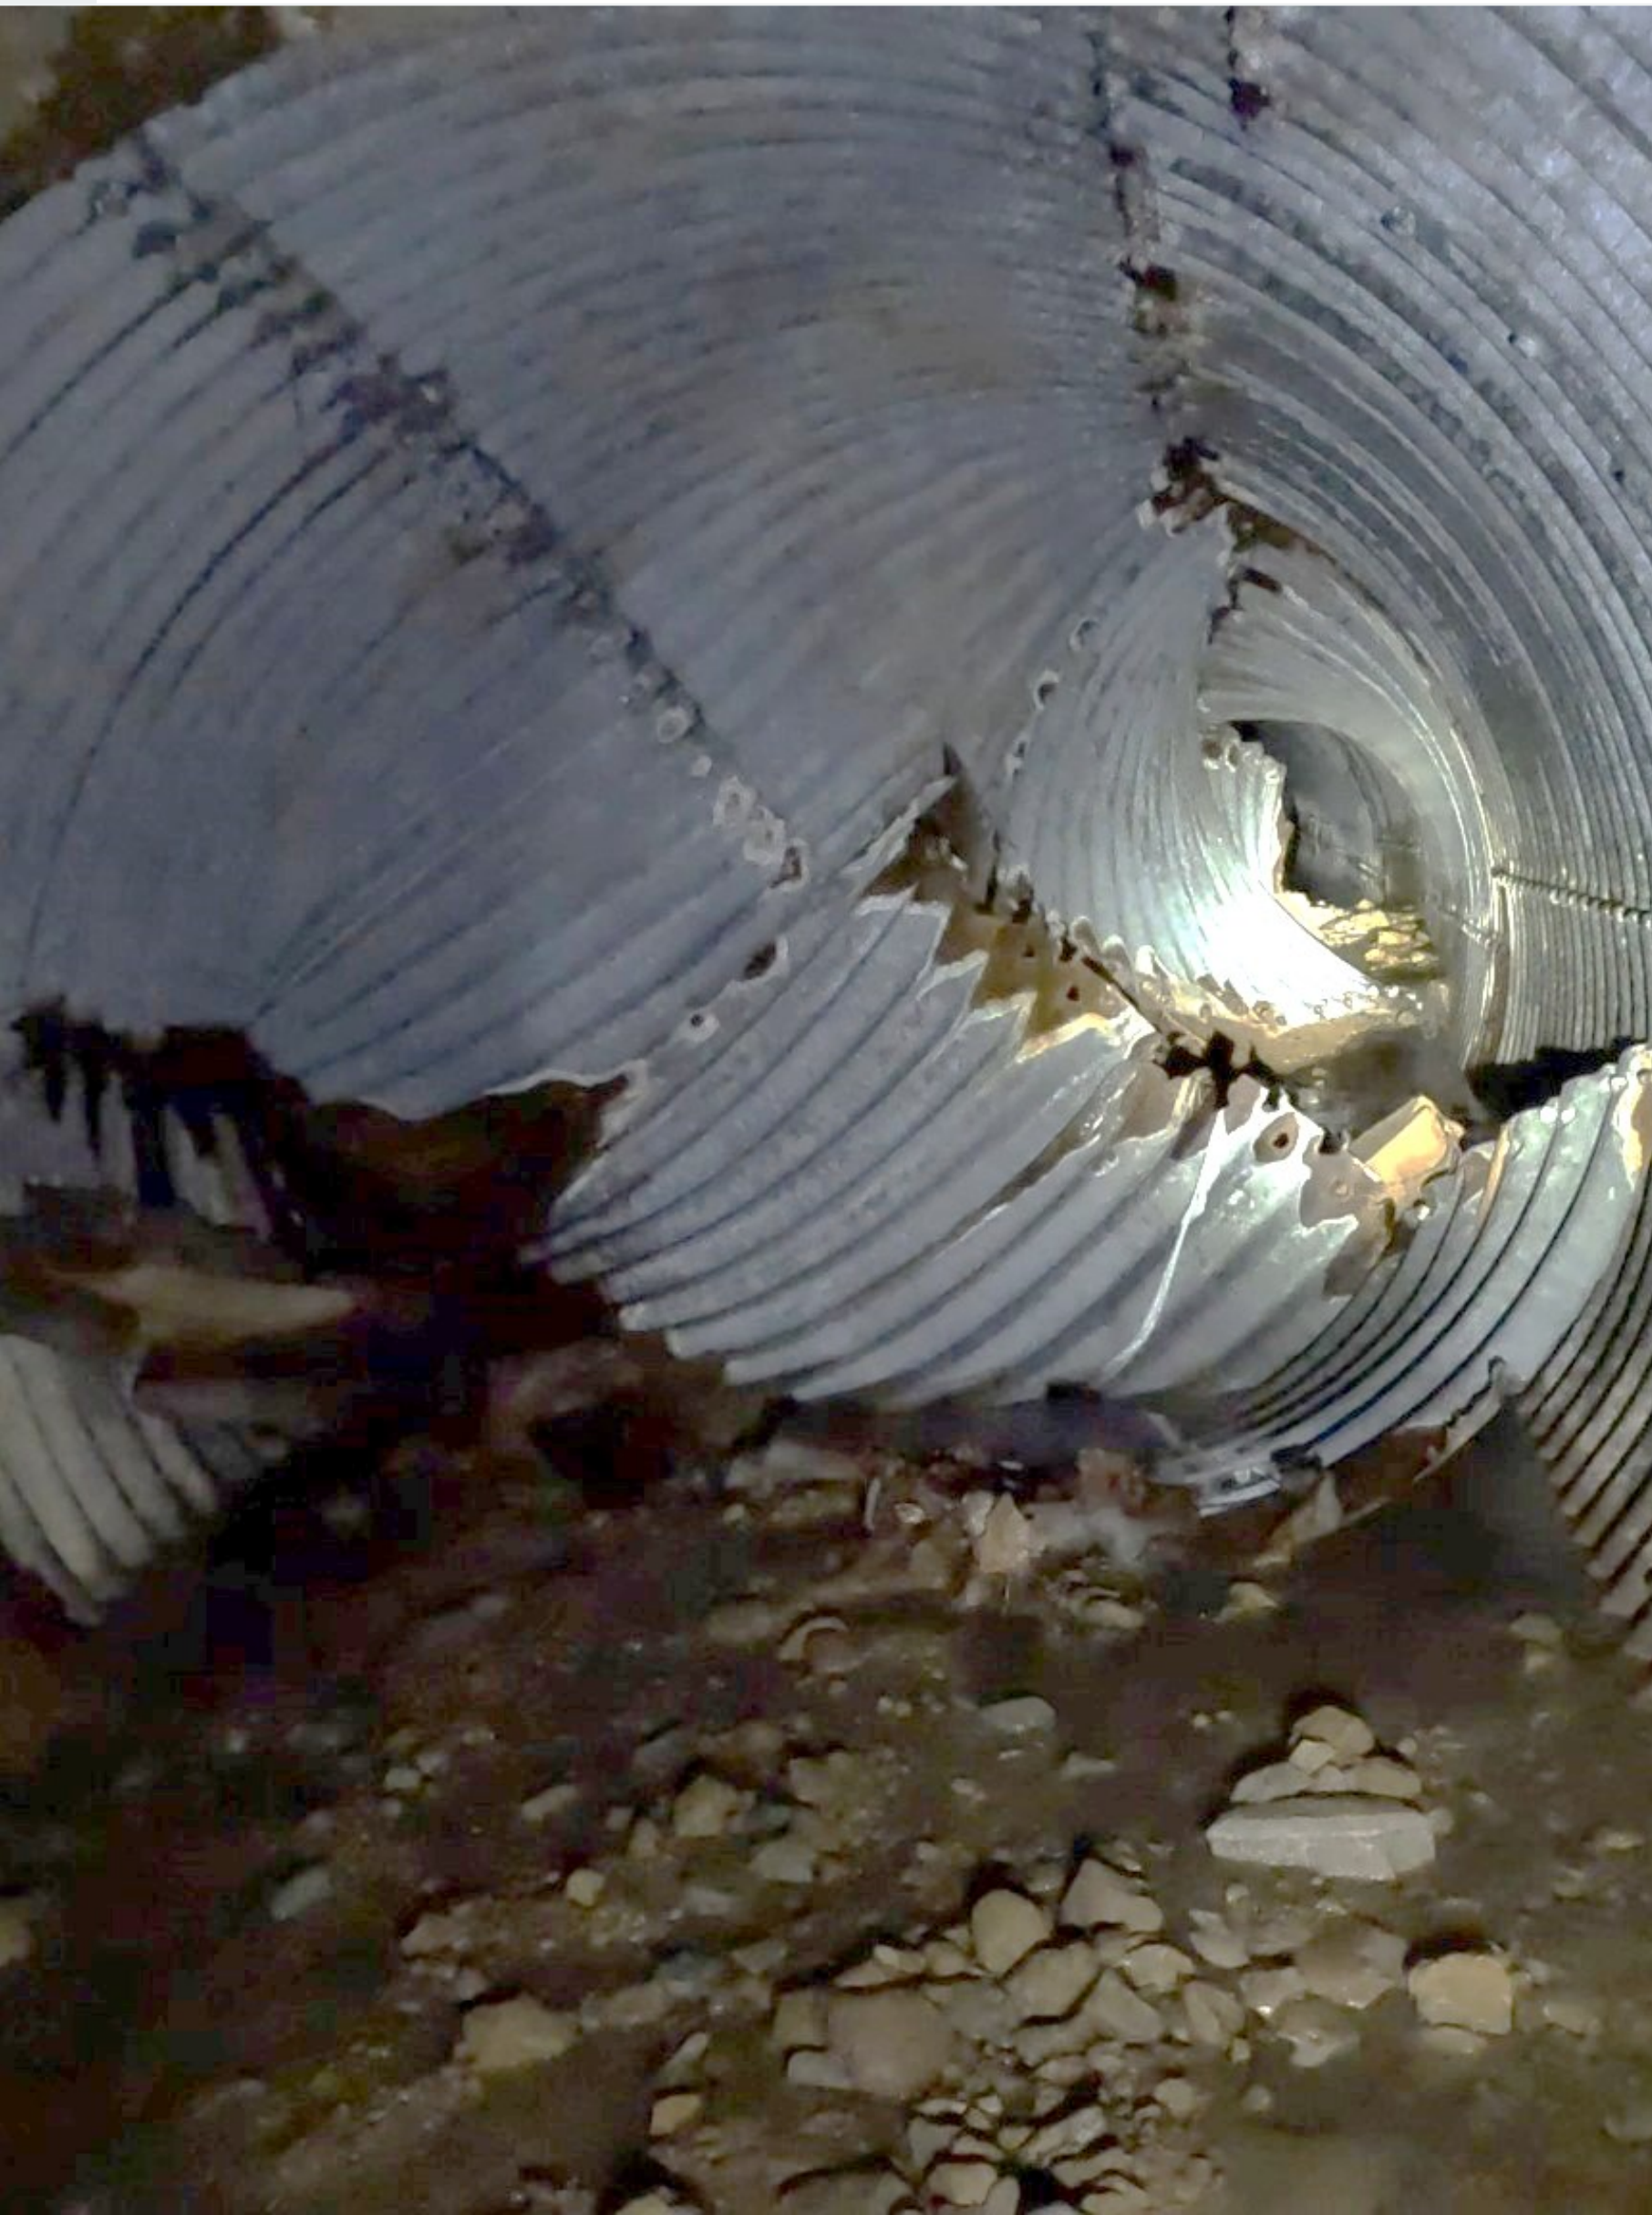
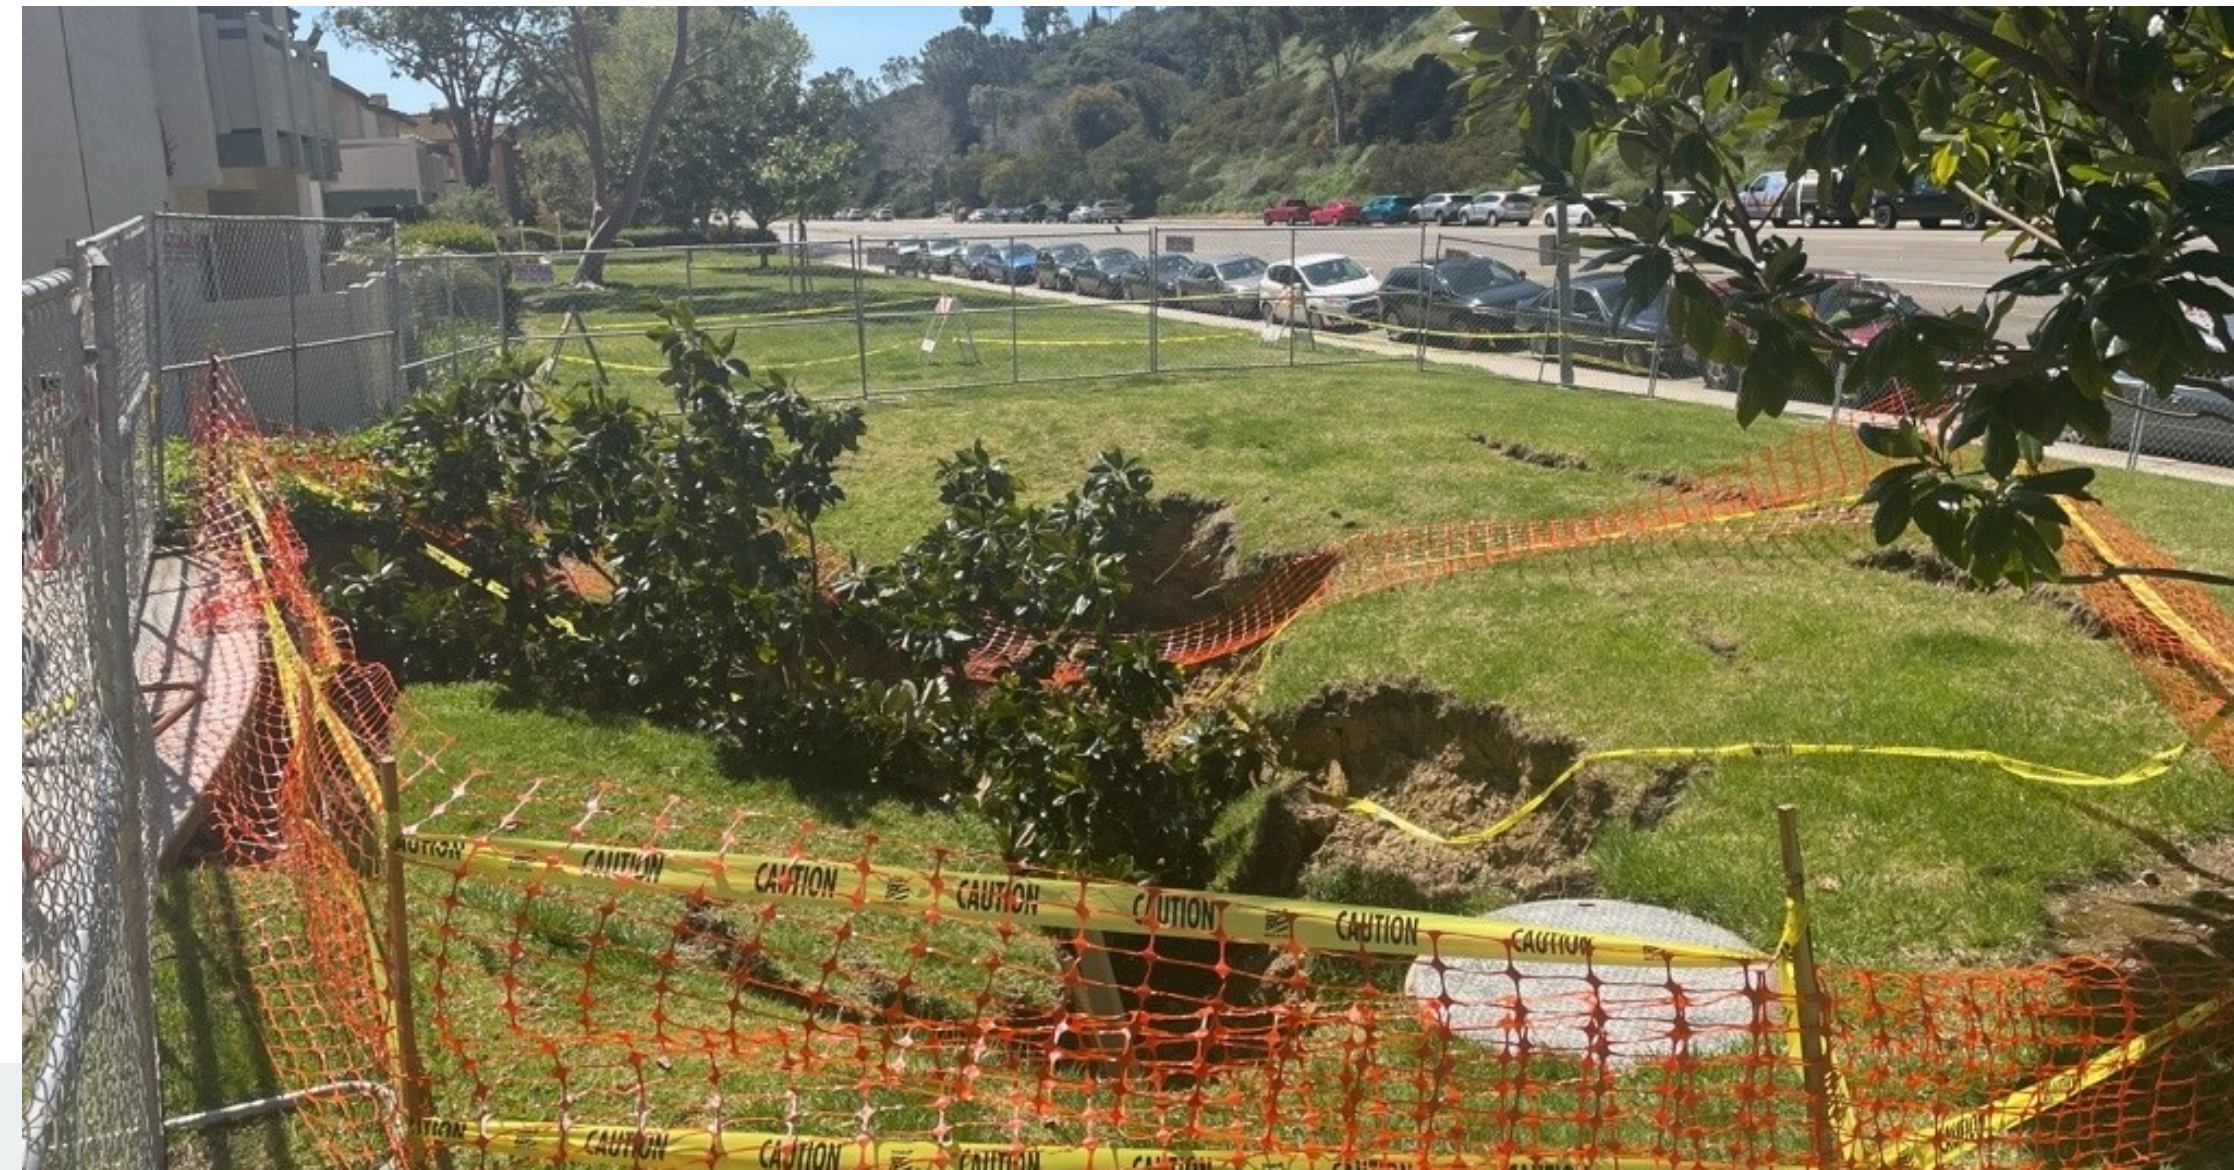
## COLLAPSE

- All of the other modes of failure can eventually lead to:
  - Complete failure and collapse of the CMP pipe
  - Sinkholes
  - Damage to nearby structures
  - Damage to adjacent drainage structures
