# CMP COMMON & UNCOMMON FAILURE MODES & REHABILITATION METHODS

2025 NORCAL PUG ANNUAL SHARING TECHNOLOGIES SEMINAR

Harris & Associates

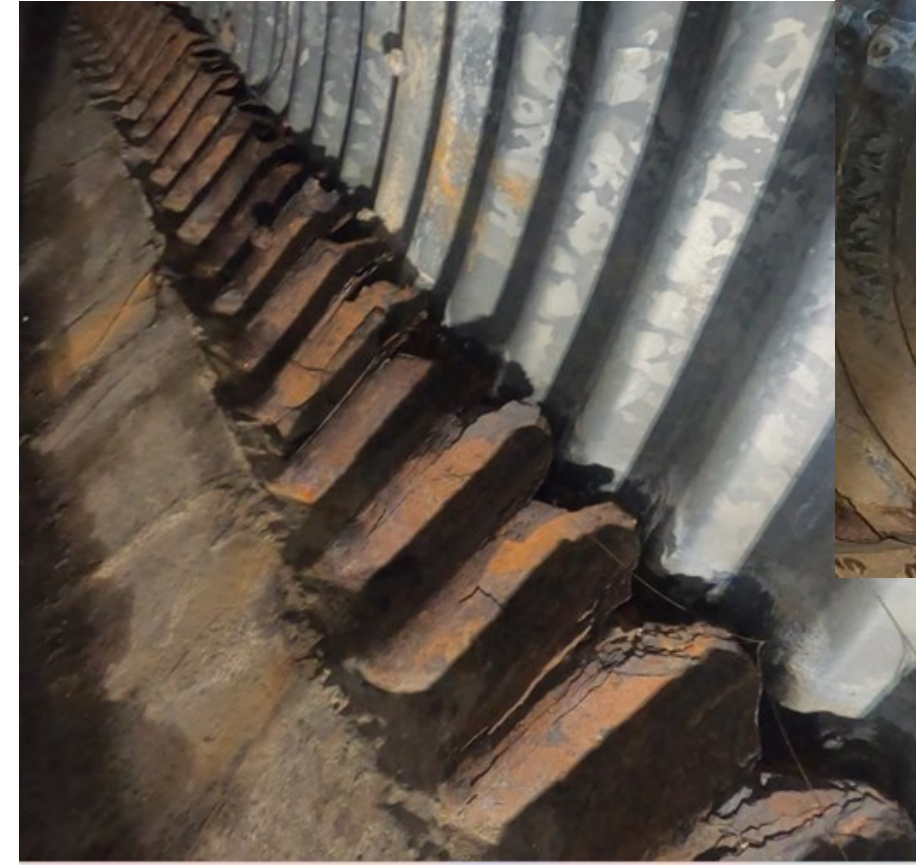
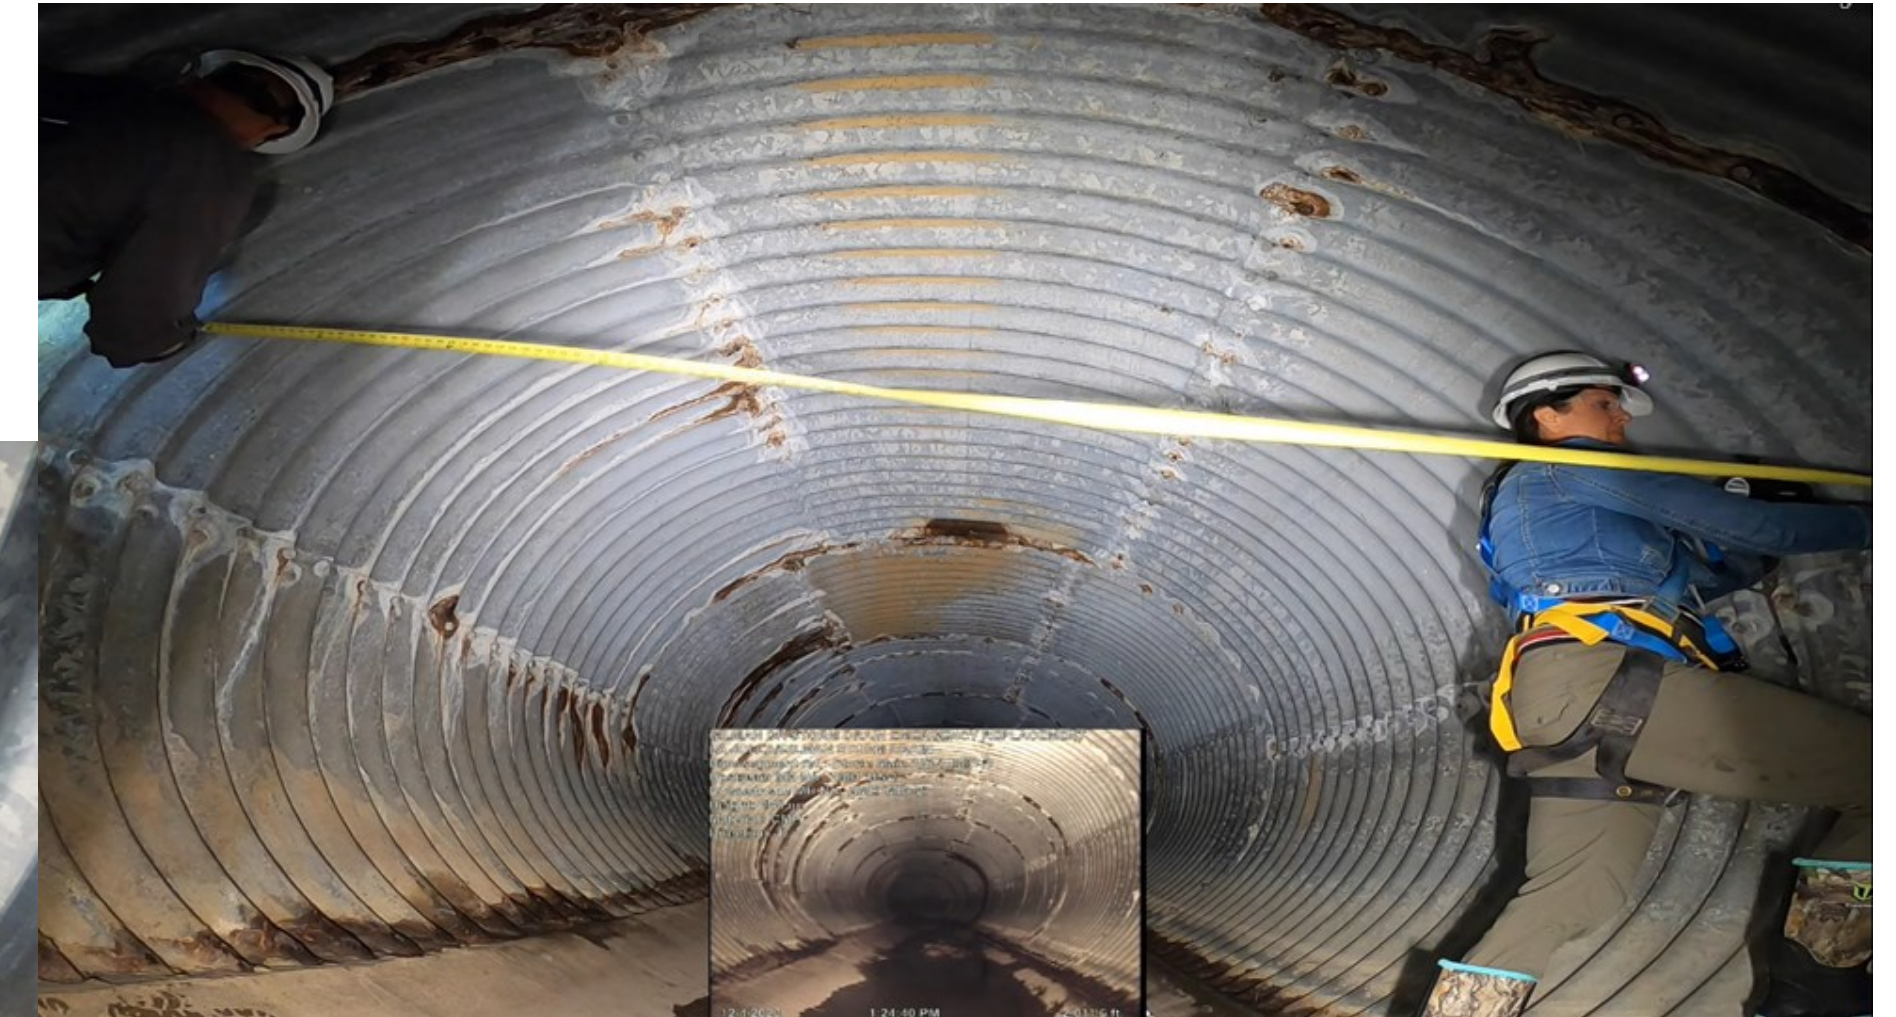
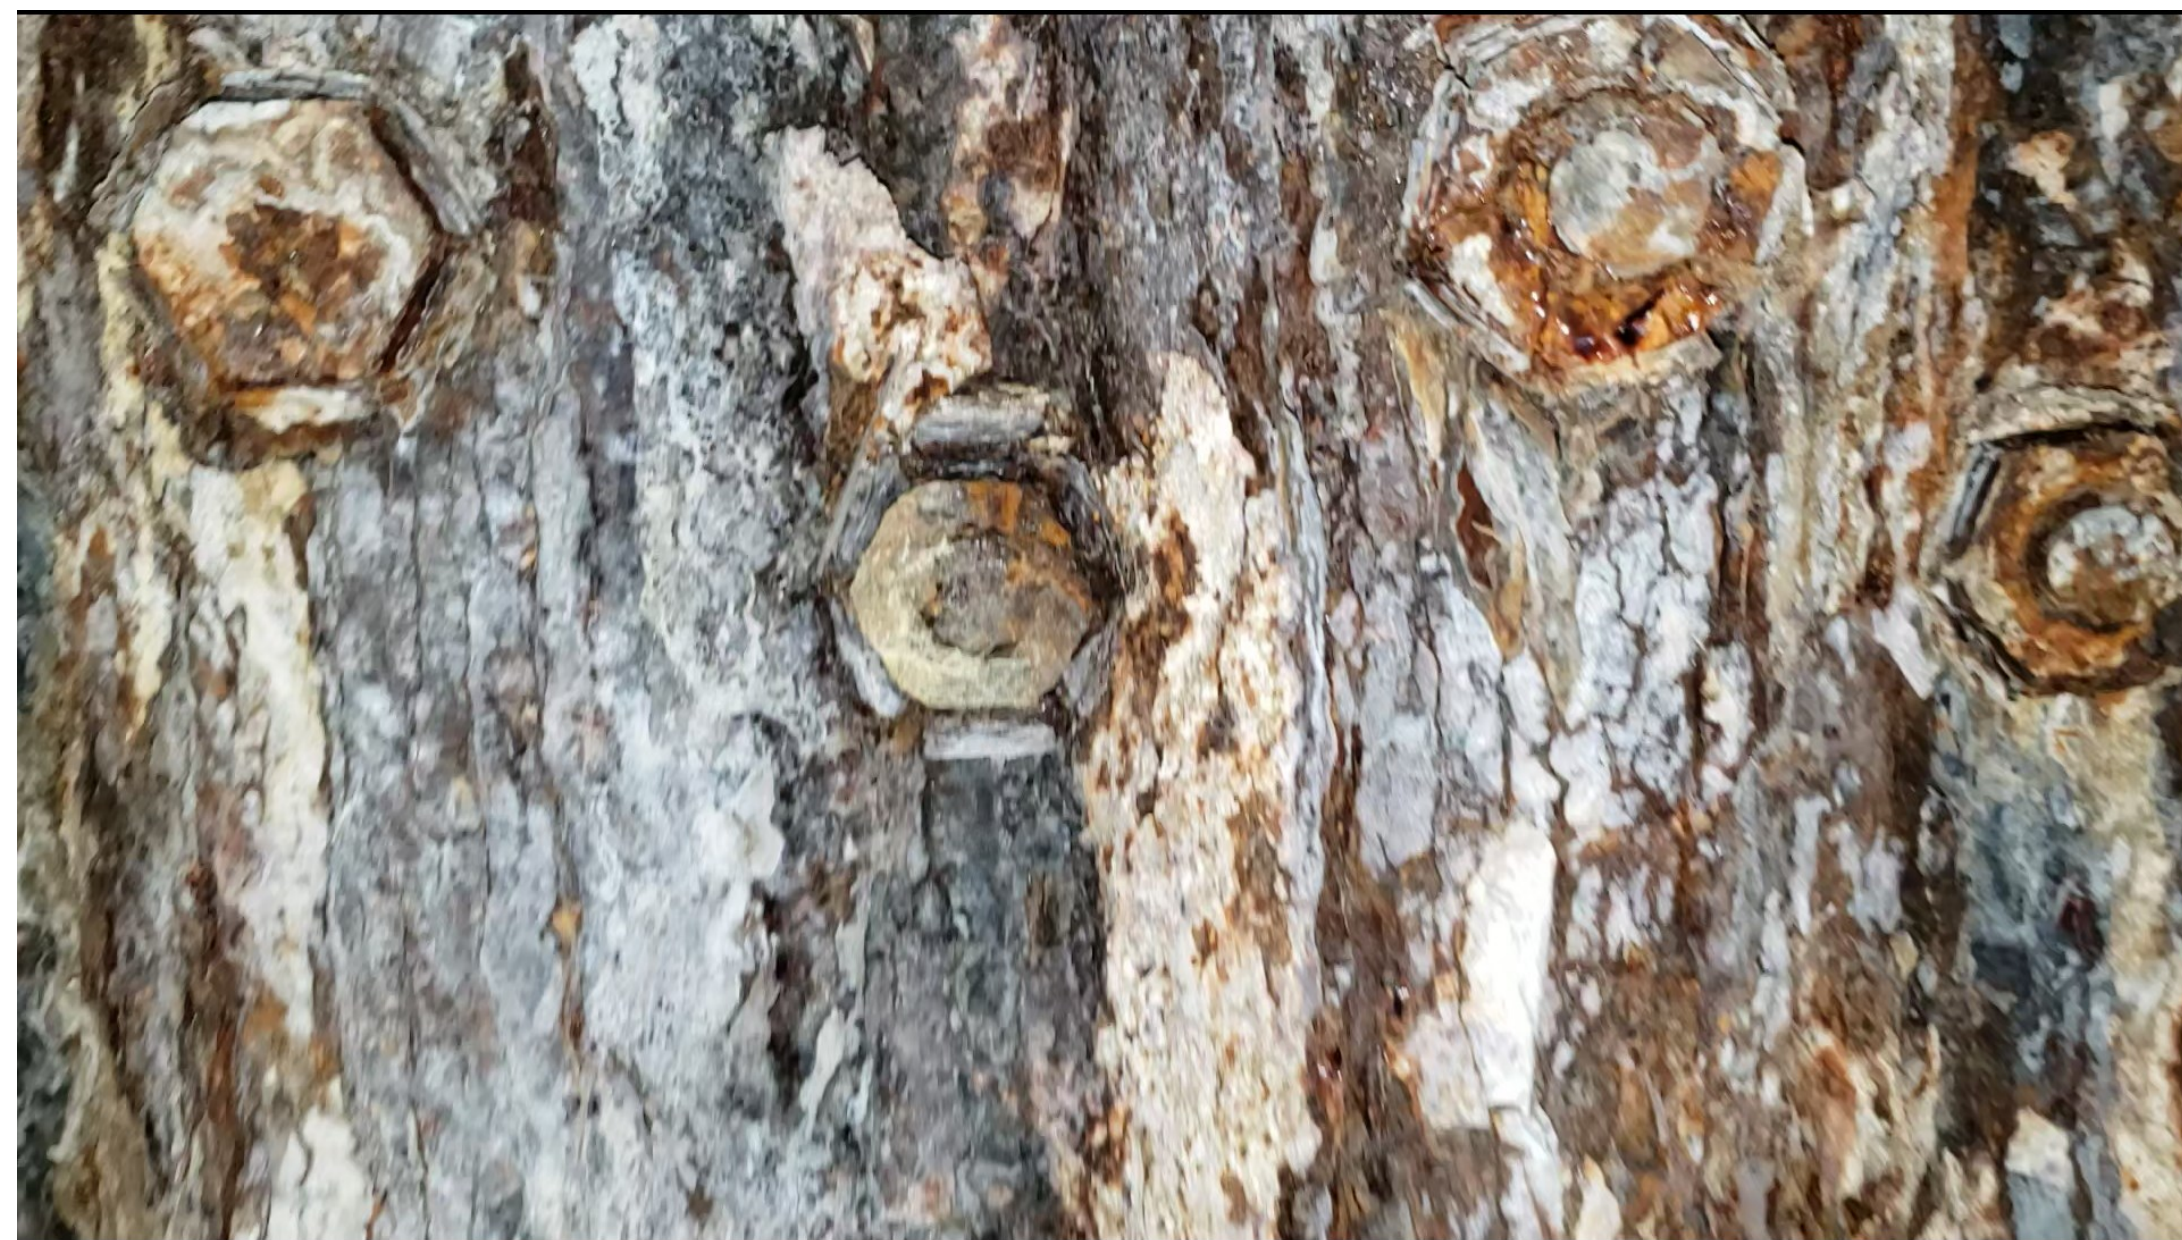
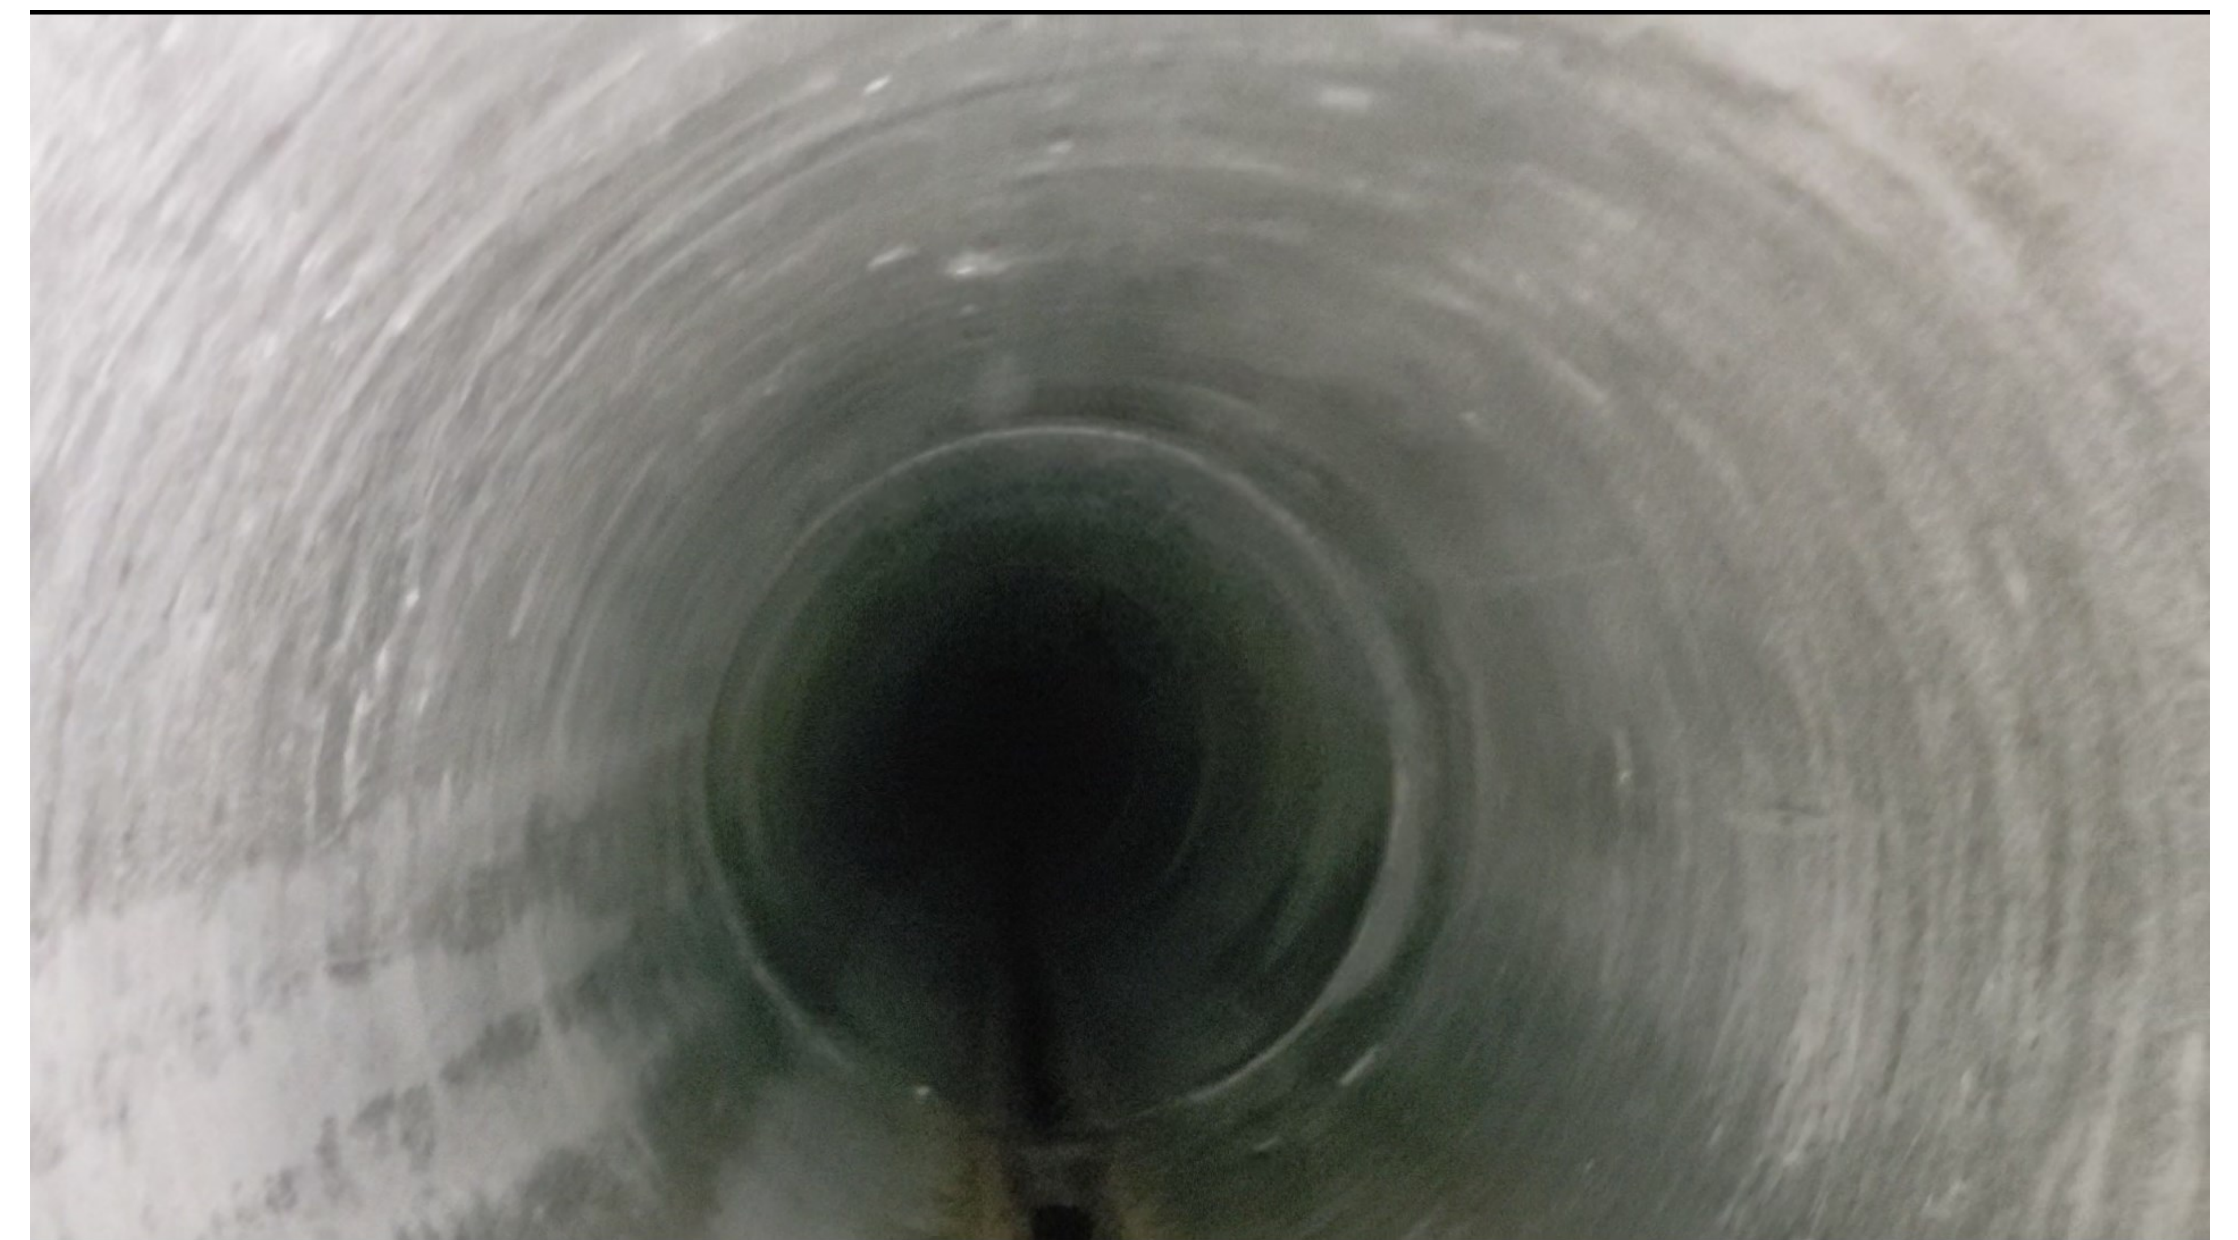
# CONFINED SPACE ENTRY

- Able to measure the pipe, bolt sizes, and defects
- Can touch the pipe to determine integrity of the metal
- Can measure voids behind the pipe walls
- Able to view from multiple angles

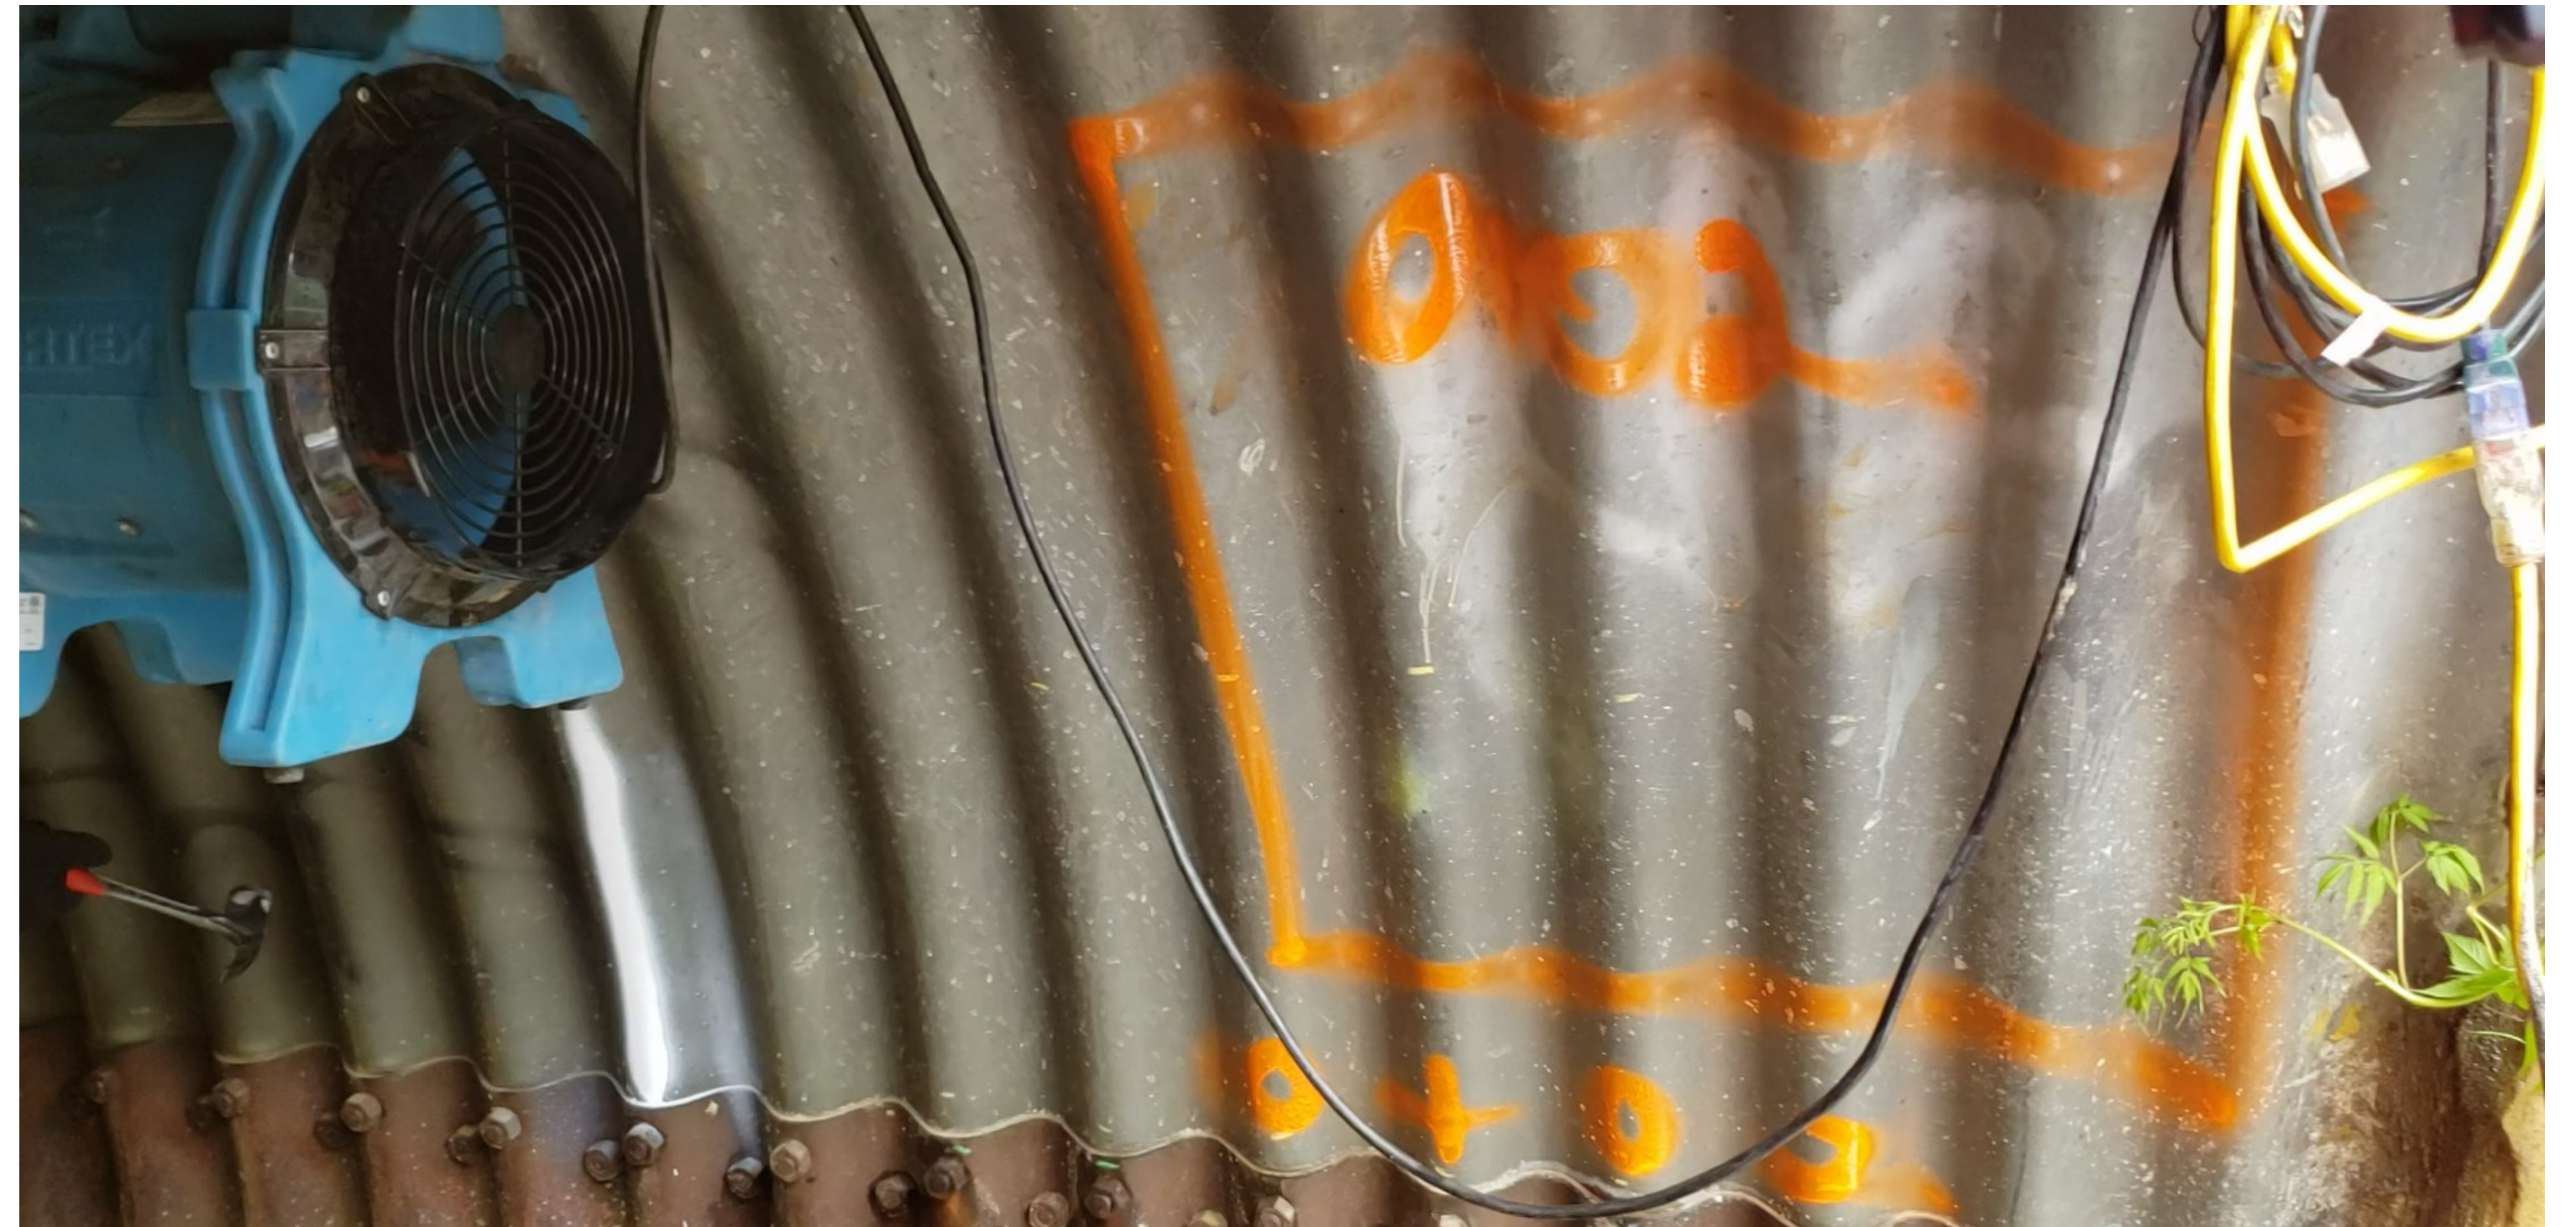
# SOUNDING FOR VOIDS

- GPR or PPR can be used to find voids but is not always reliable.
- Good old-fashioned soundings using a hammer work great

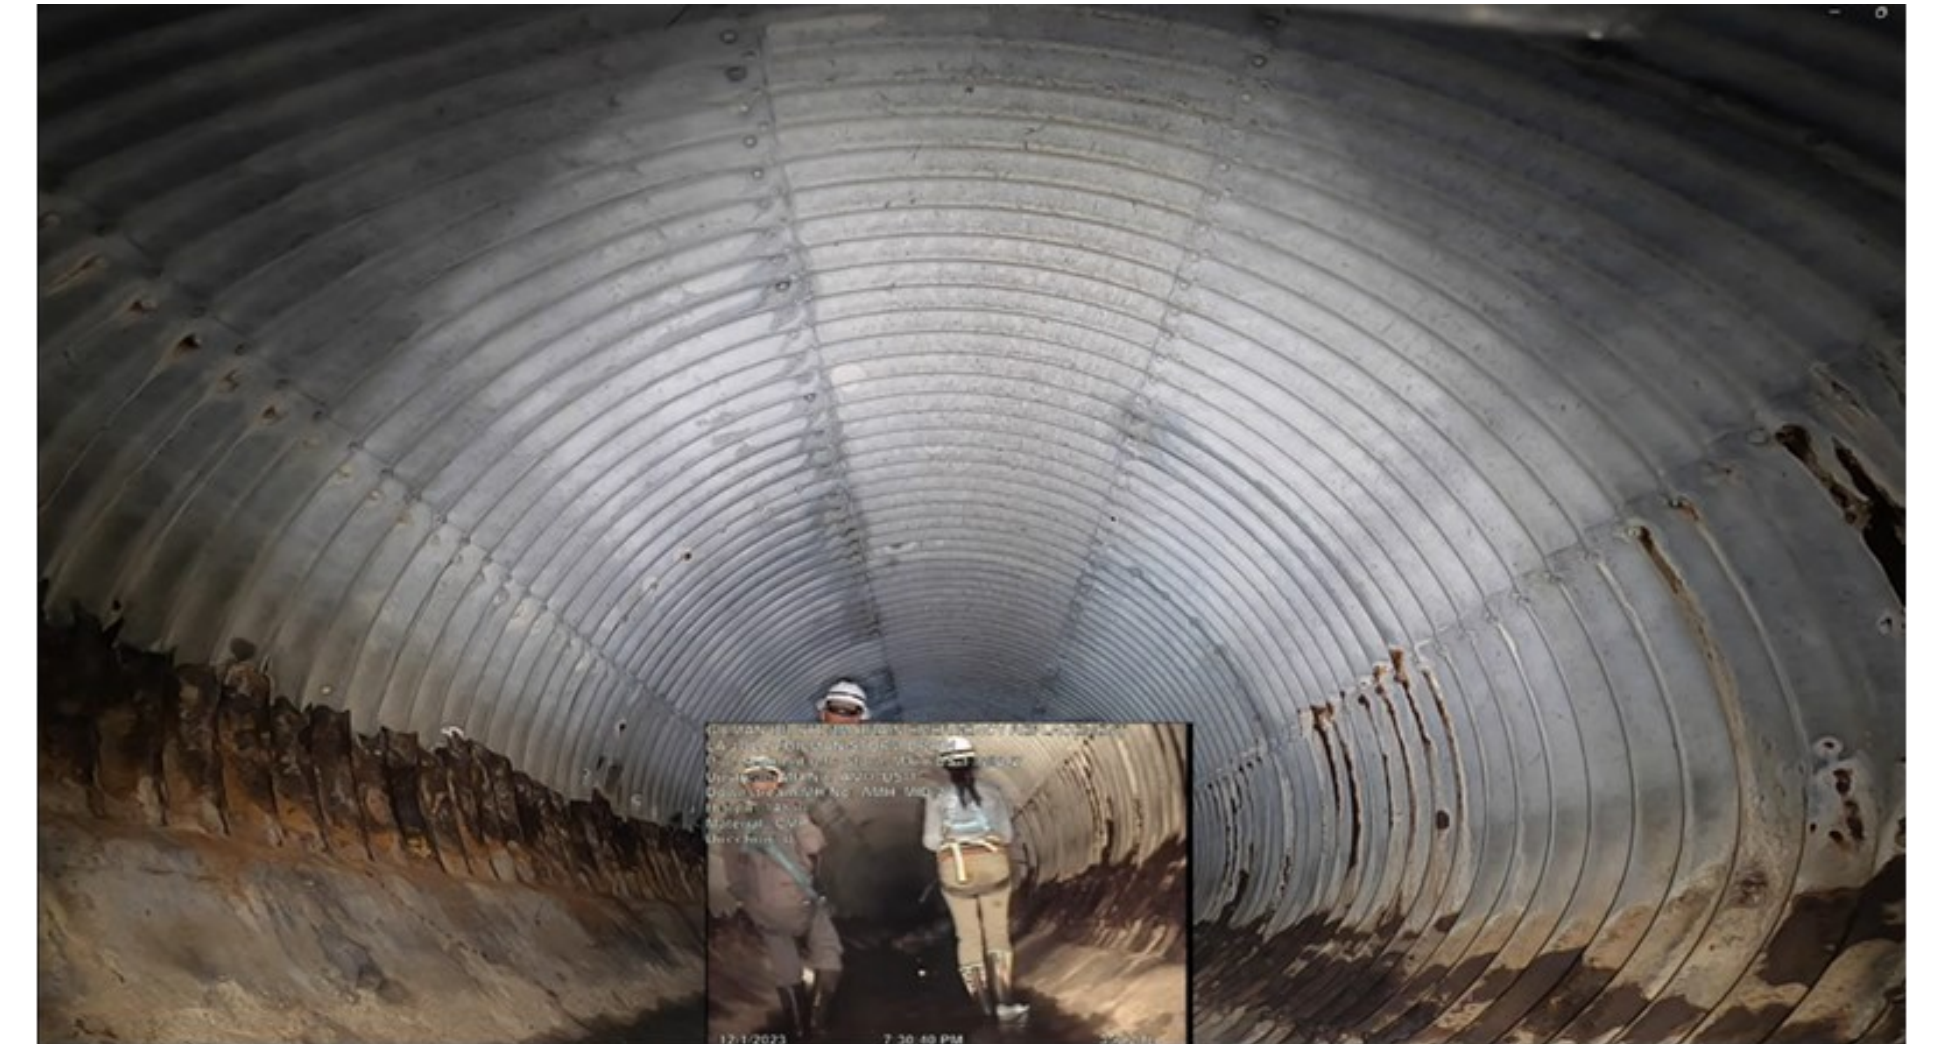
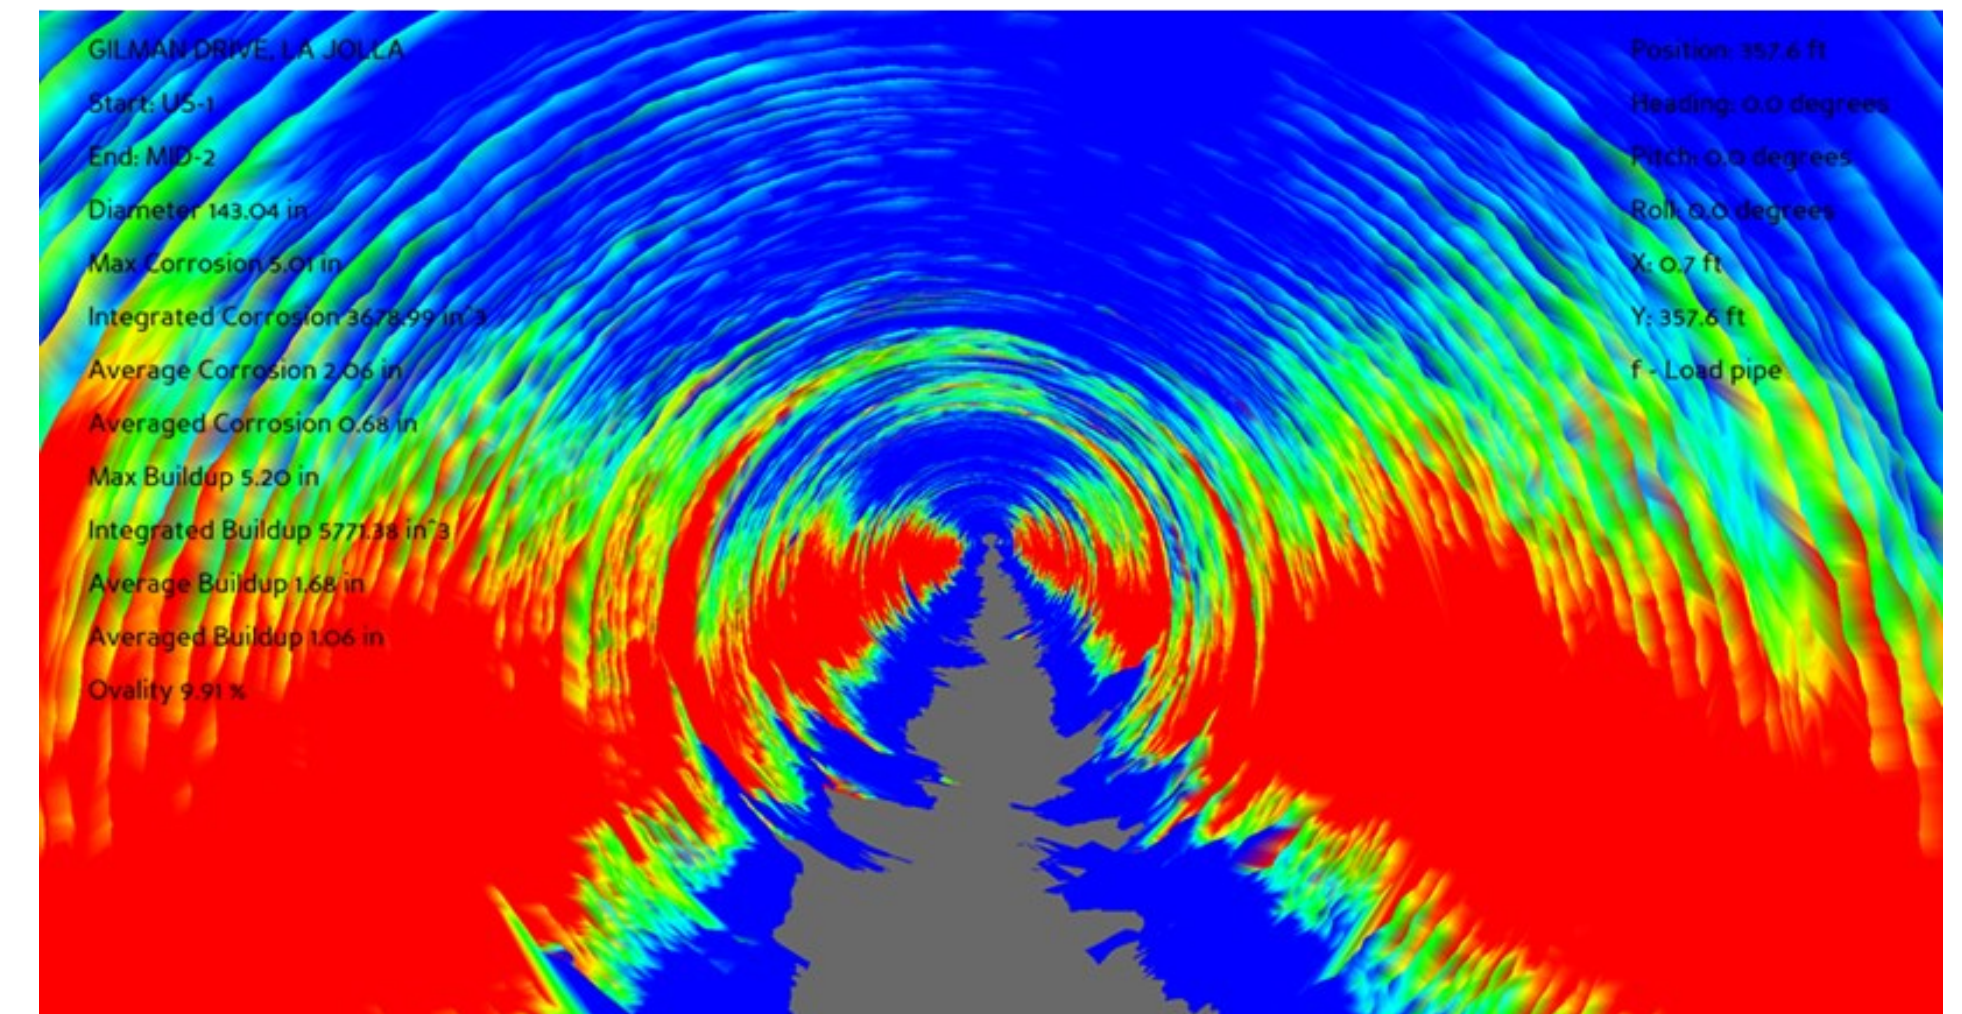
CMP with over a 20% change in ovality is at risk for buckling/collapse.

The color ramp graduates automatically depending on the range of measurements outside the reference circle/as-built (or the amount of concrete corrosion in RCP Pipes).

- Green indicates as-built pipe size/condition, or pipe in better condition than the rest
- Yellow indicates minor deviation from as-built
- Orange indicates more deviation from as-built
- Red indicates more major deviation from as-built
- Blue indicates buildup, or where pipe is inside as-built measurements.

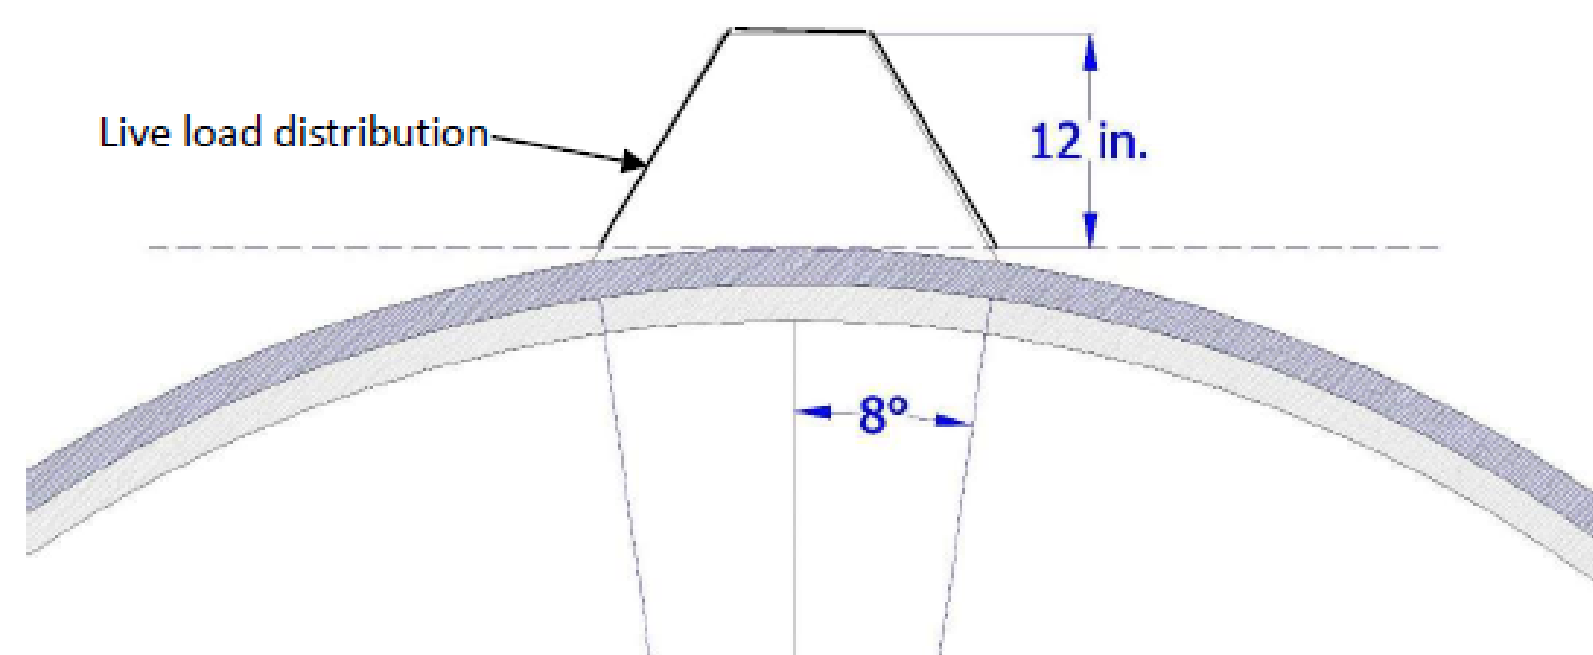
# ARCH PIPE DEFORMATION

In an arch pipe, most of the load is concentrated at the top of the pipe.

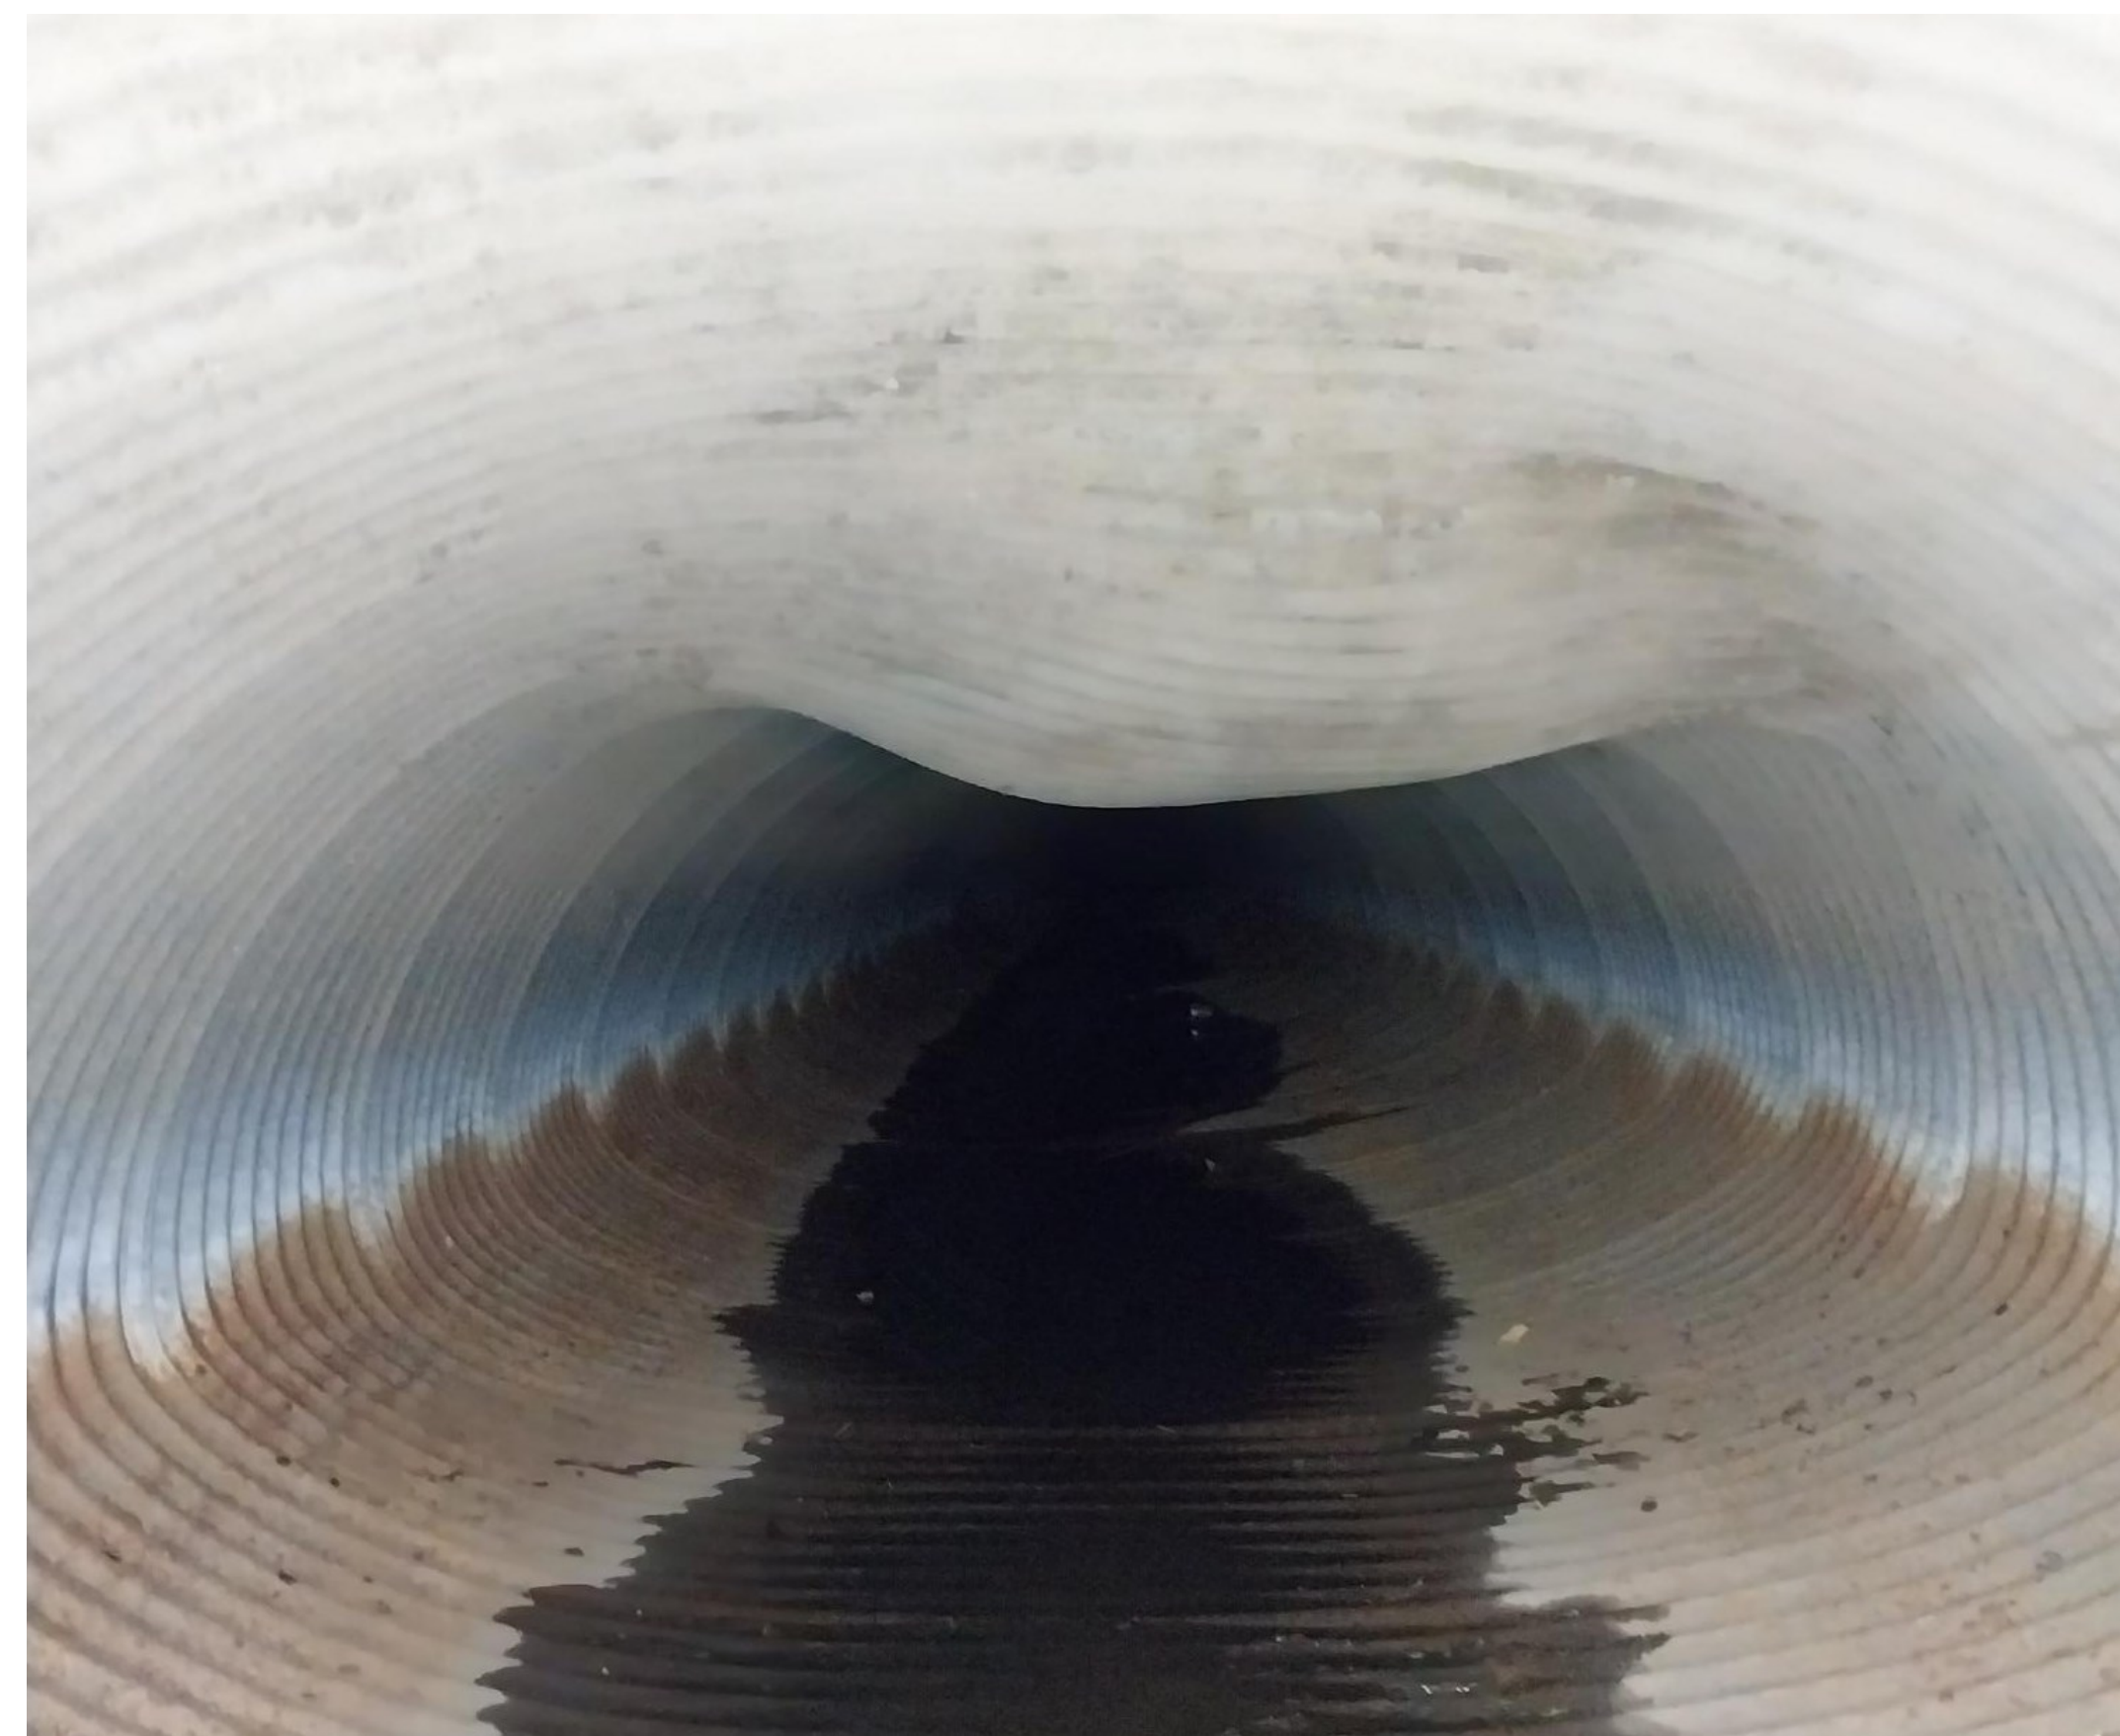
**BULGE WAS 14.25 inches – THIS WAS CUT OUT AND PATCHED WITH A NEW PIECE OF CMP**
