# CMP COMMON & UNCOMMON FAILURE MODES & REHABILITATION METHODS

2025 NORCAL PUG ANNUAL SHARING TECHNOLOGIES SEMINAR

Harris & Associates

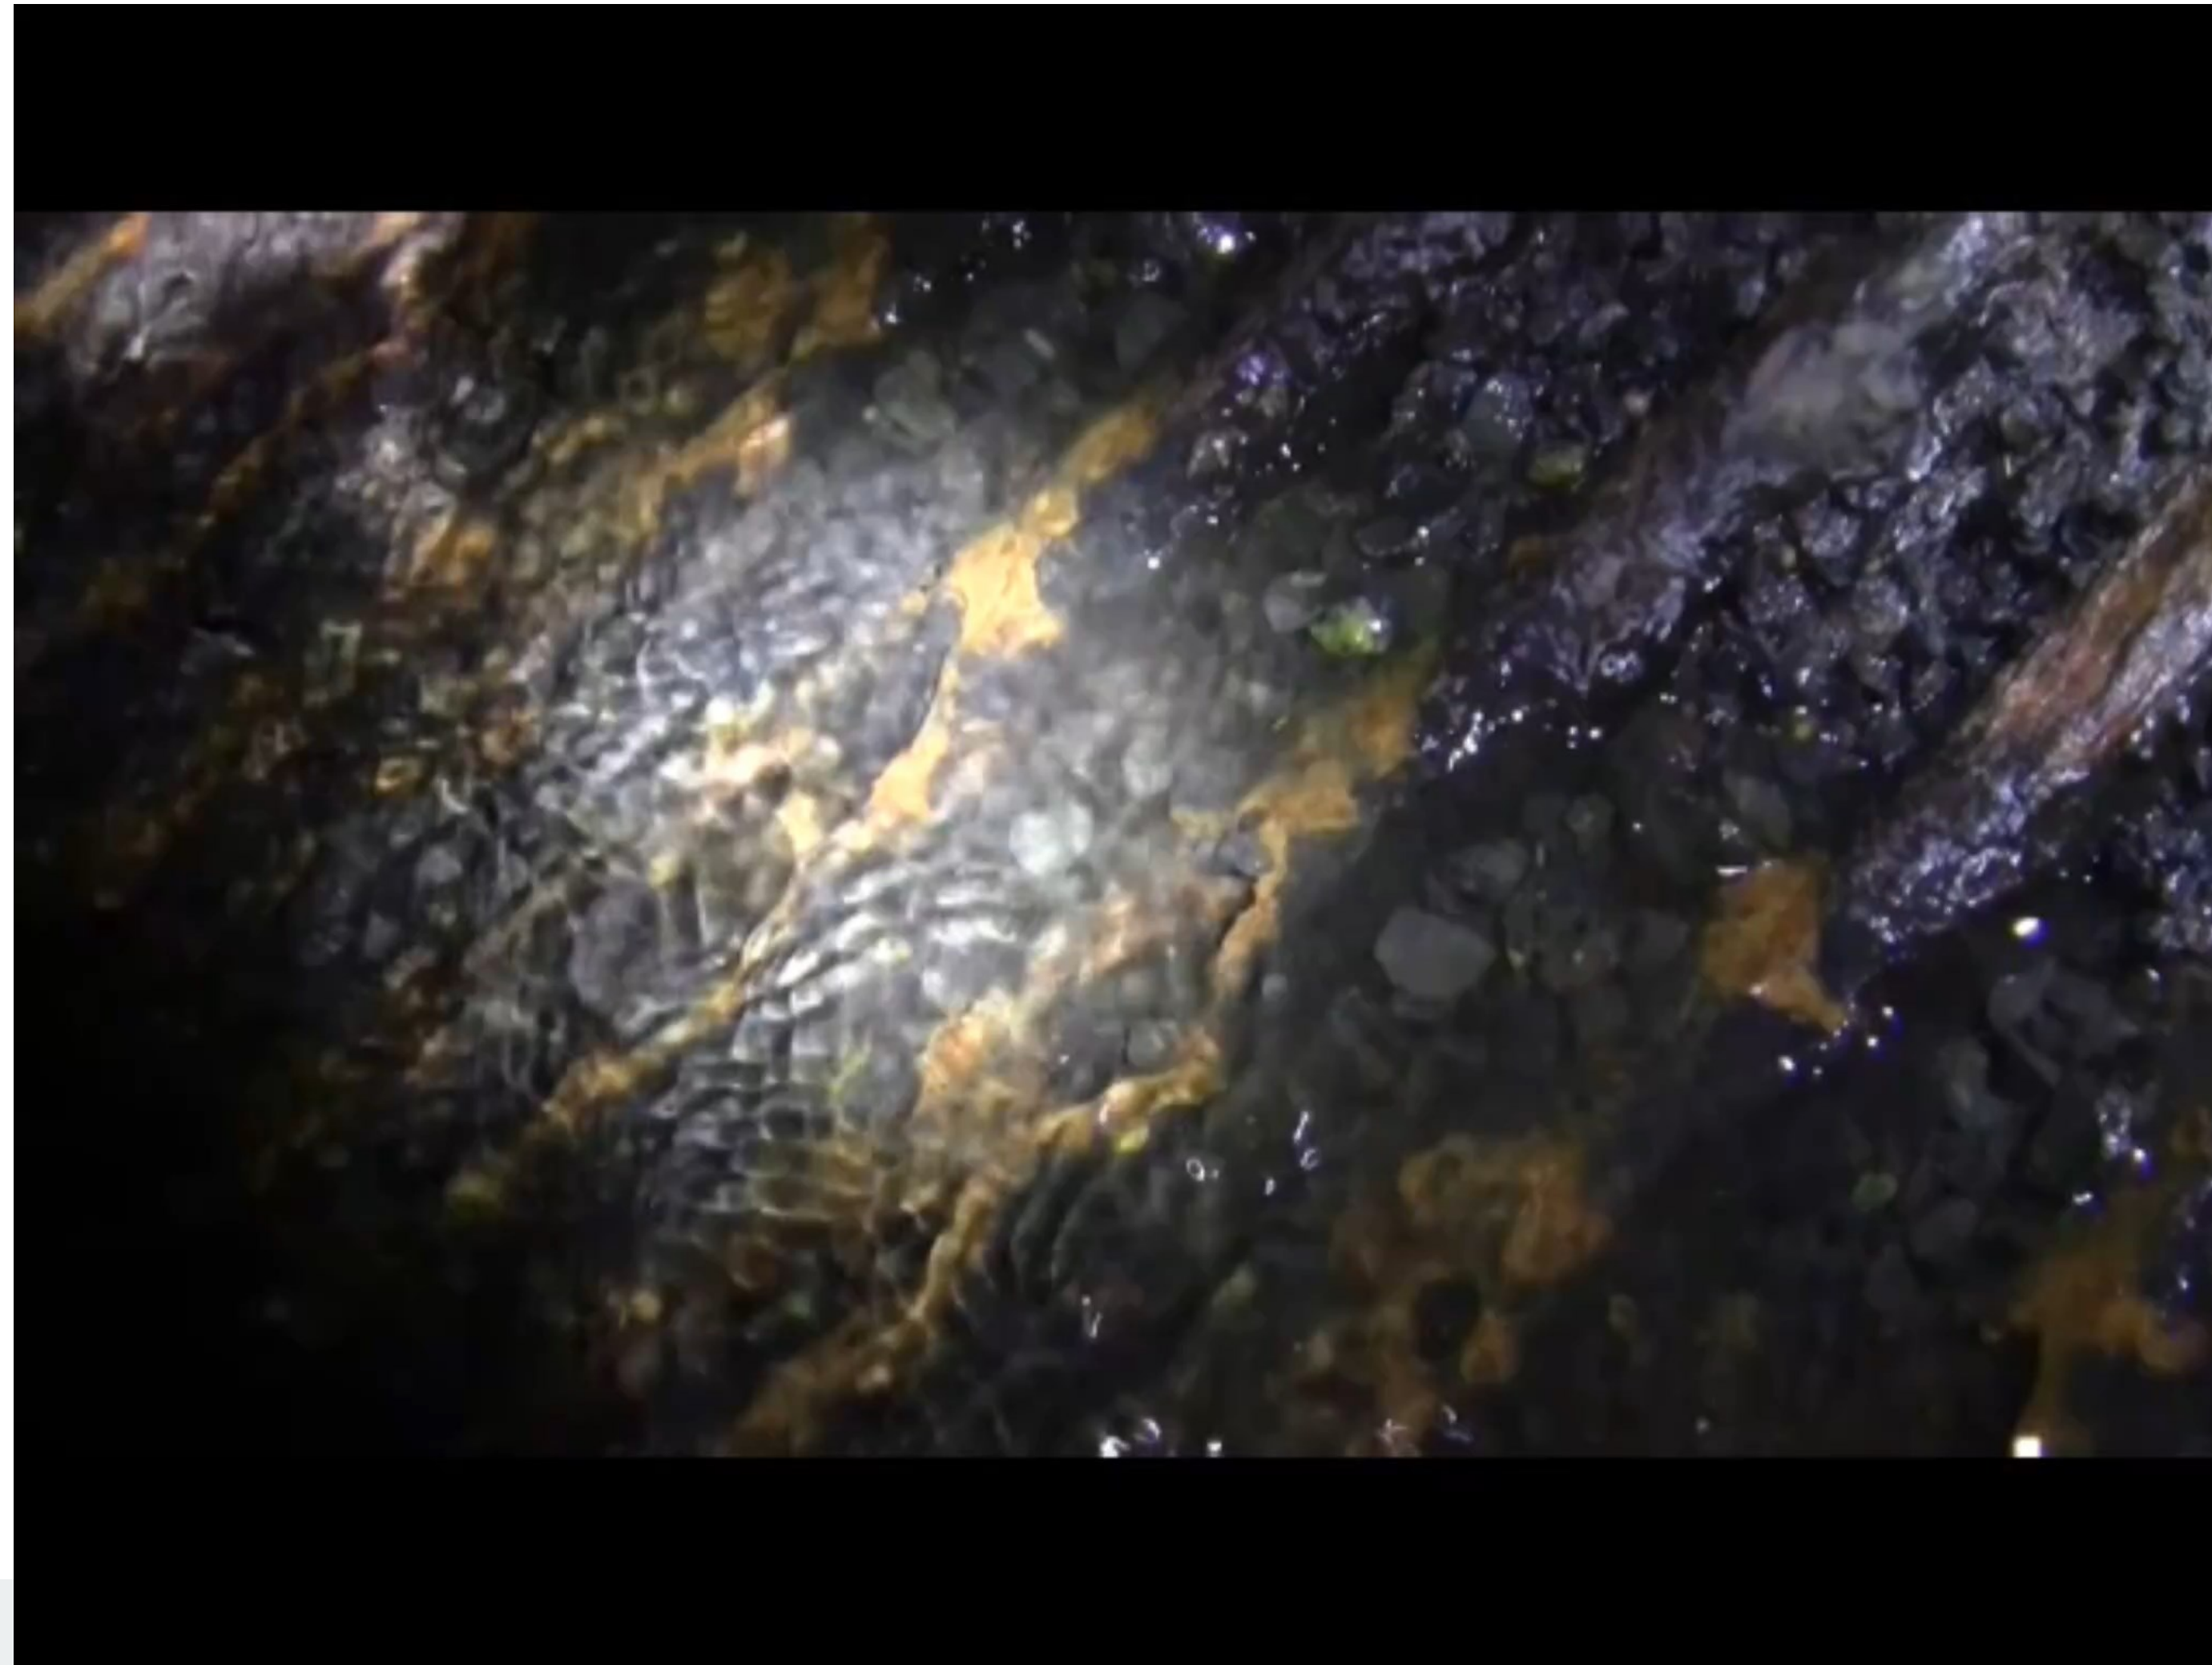
# 1. PUA NANI 84-INCH CMP REHAB, LIHUE, KAUAI

METHOD: CCCP USING PERMACAST PL-8000

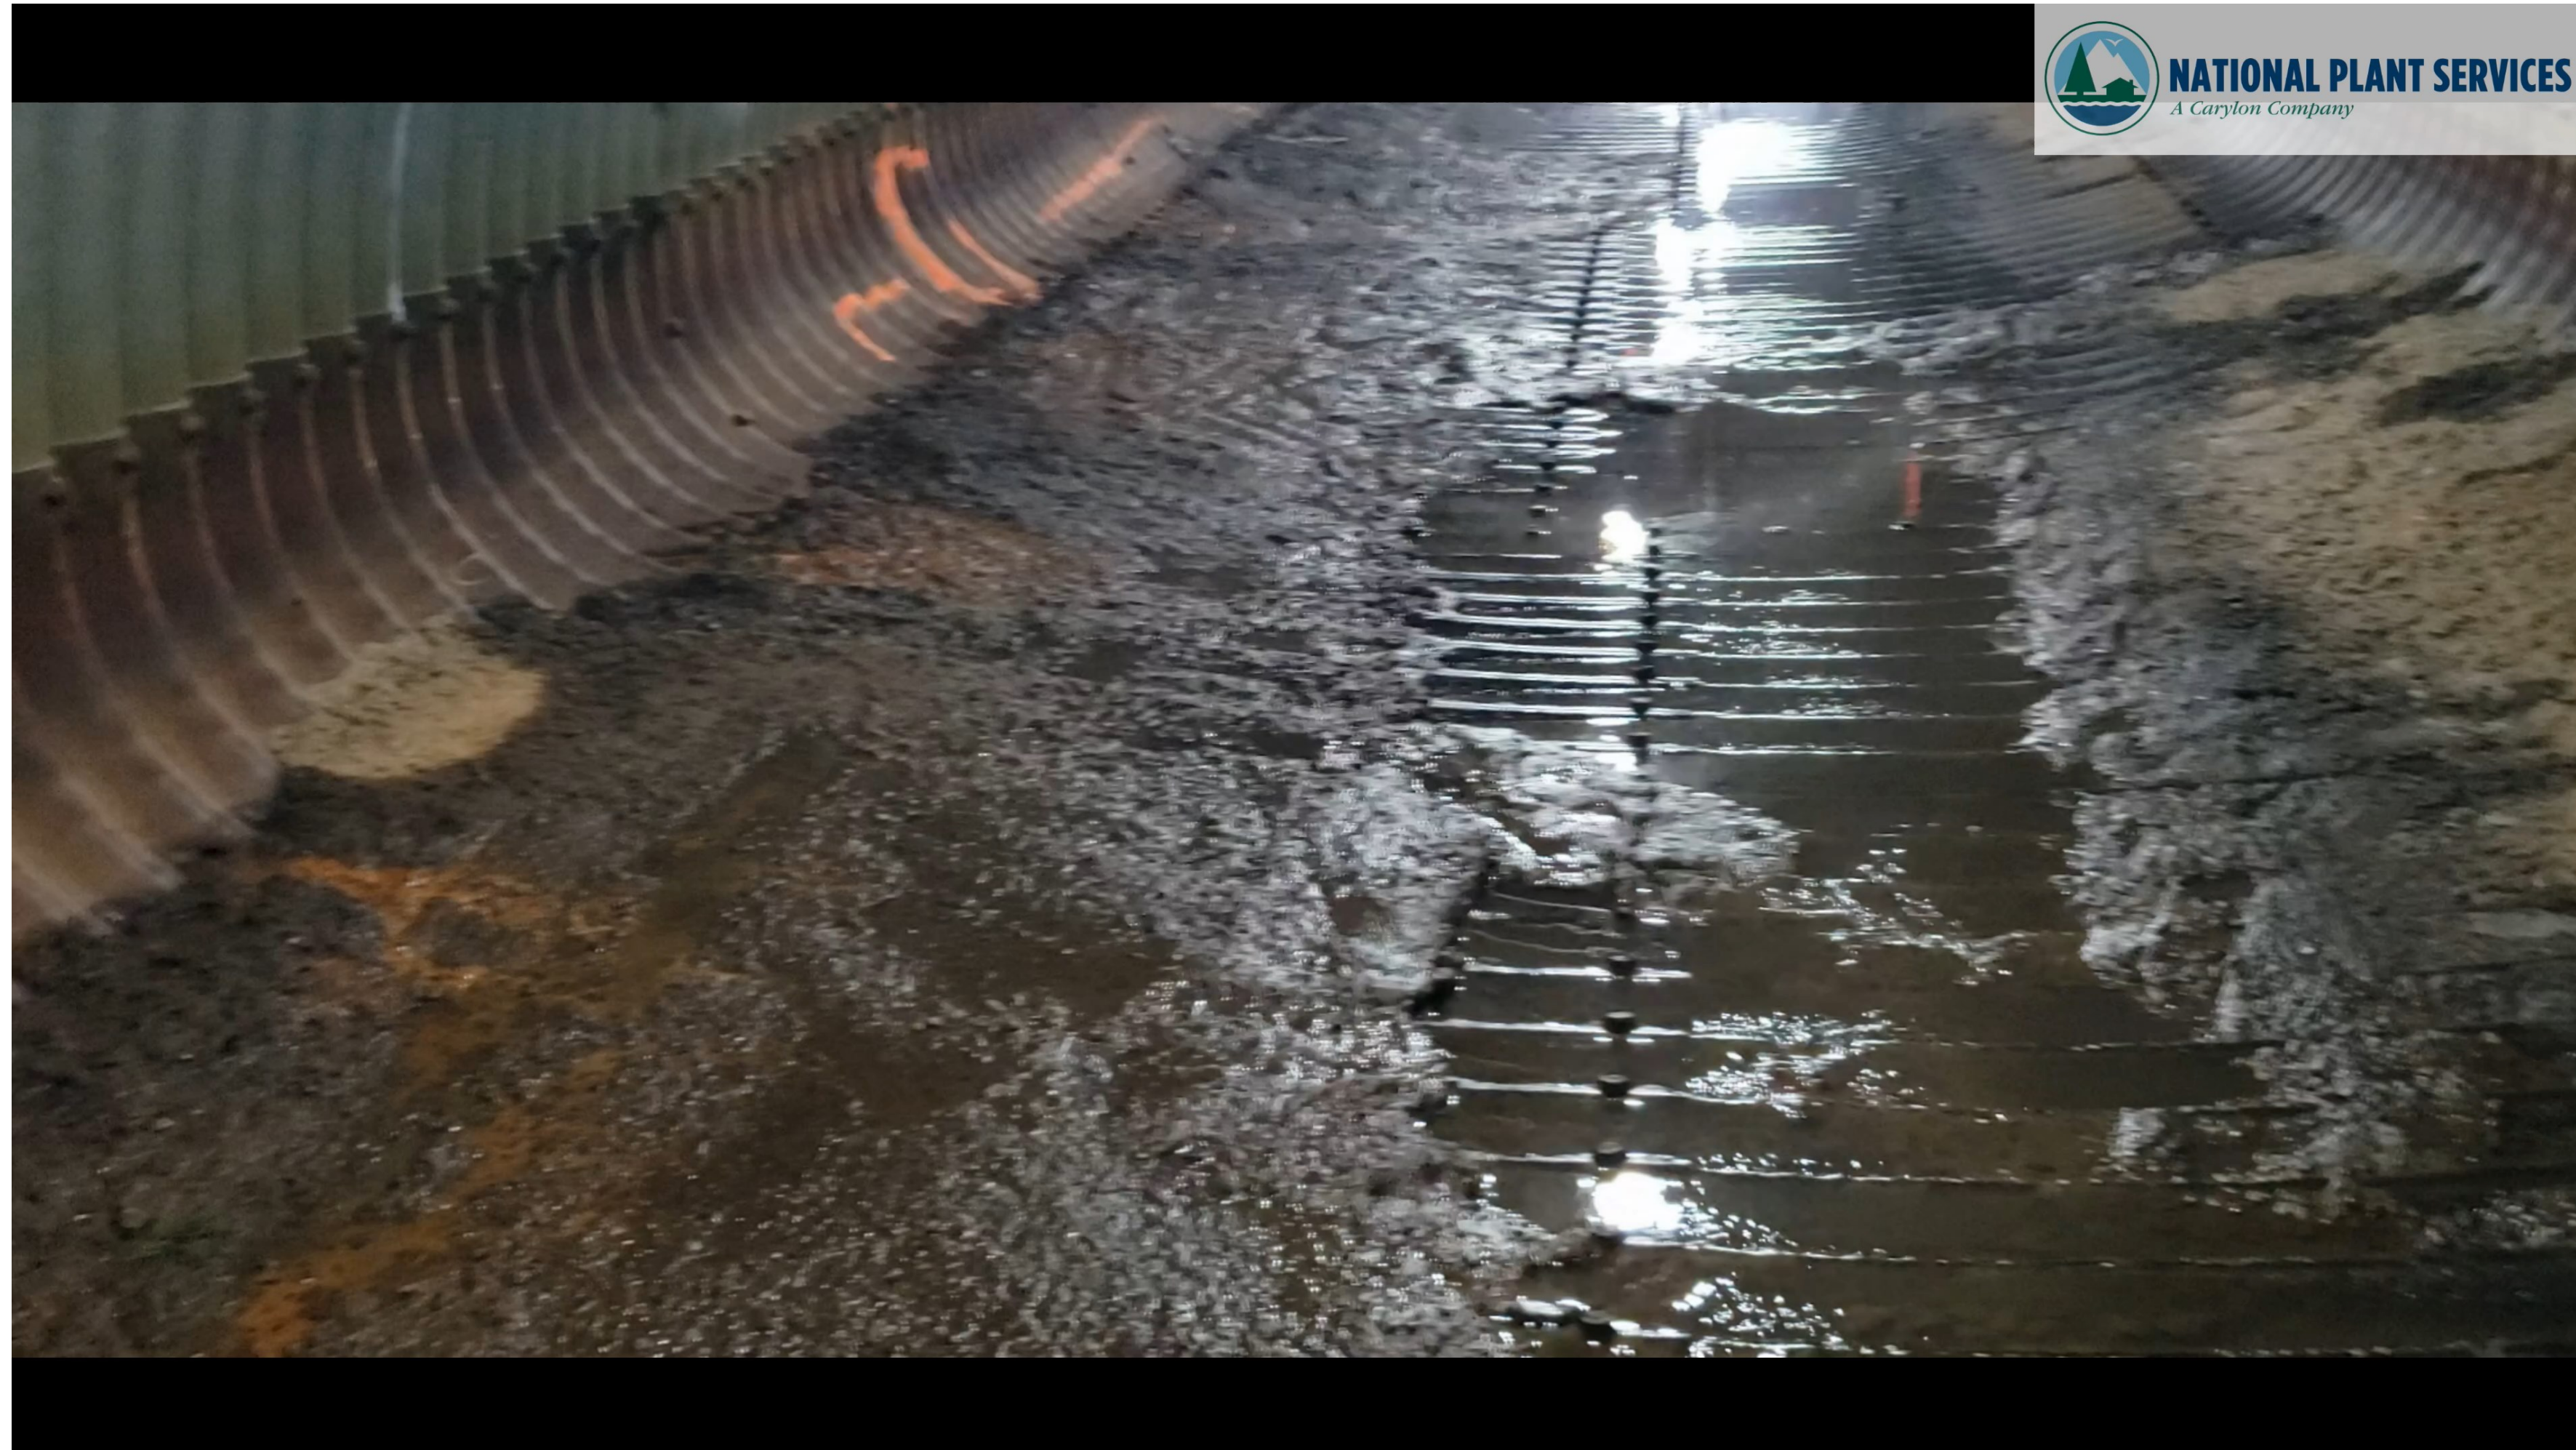
## 2. SCHOENBAR CULVERT (7 FT X 12 FT), KETCHIKAN, AK

METHOD: CCCP USING PERMACAST PL-8000

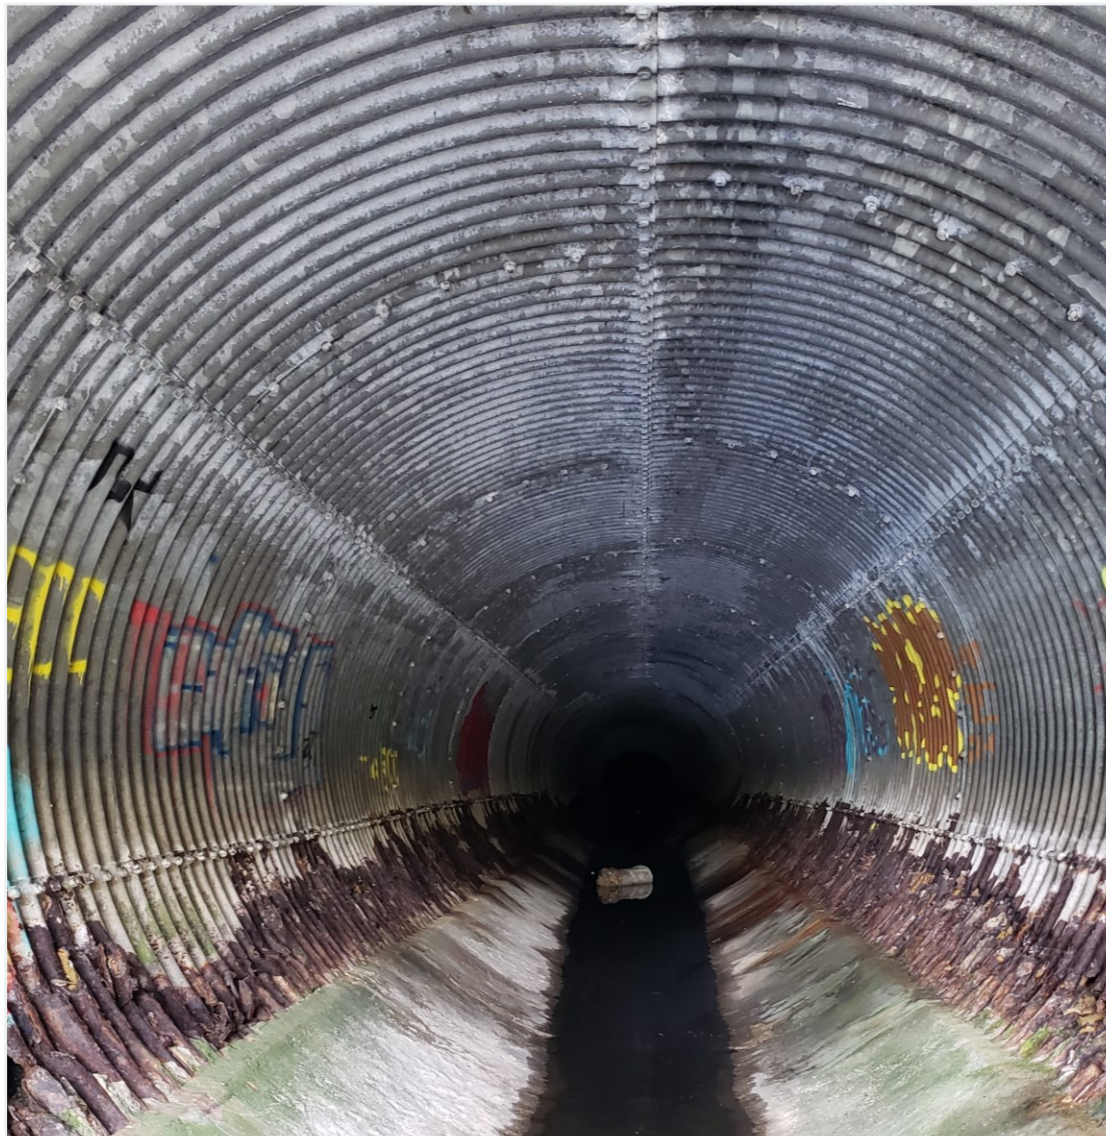
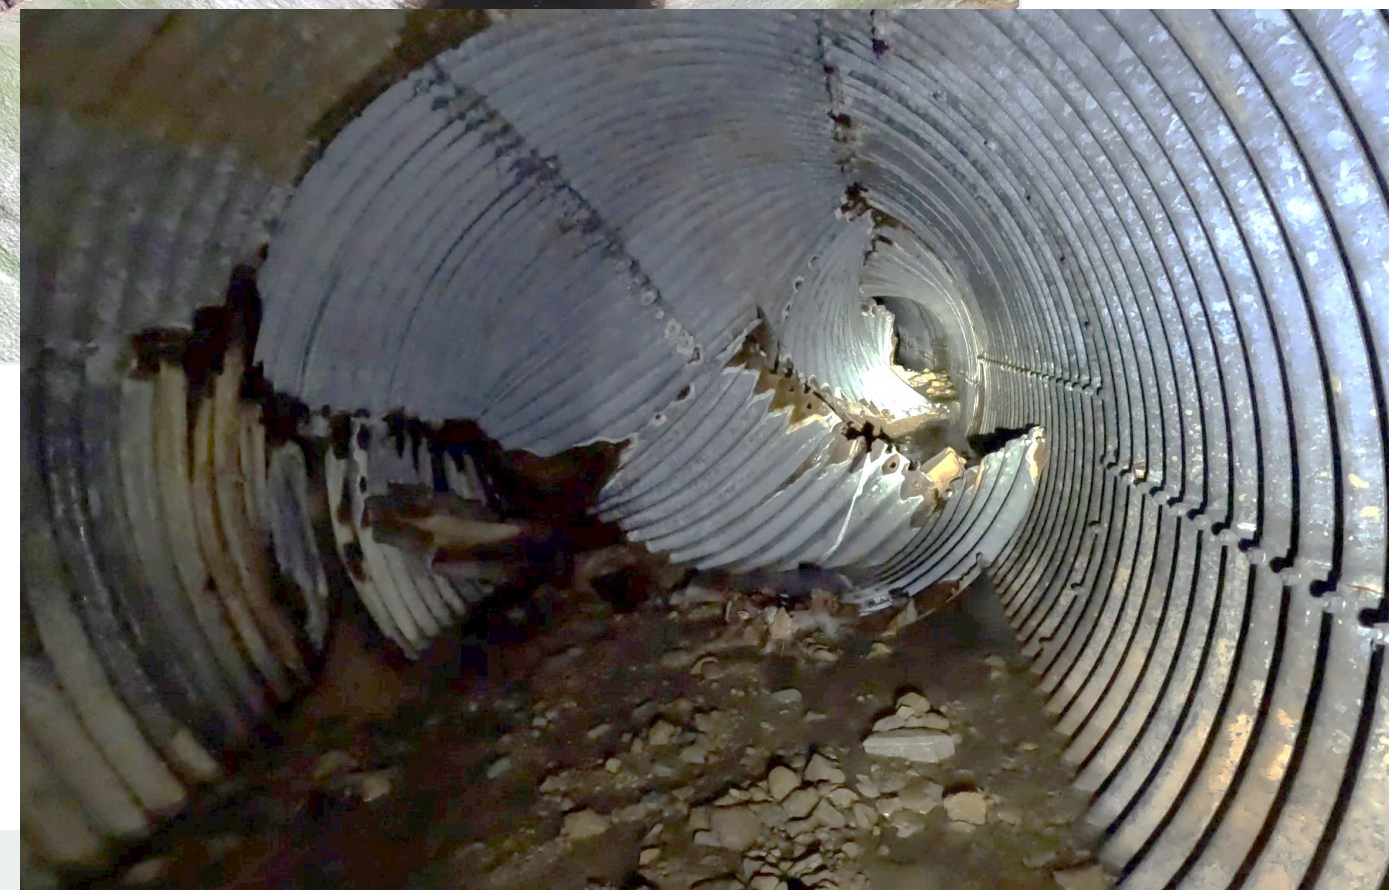
# 3. 132-INCH CMP REPLACEMENT, SOUTHERN CA

## METHOD: CCCP USING VORTEX GEOPOLYMER

- 132-inch diameter CMP pipe had failed
- Ground settlement, cave in, and sinkhole
- CMP pipe had collapsed entirely
- Previously had been repaired with concrete invert lining
- Pipe had corroded along the edge of the invert lining
- Close proximity to apartment buildings
  - Required daily settlement surveys to monitor building foundations

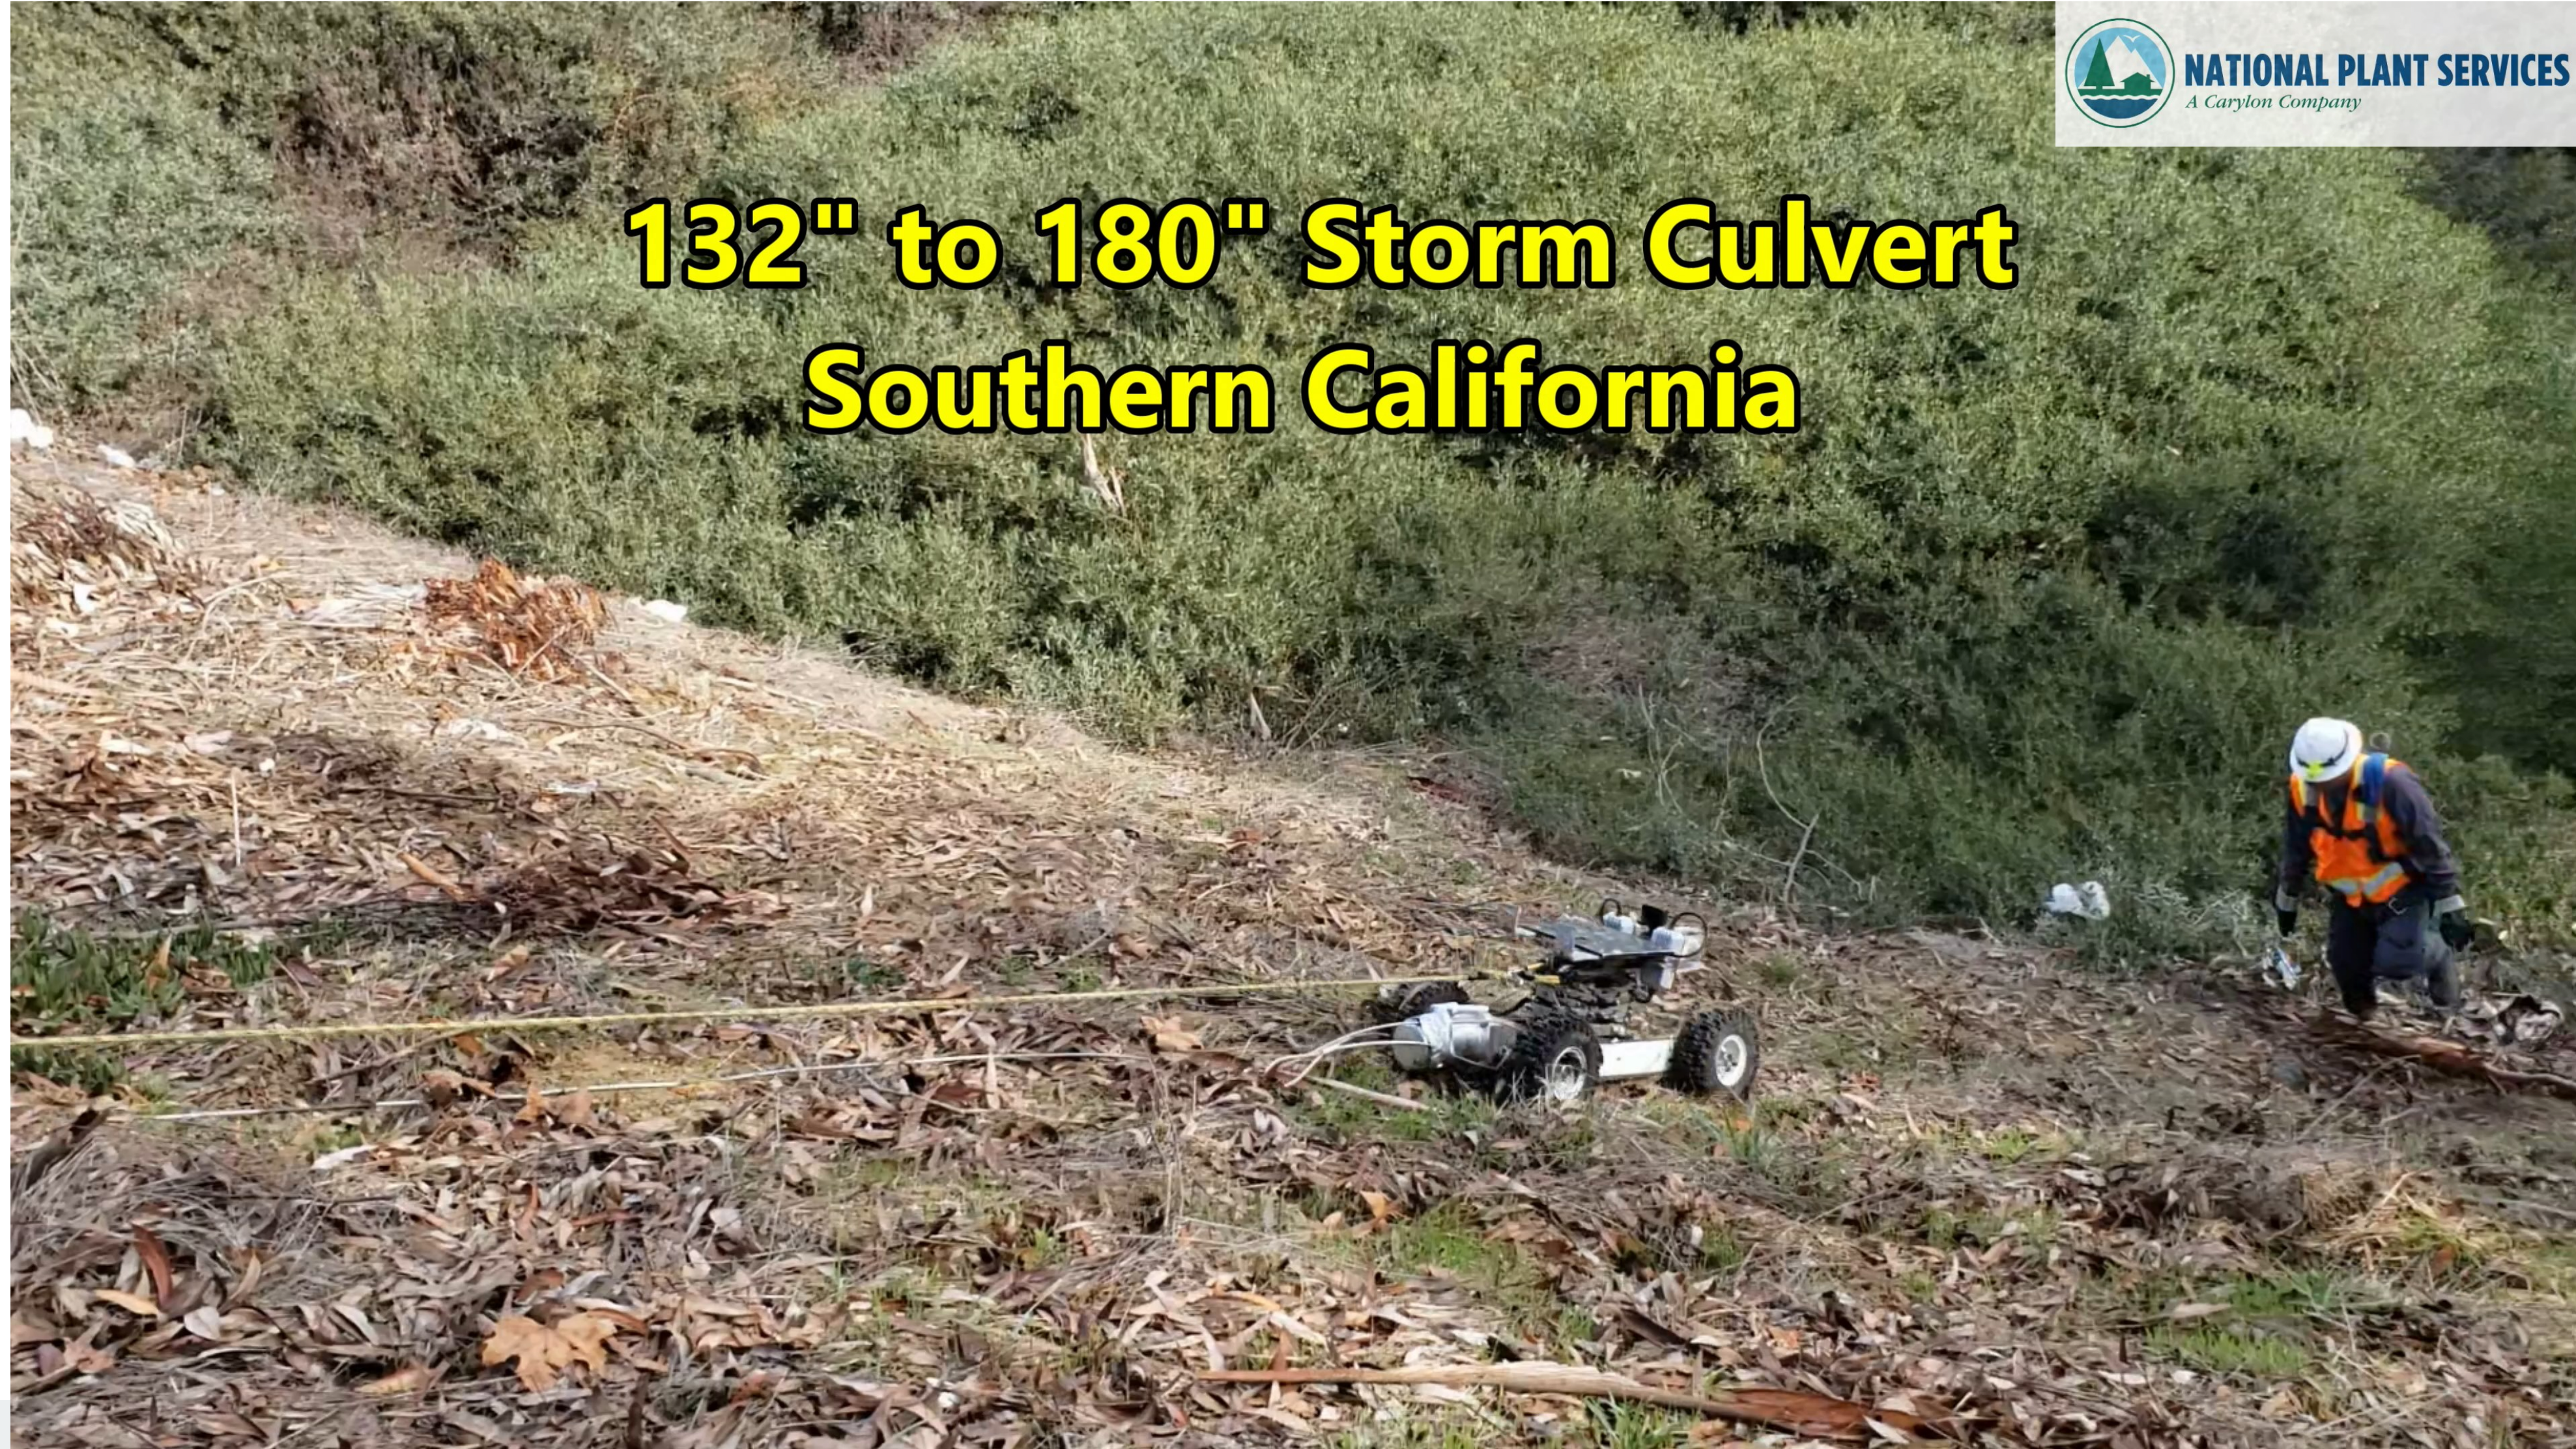
**132" to 180" Storm Culvert  
Southern California**

## CCTV/LIDAR INSPECTION

Start (ft)	End (ft)	Ovality (%)
3	11	<10
12	192	10-20
193	206	20-30
207	250	30-40
257	268	20-30
269	410	10-20
411	447	<10
448	1685	10-20
1686	1796	20-30
1797	1883	10-20
1884	1931	<10
1932	1966	10-20
1967	2039	20-30
2040	2060	30-35
2061	END	20-30
<b>AVERAGE</b>		<b>16.19</b>
<b>MAXIMUM</b>		<b>38.26</b>

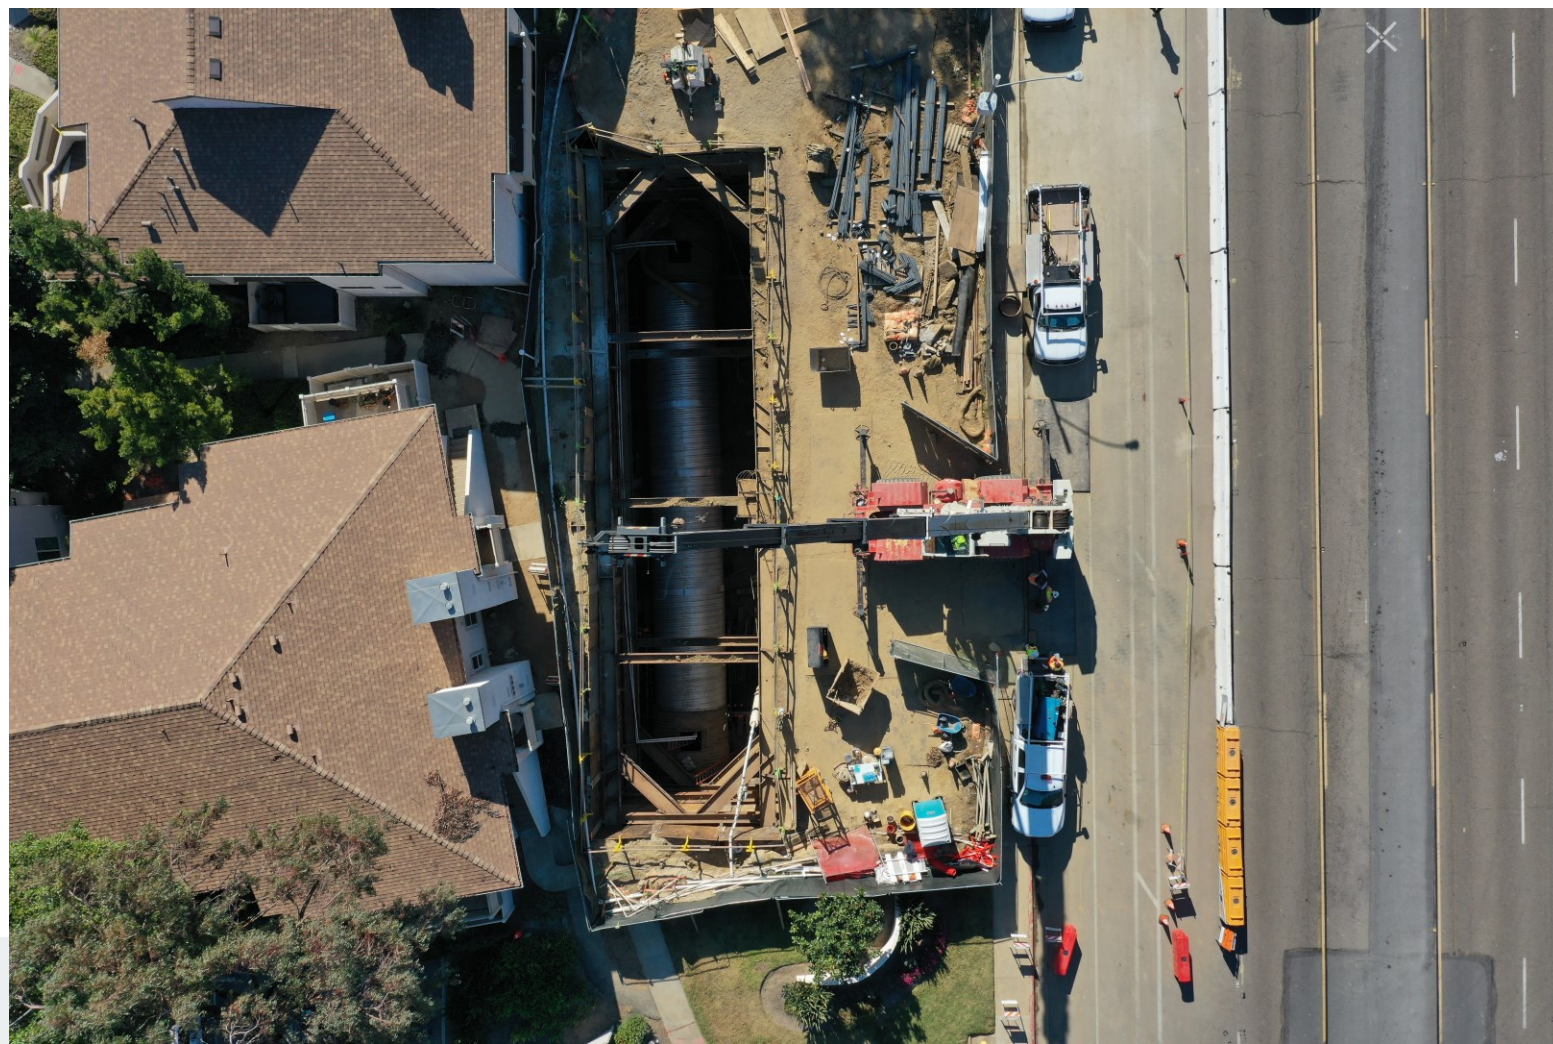
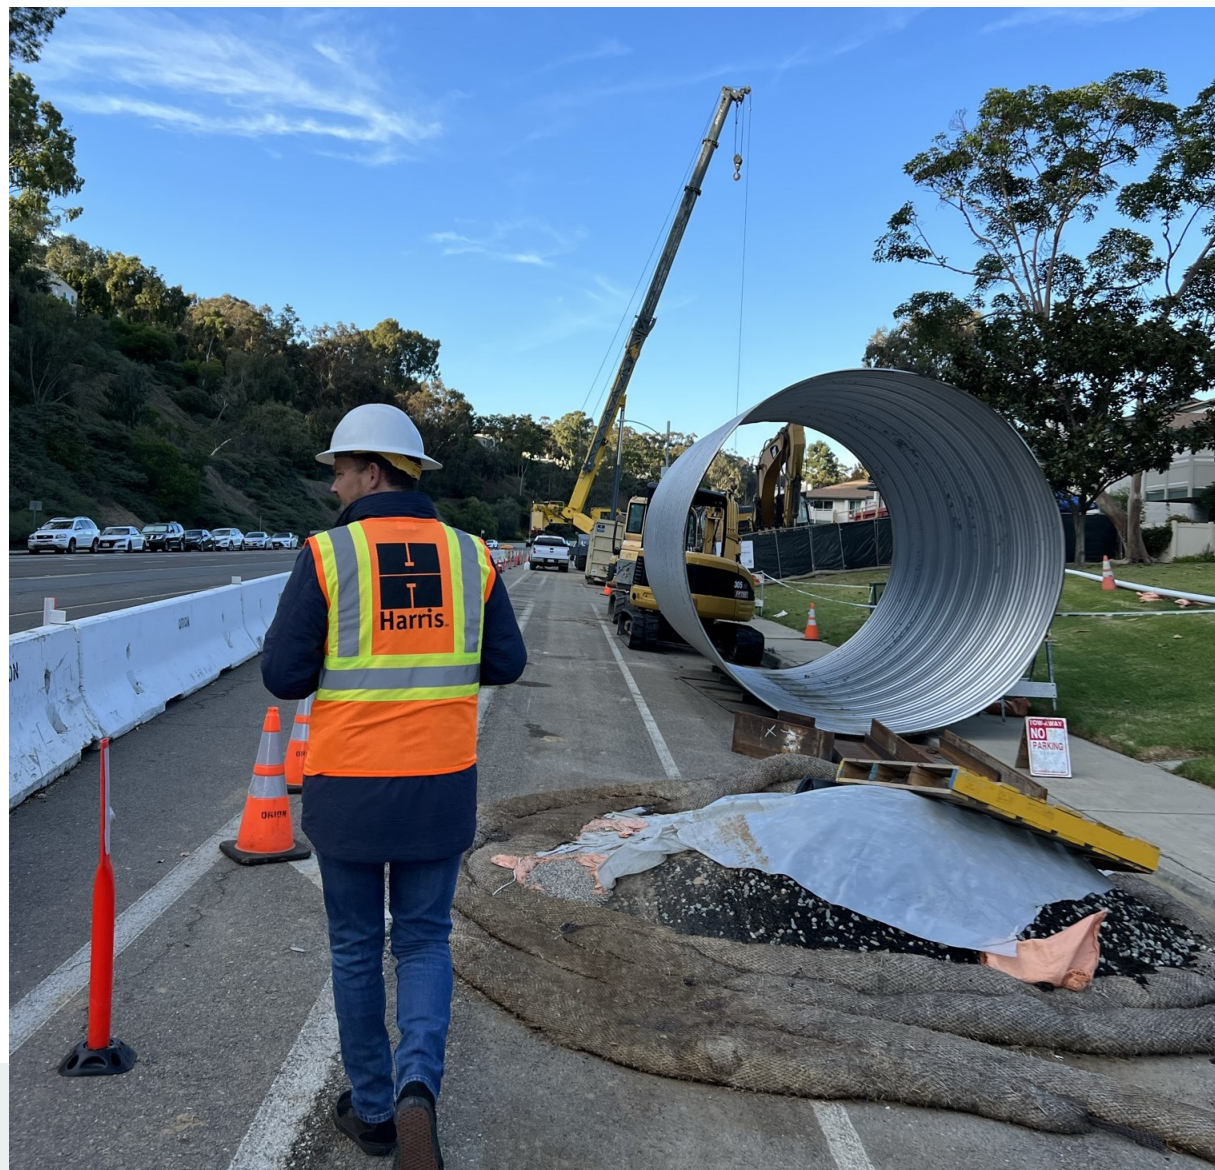
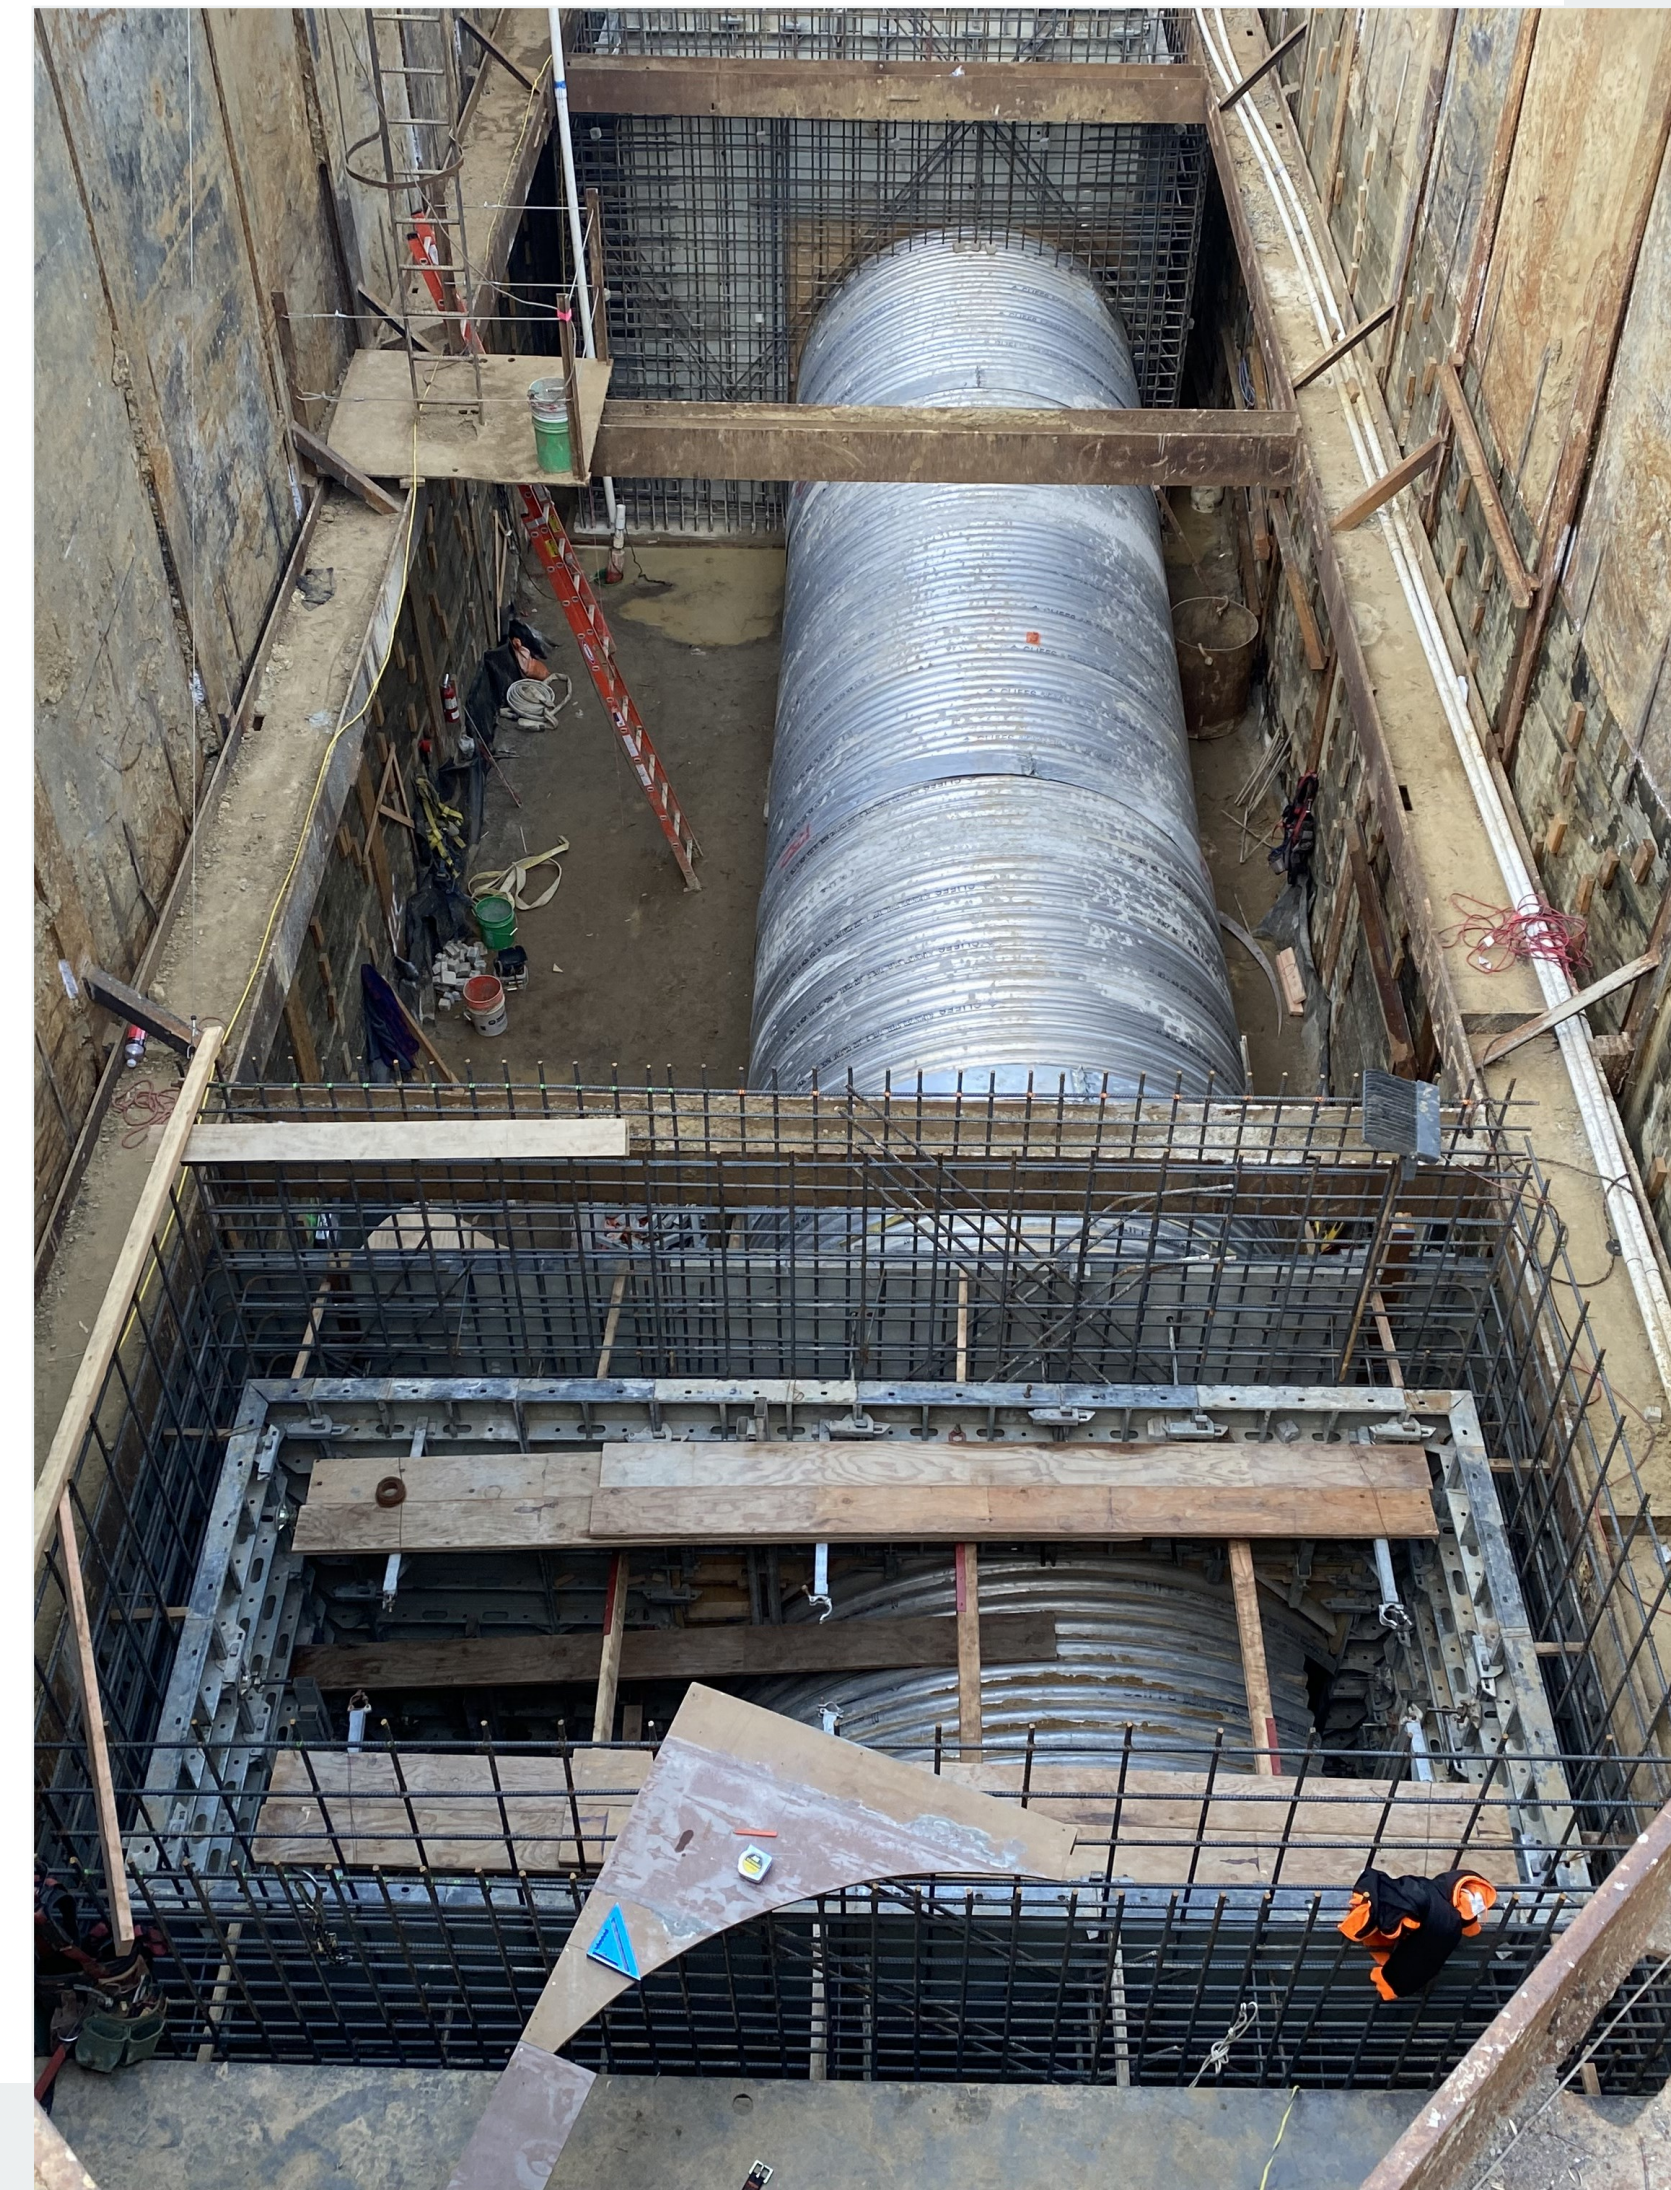
# 3. 132-INCH CMP REPLACEMENT, SOUTHERN CA

## DESIGN APPROACH

- 40-foot-deep excavation and extensive shoring
- Replacement of the 132-inch diameter CMP
- 2 large storm drain clean-outs with multiple access manways, safety ladders, observation platforms, handrailing
- Application of a geopolymer lining to protect the new CMP
