# CMP COMMON & UNCOMMON FAILURE MODES & REHABILITATION METHODS

2025 NORCAL PUG ANNUAL SHARING TECHNOLOGIES SEMINAR

Harris & Associates

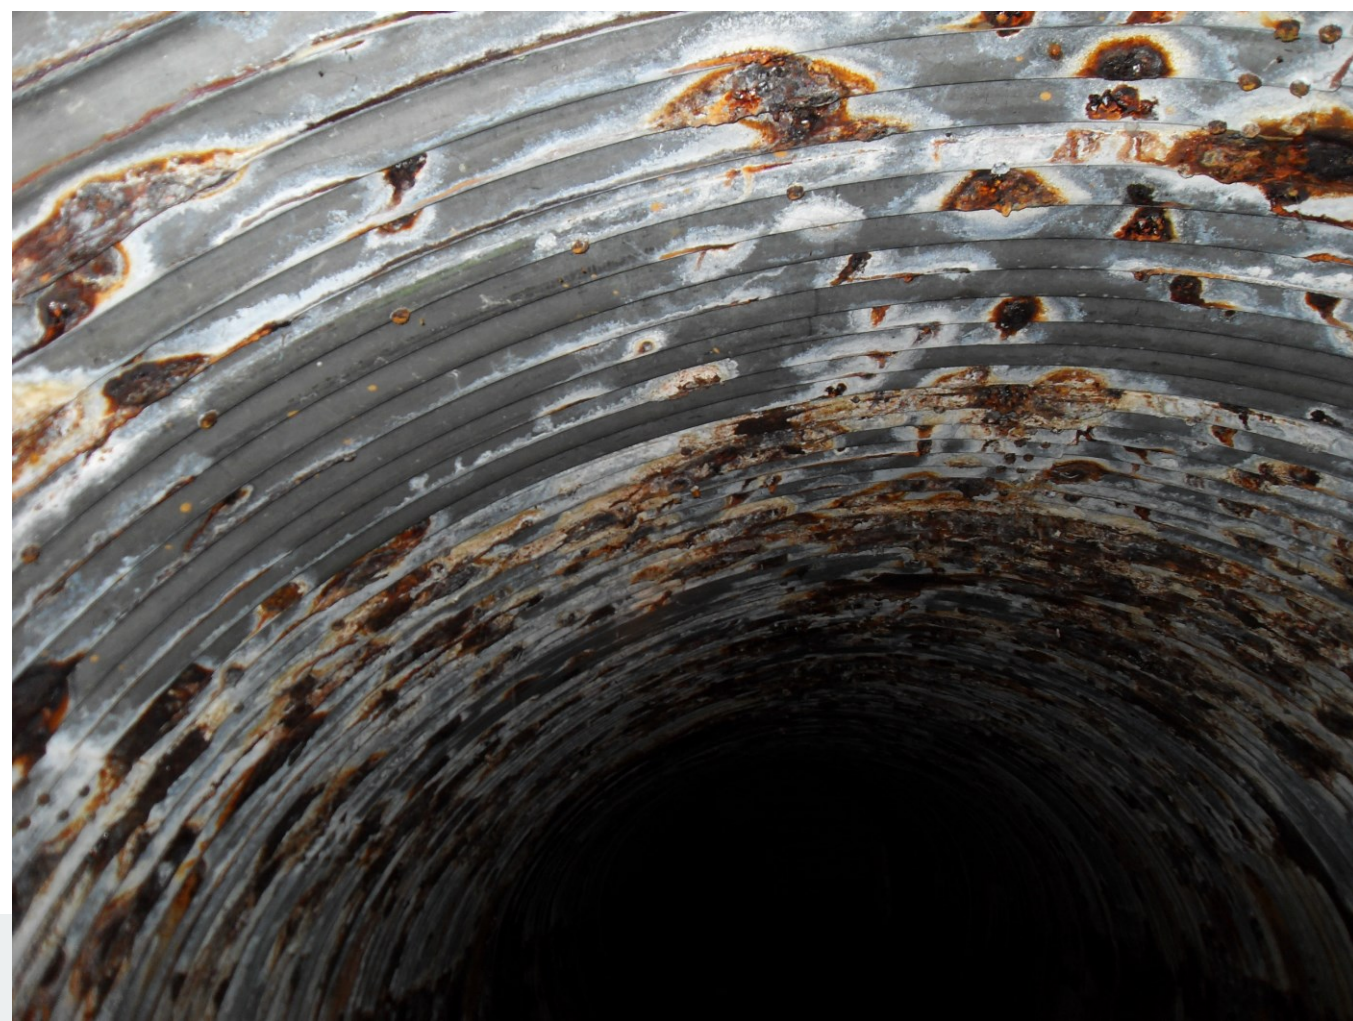
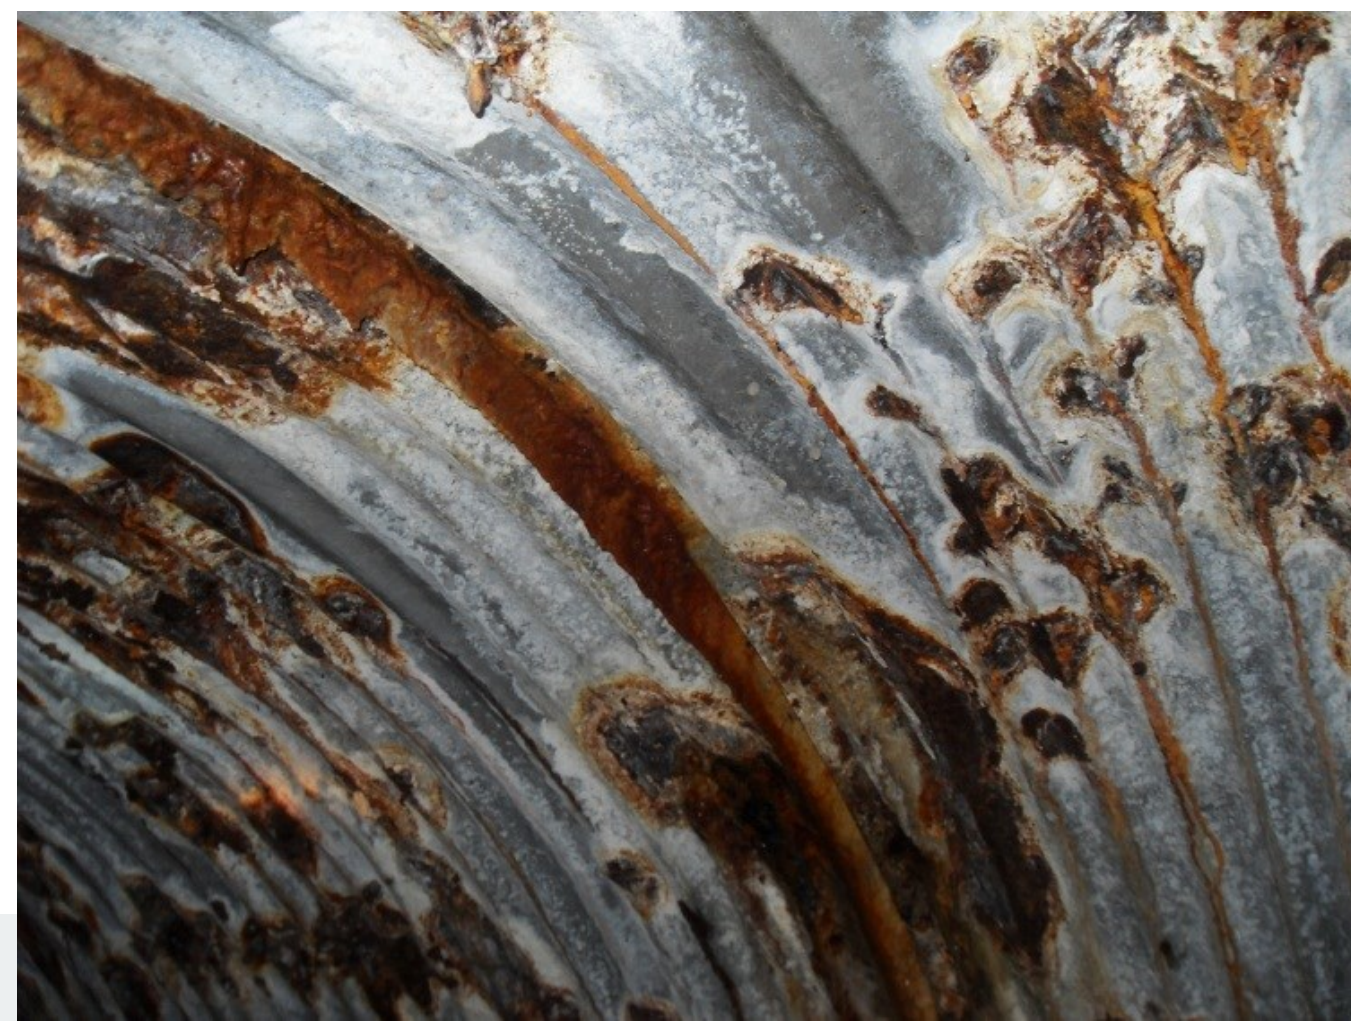
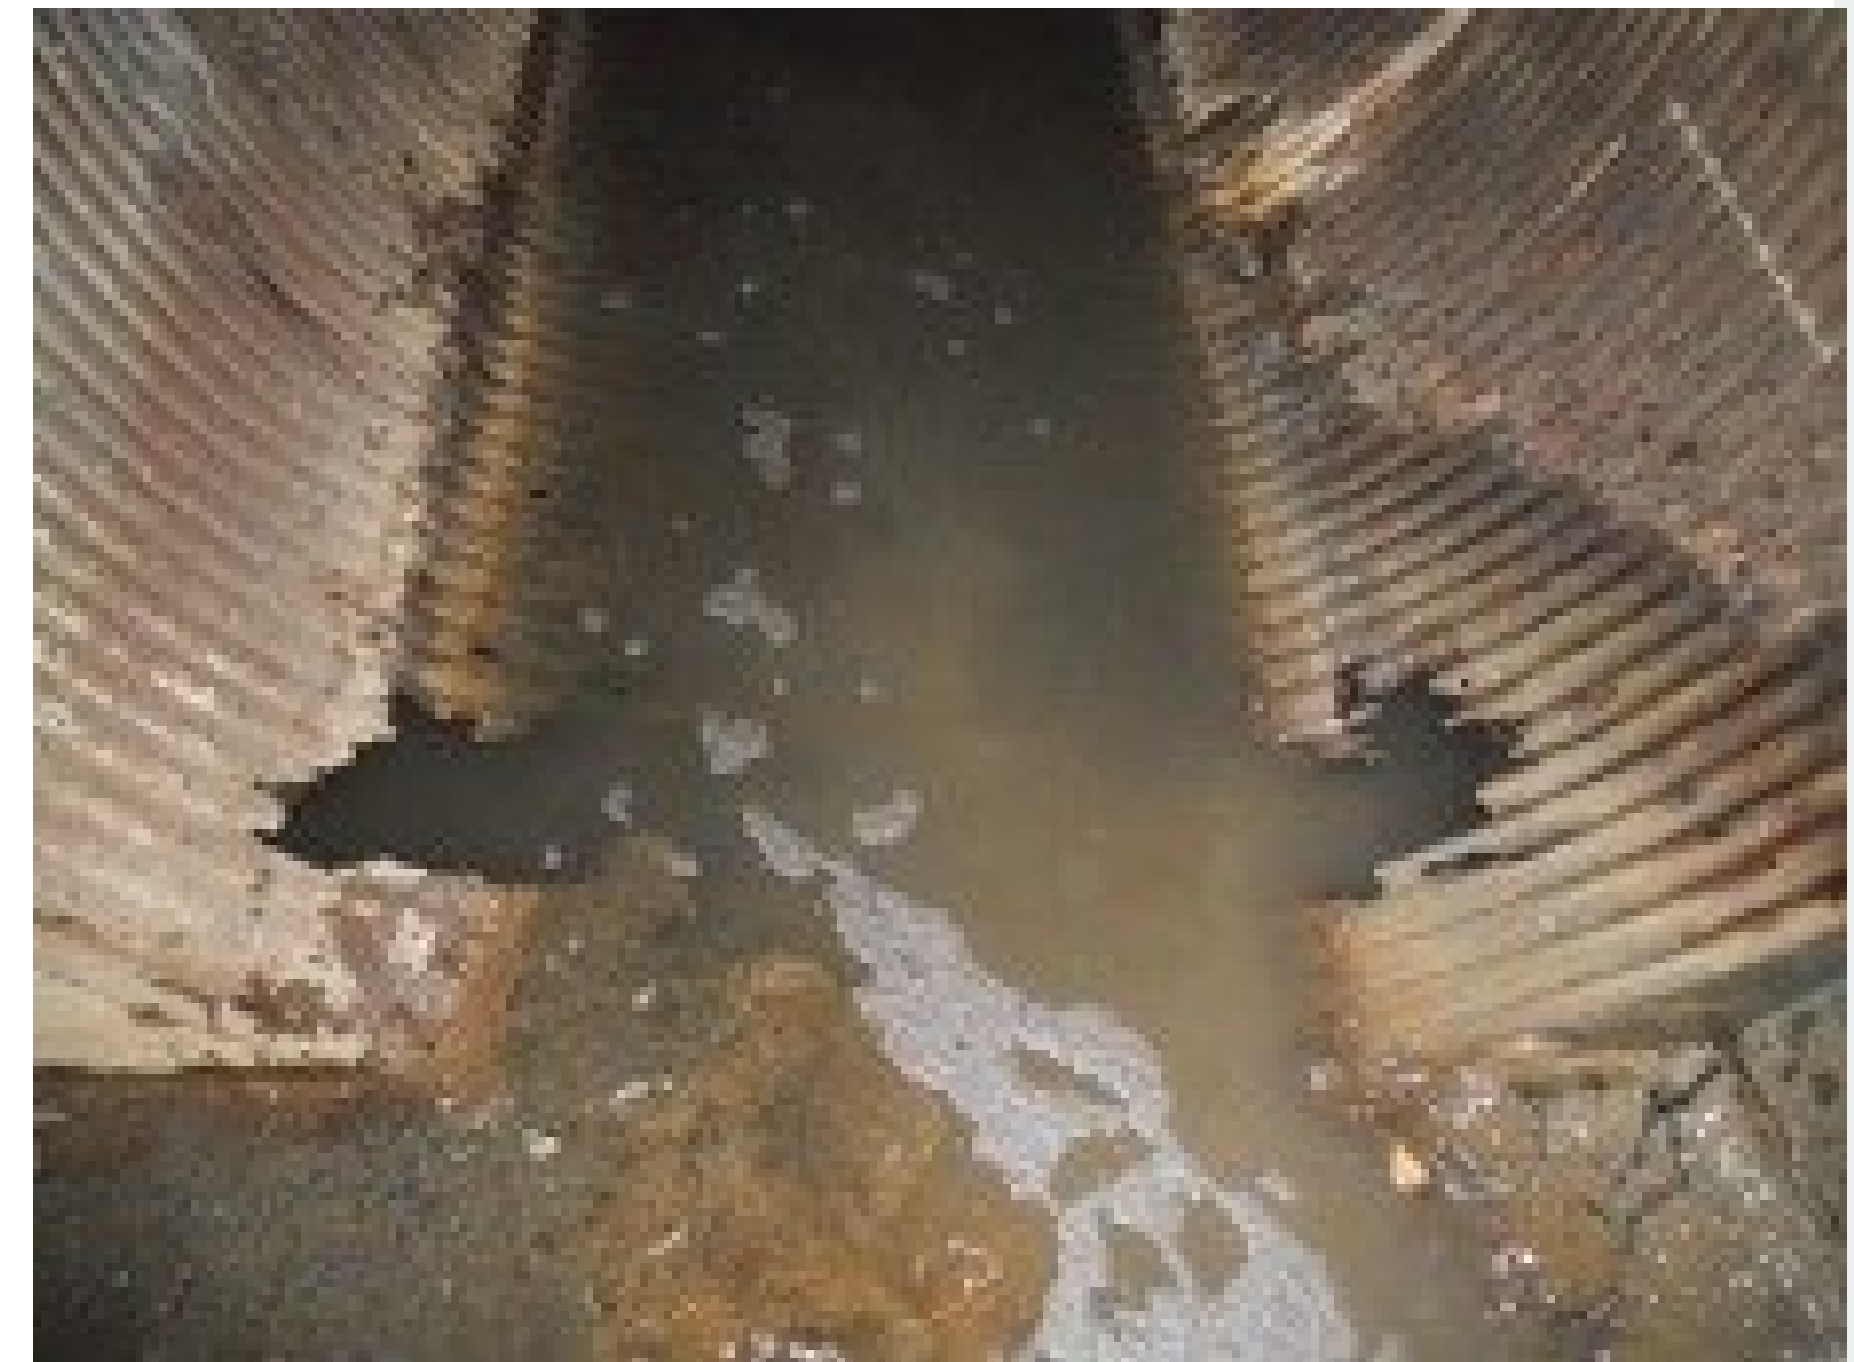
# 4. VALLEY VIEW 88-INCH CMP REHAB, RICHMOND, CA

METHOD: CCCP USING GEOTREE SOLUTIONS FIBER-REINFORCED GEOPOLYMER

- 88-inch CMP pipe was beginning to fail
- Large void under AC discovered by PG&E
- Emergency repair filled void with CDF
- Up to 7% Ovality

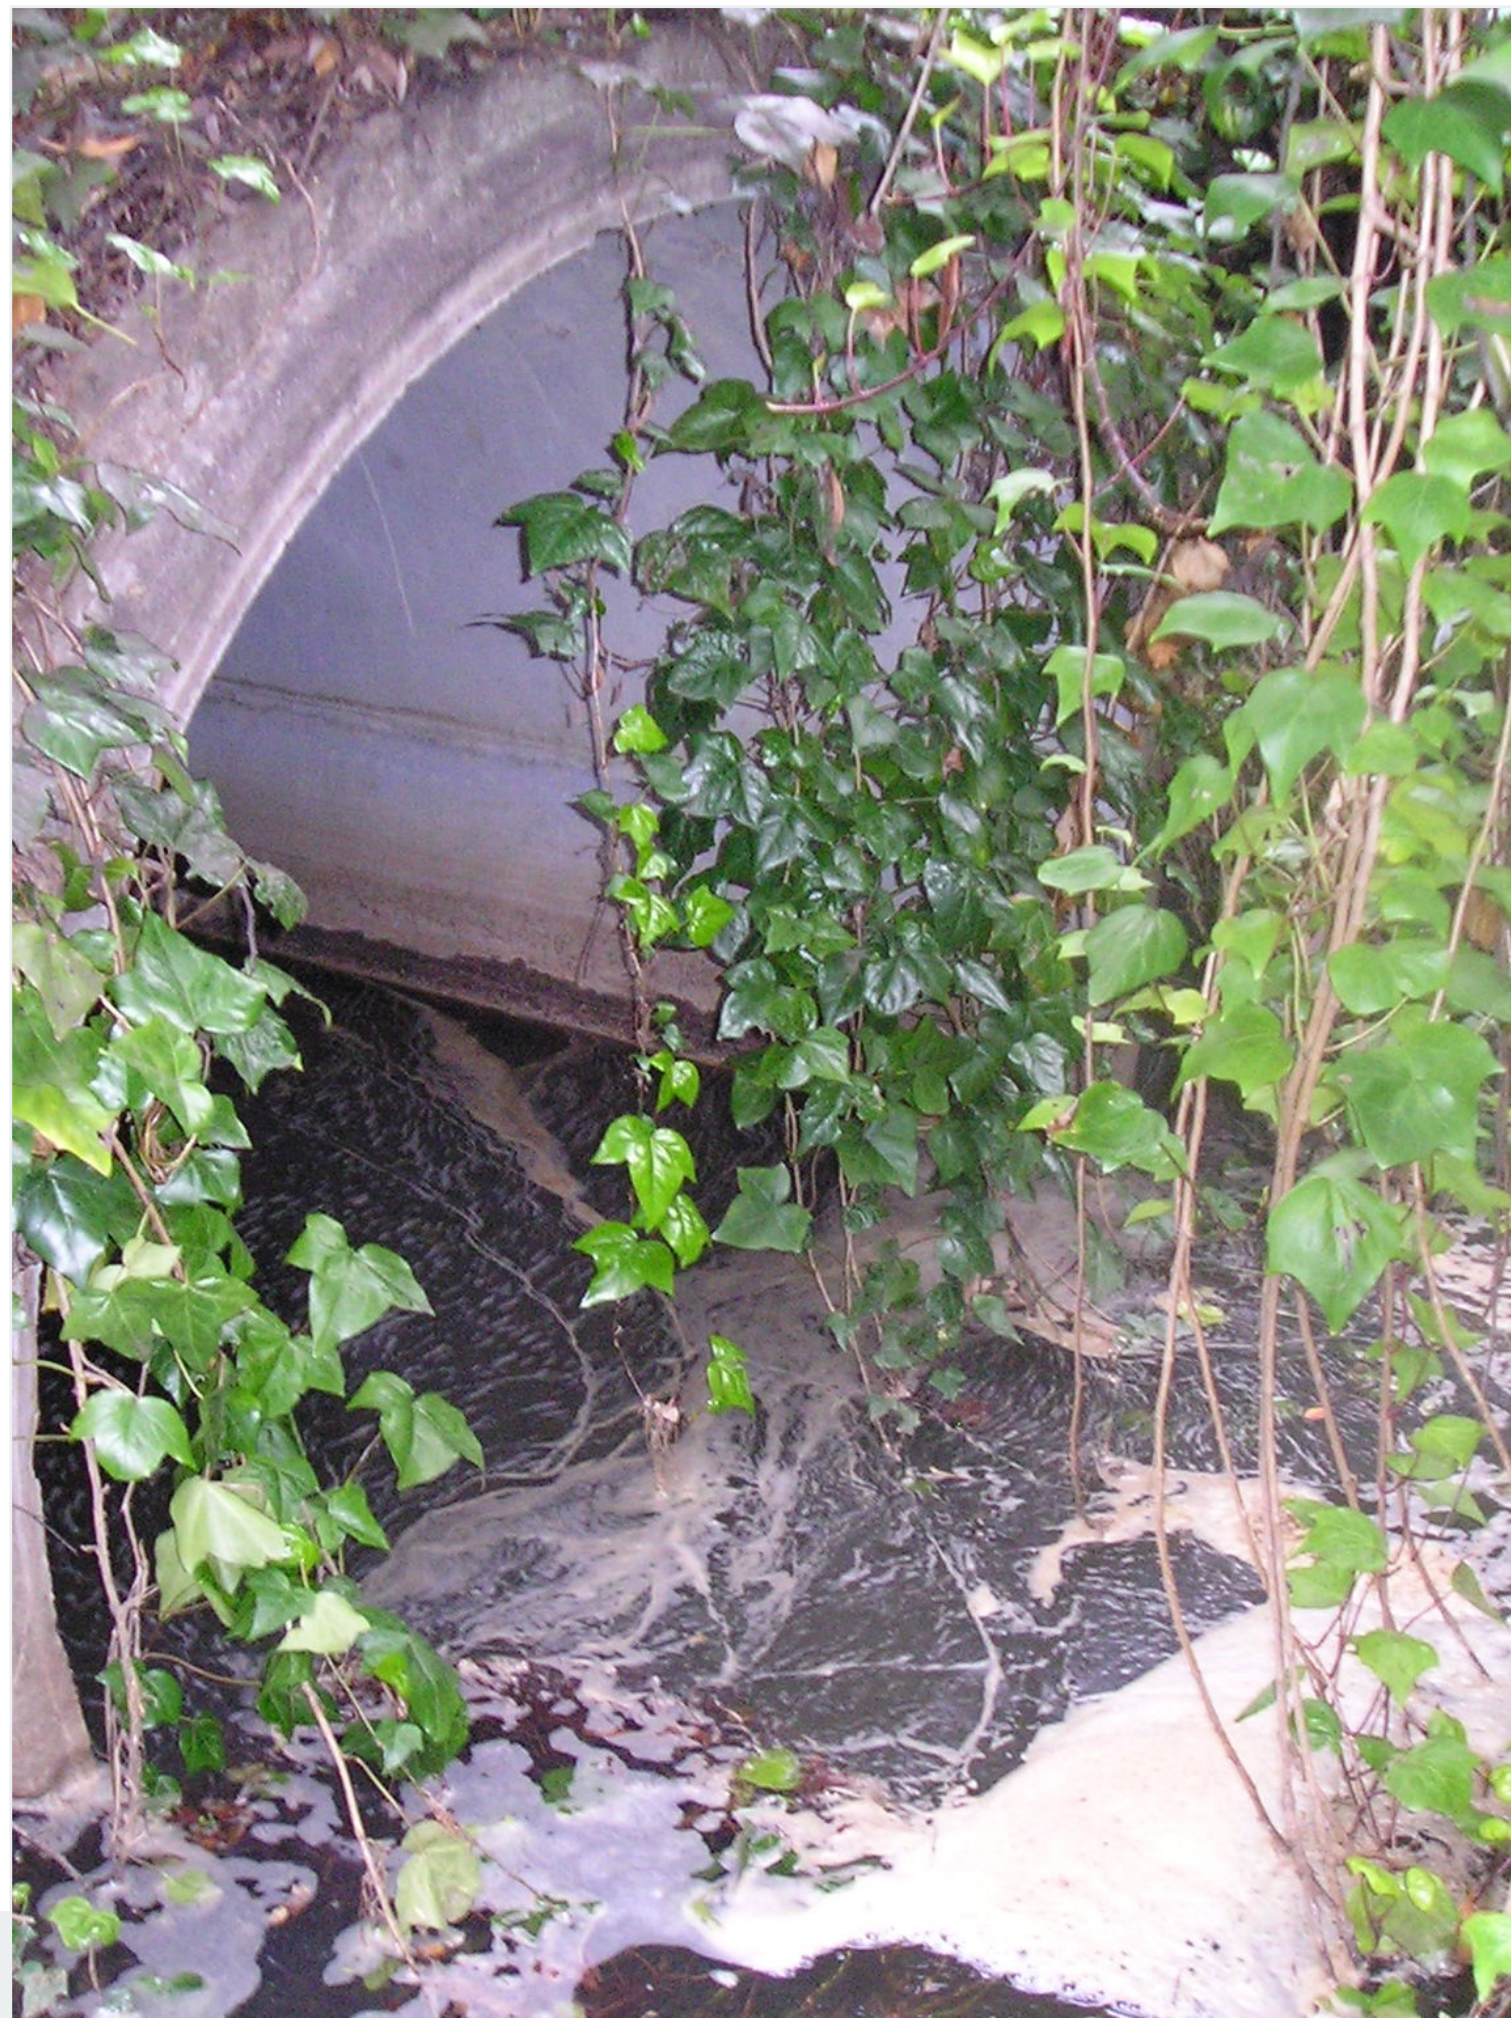
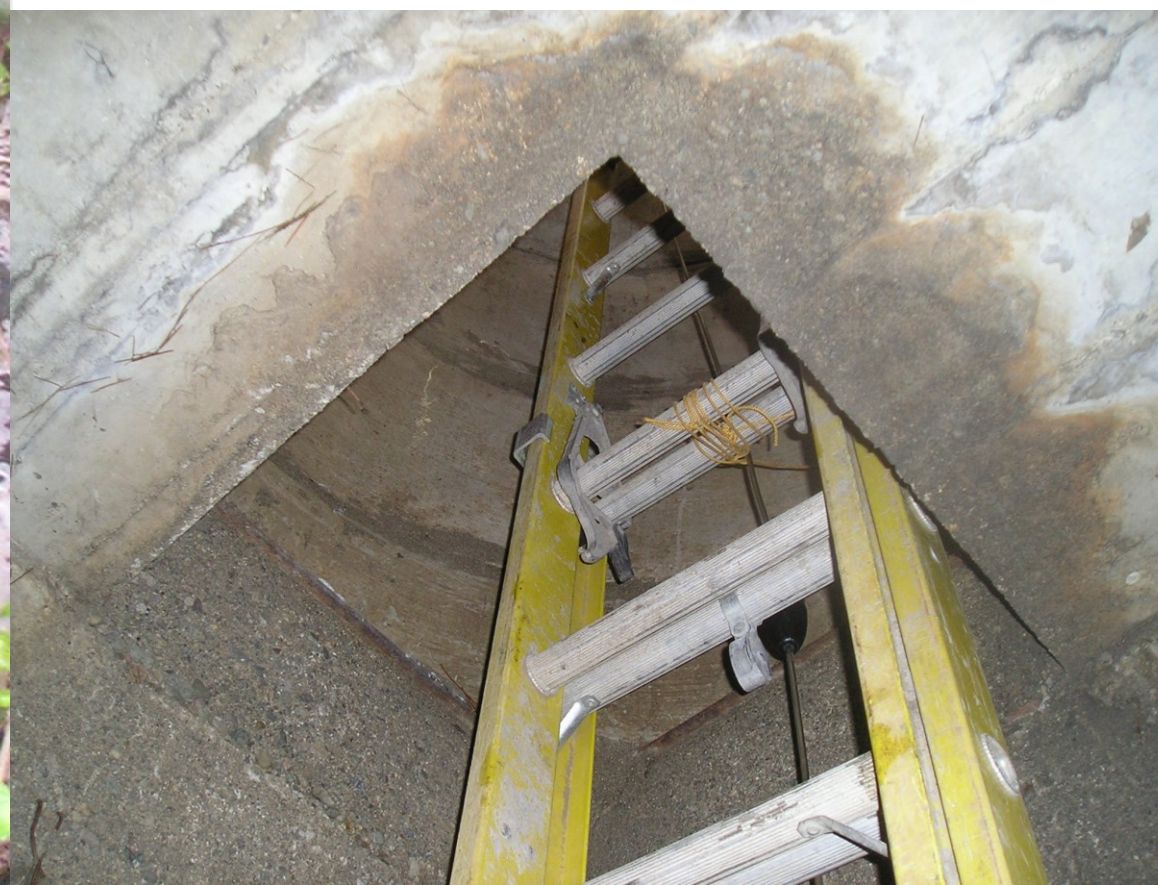
# 4. VALLEY VIEW 88-INCH CMP REHAB, RICHMOND, CA

METHOD: CCCP USING GEOTREE SOLUTIONS FIBER-REINFORCED GEOPOLYMER

- Site constraints
  - Continuous flow
  - Length only 50 feet.
  - 18-foot depth to invert or 11 feet of cover
  - Limited access
  - Partially submerged outfall at creek

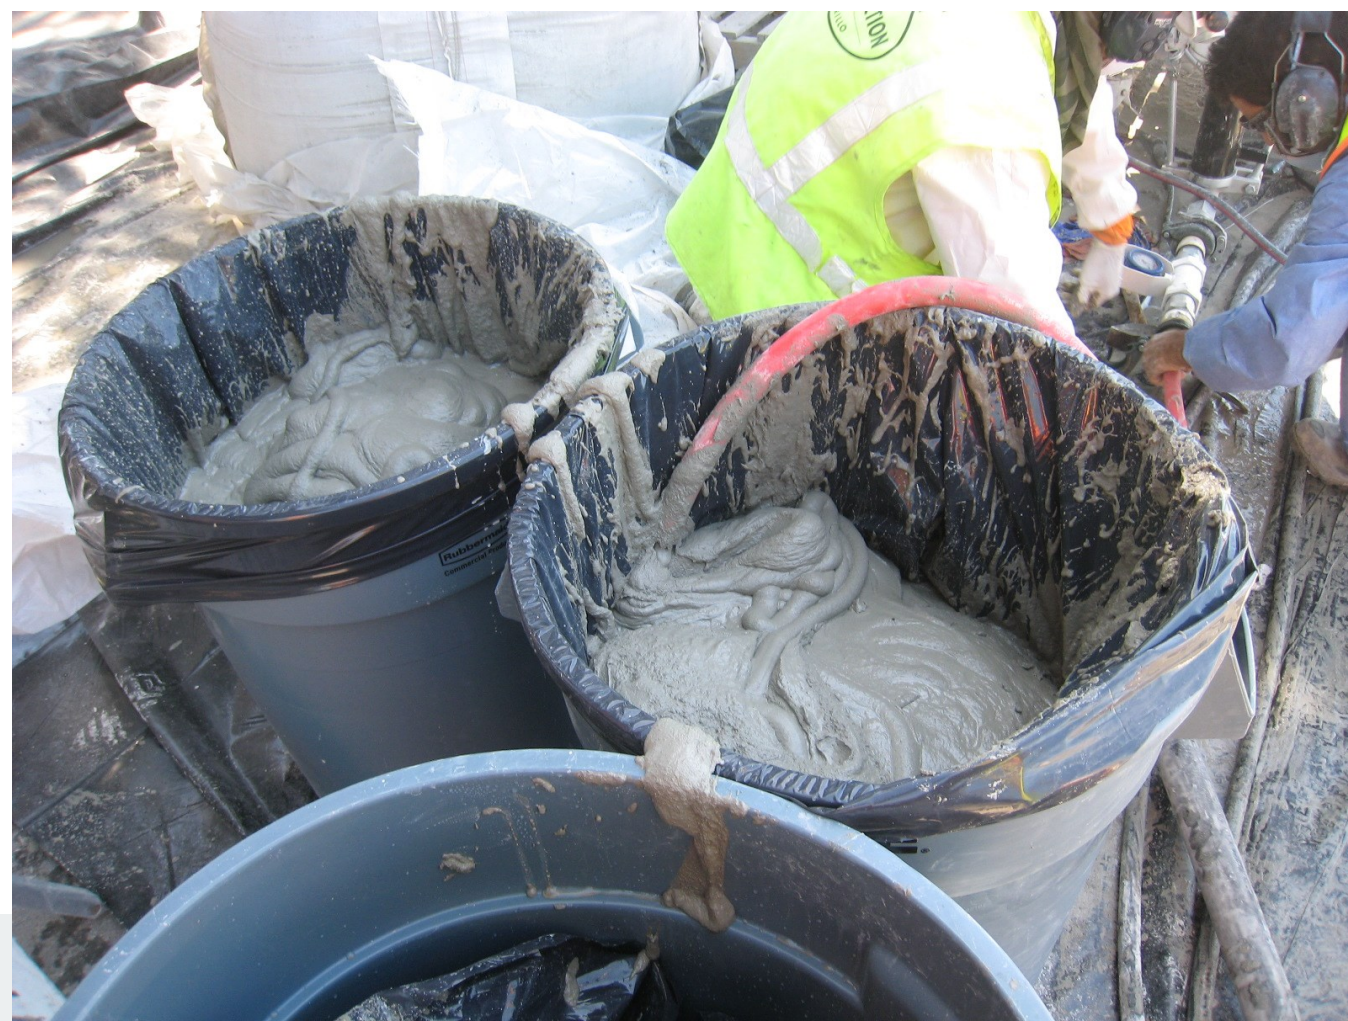
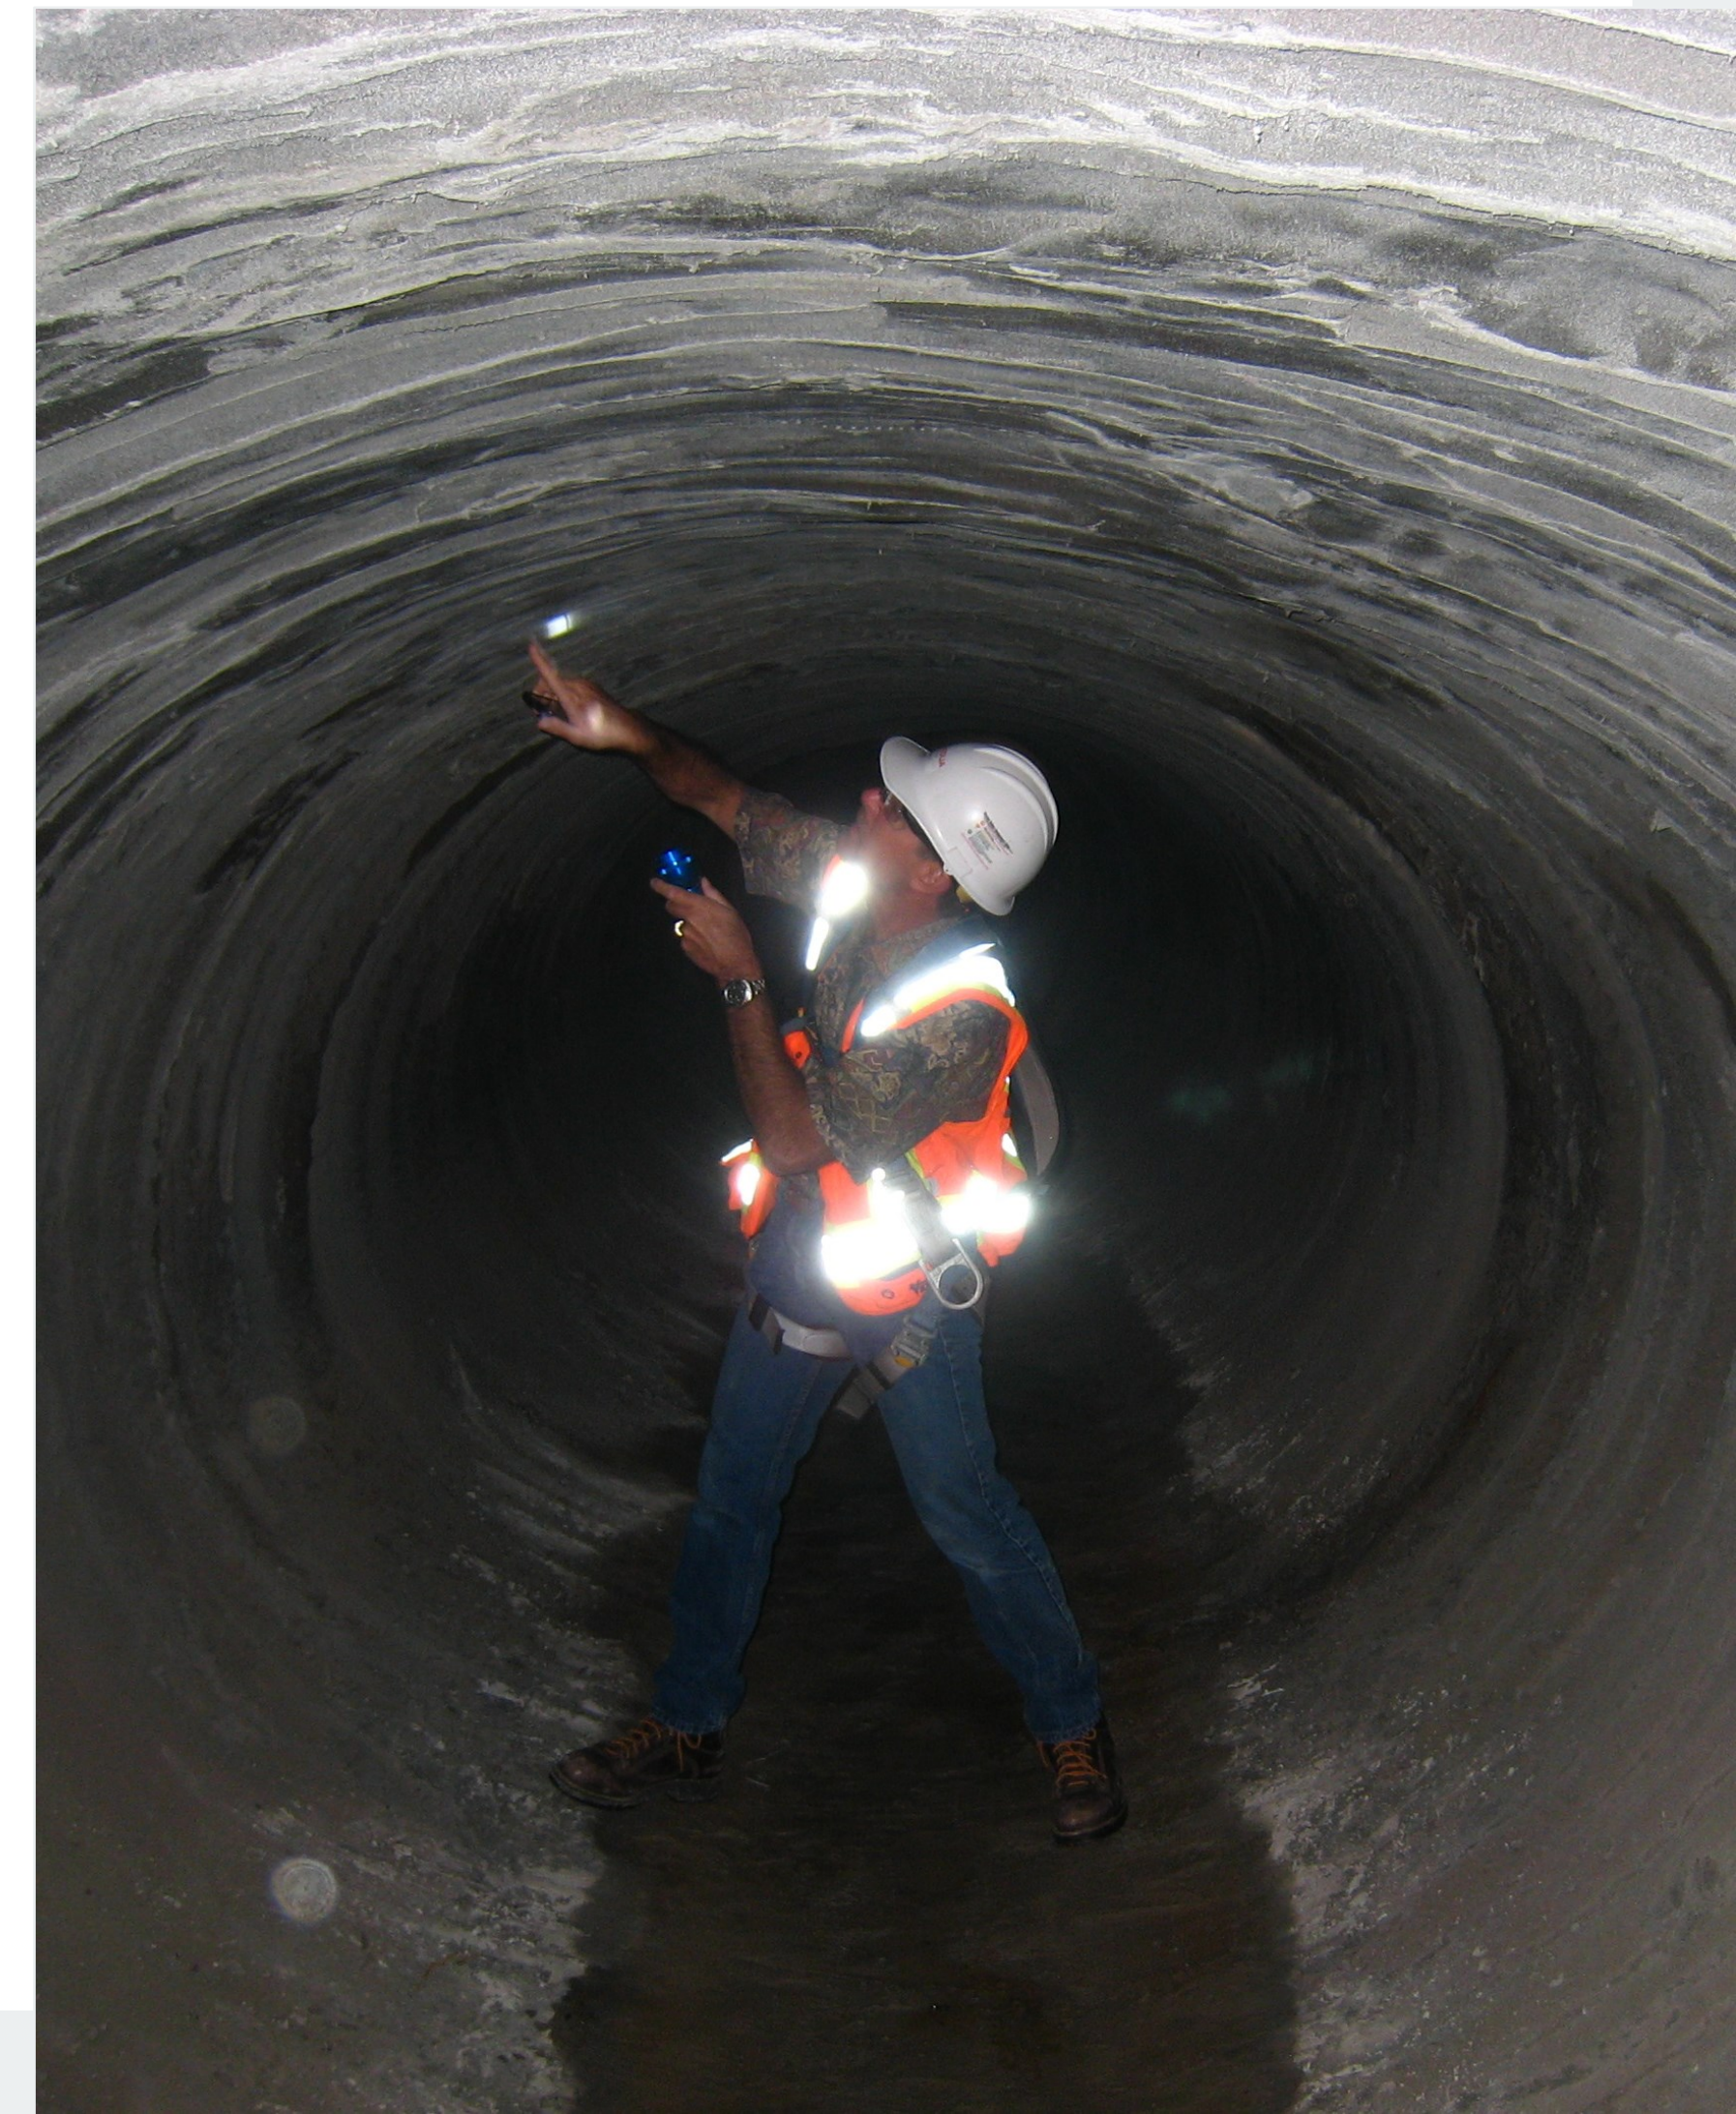
METHOD: CCCP USING GEOTREE SOLUTIONS FIBER-REINFORCED  
GEOPOLYMER

- Rehabilitation Method: Spray-On Fiber Reinforced Geopolymer
- Required 28-day Compressive Strength = 8,000 PSI

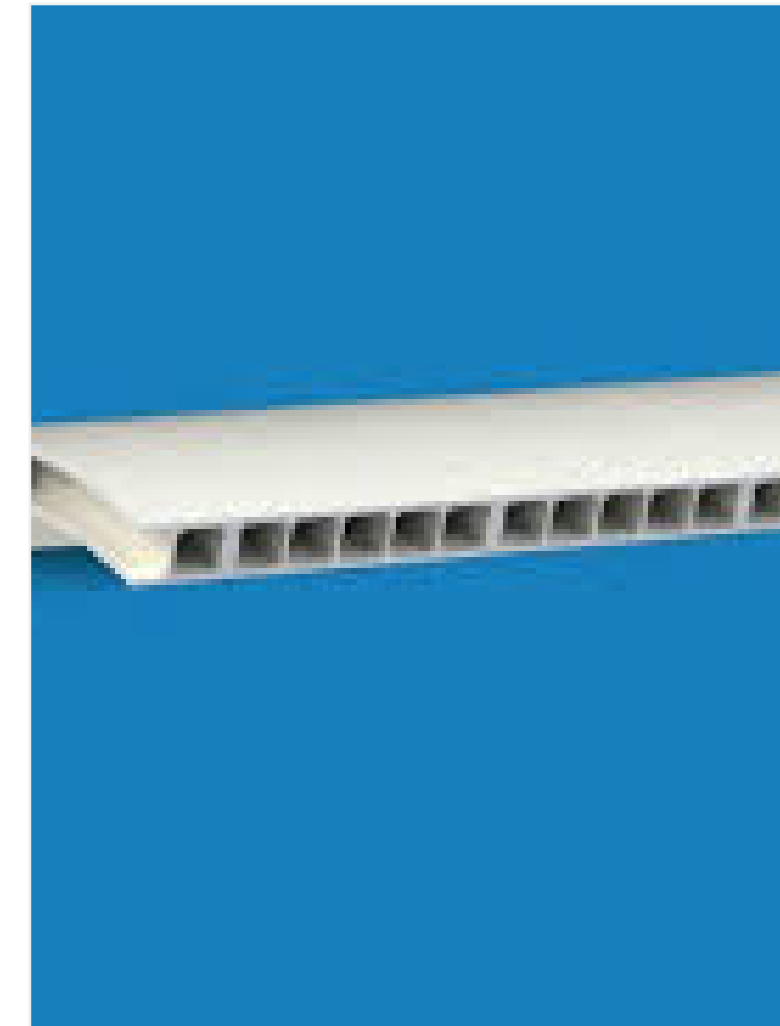
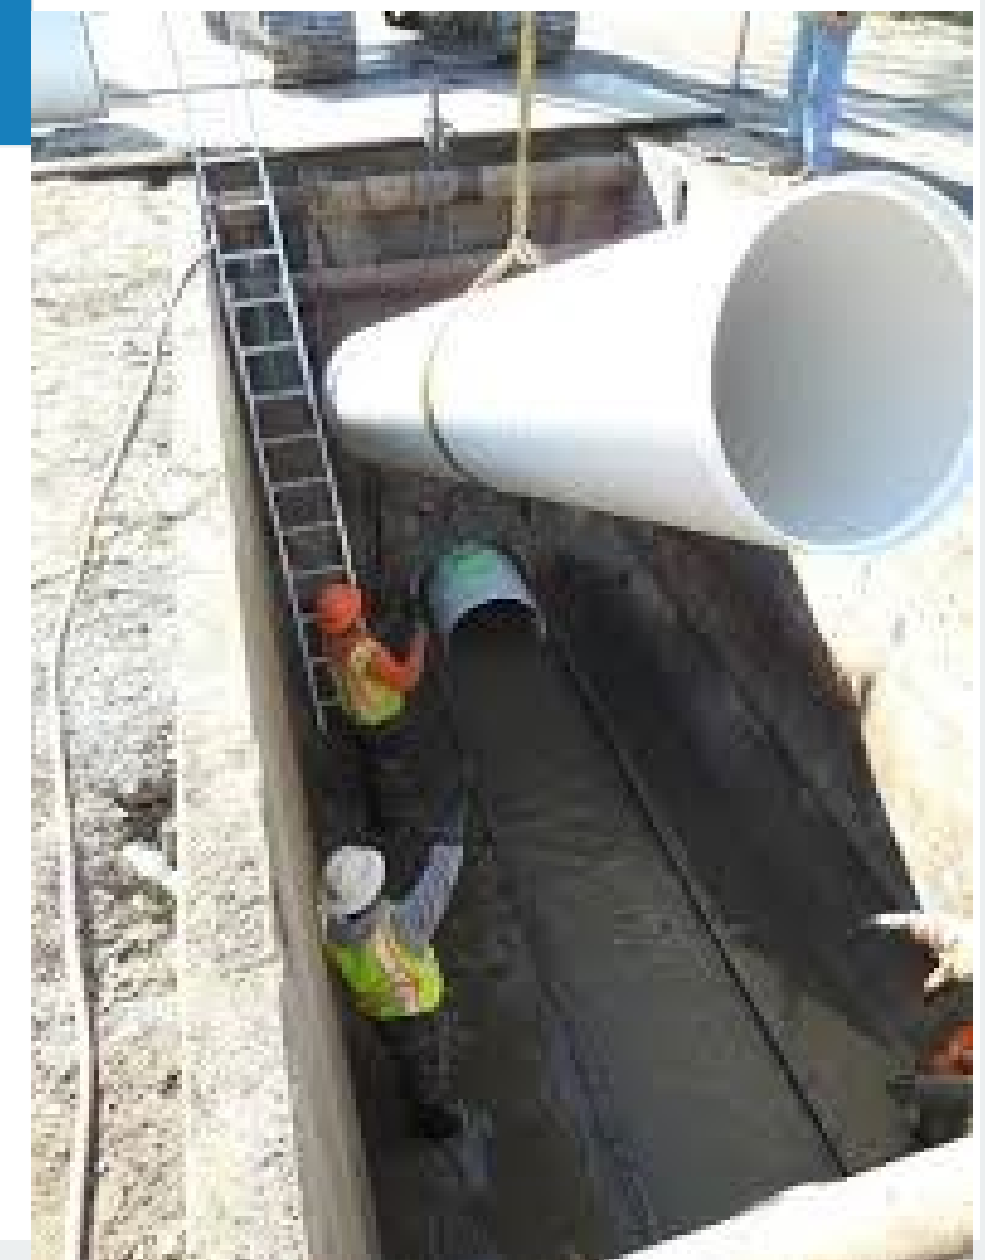
## METHOD: SLIPLINING

- Problem
  - 1000 feet of 48-inch CMP
  - Invert had completely corroded
  - Some ovality was discovered
- Solution
  - Sliplining using 42-inch I.D. Vylon Pipe (44.48-inch avg O.D.)
  - 16-foot segments of pipe were slipped in using existing drainage flows and supplemental water flows to assist in placement.
  - Annular space was grouted with a cellular concrete.

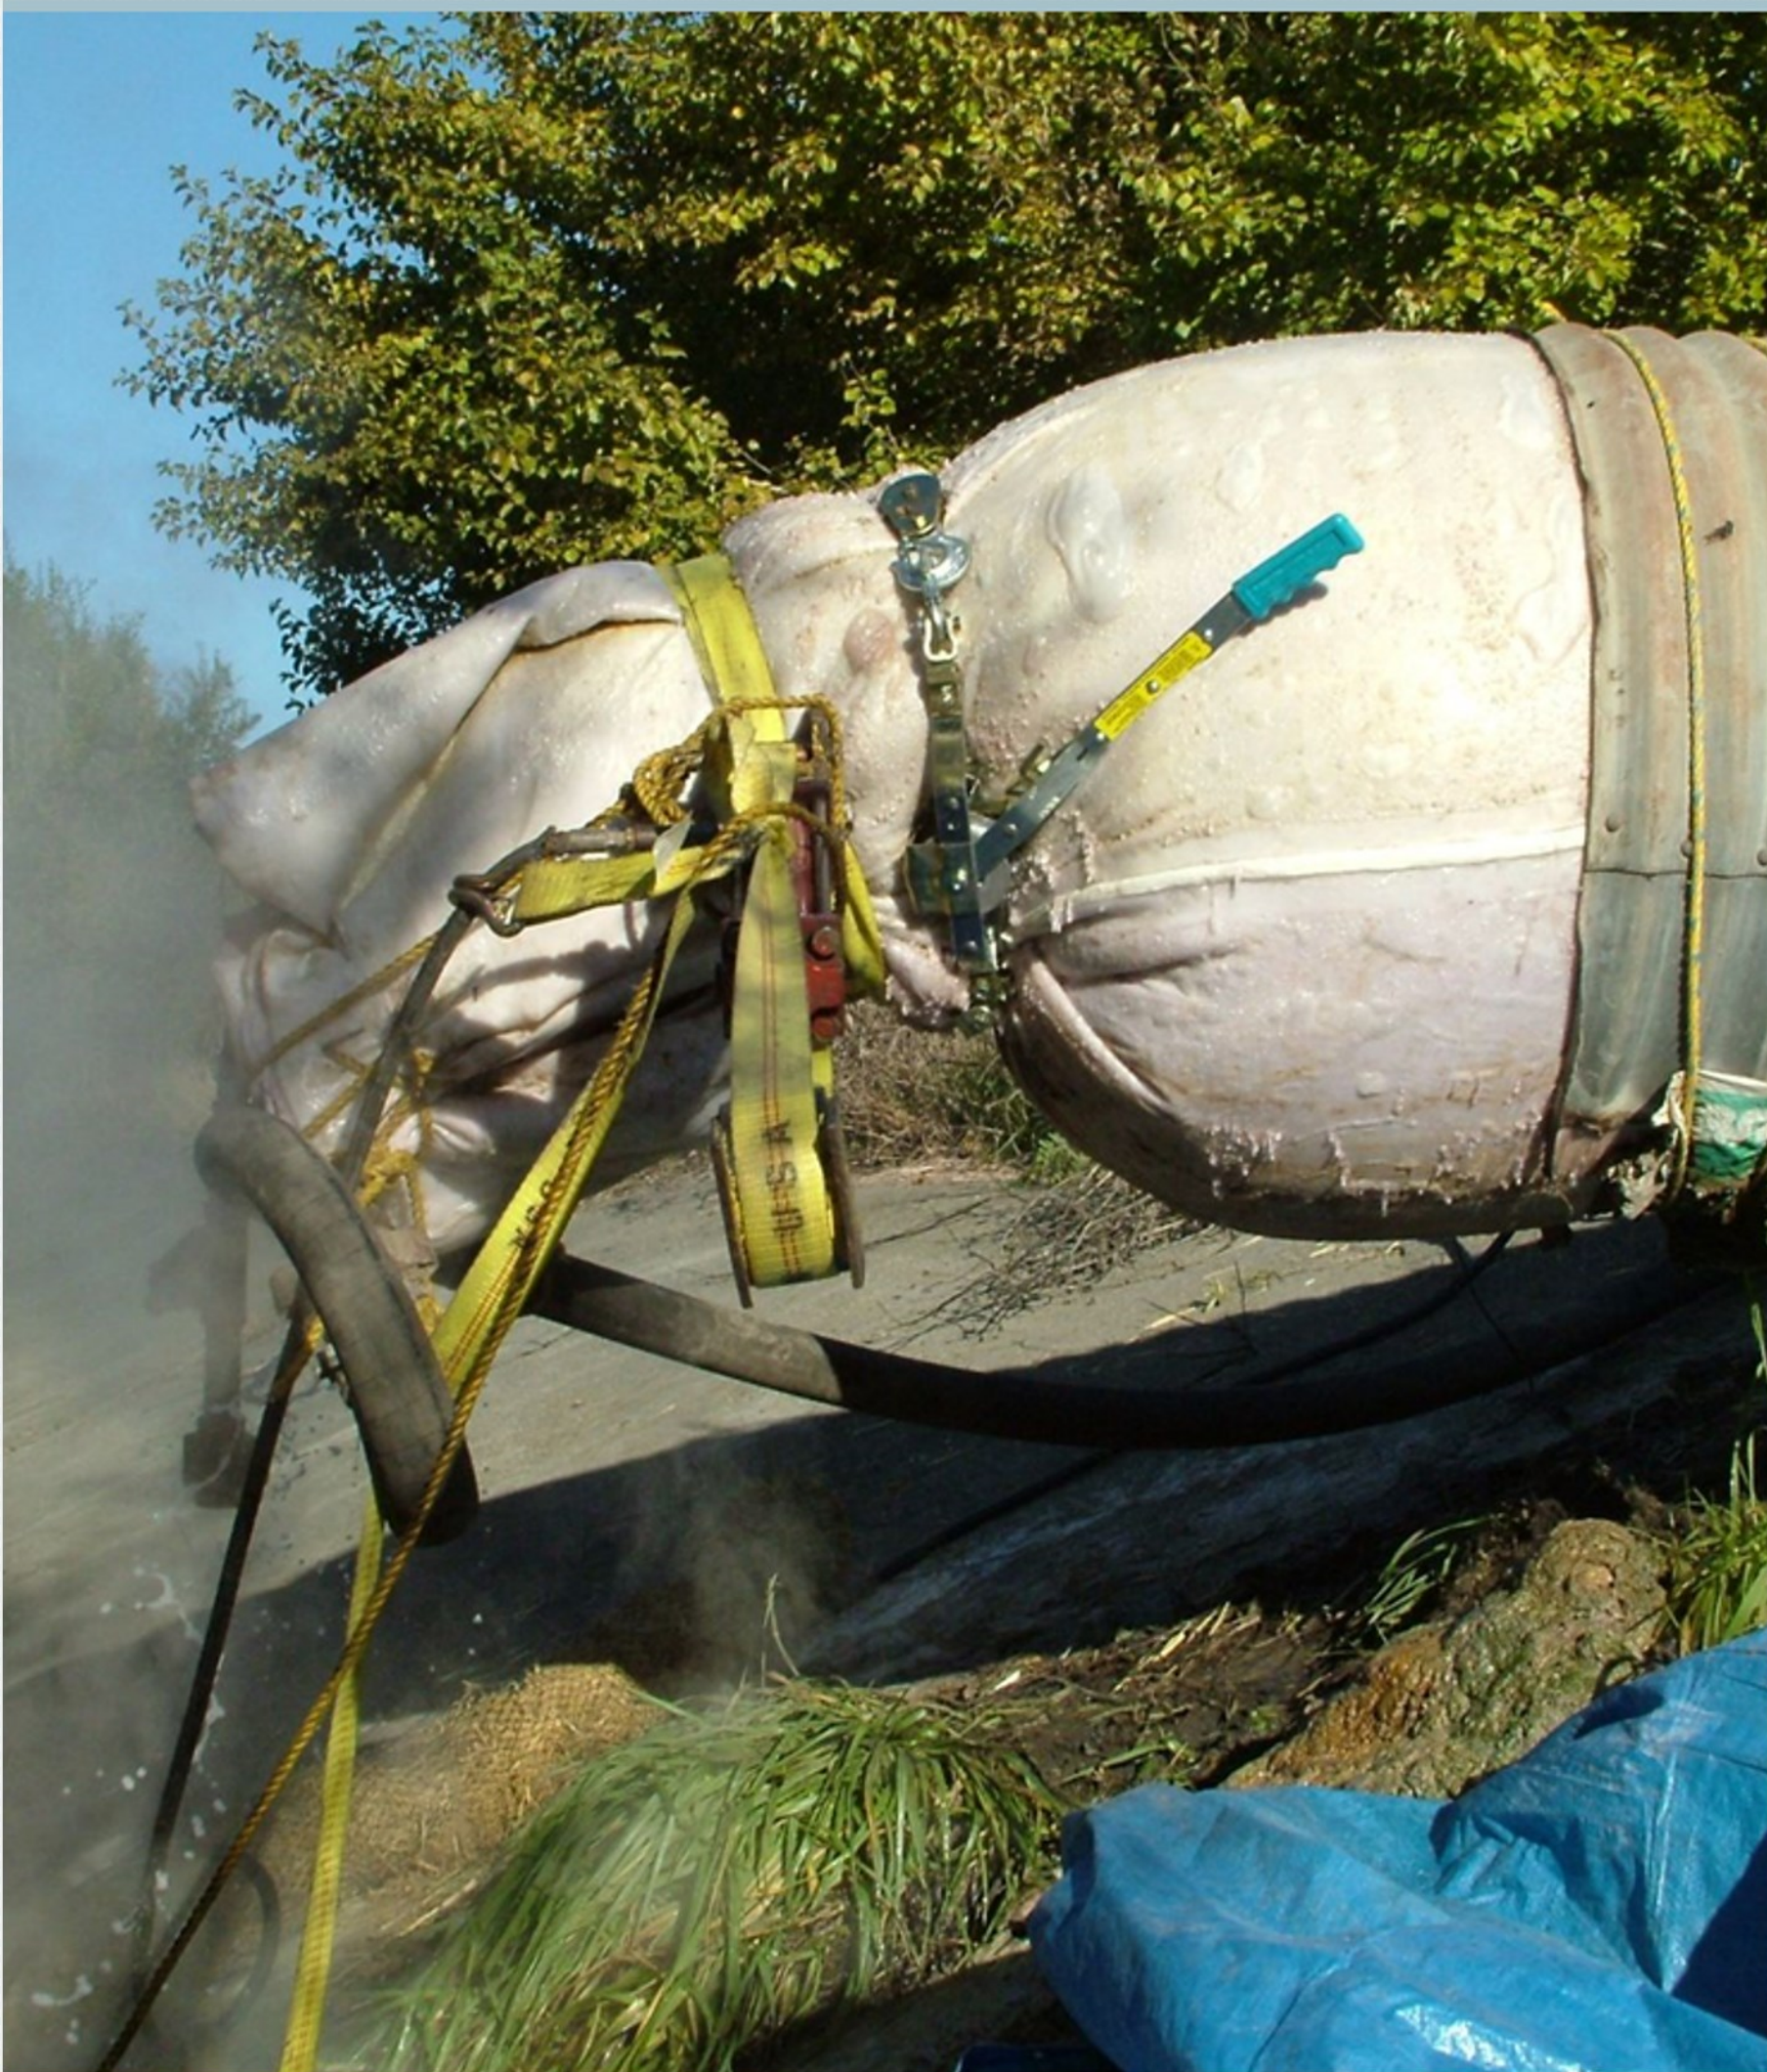
## METHOD: WINCHED-IN CIPP LINING

- 36-inch CMP was completely corroded
- Located in environmentally sensitive habitat
- Access was difficult and deep
- CIPP was the selected rehabilitation method
  - Steam cured
  - Winched-in installation

- Minimal reduction in diameter and capacity
- Invert or winch the liner in place
- Cured via hot water, steam, or UV
- Upfront costs for fabrication, equipment, mobilization, etc. – sometimes not cost complete on smaller runs of pipe
- Segmented liners can be used for quick point repairs
