# CMP COMMON & UNCOMMON FAILURE MODES & REHABILITATION METHODS

2025 NORCAL PUG ANNUAL SHARING TECHNOLOGIES SEMINAR

Harris & Associates

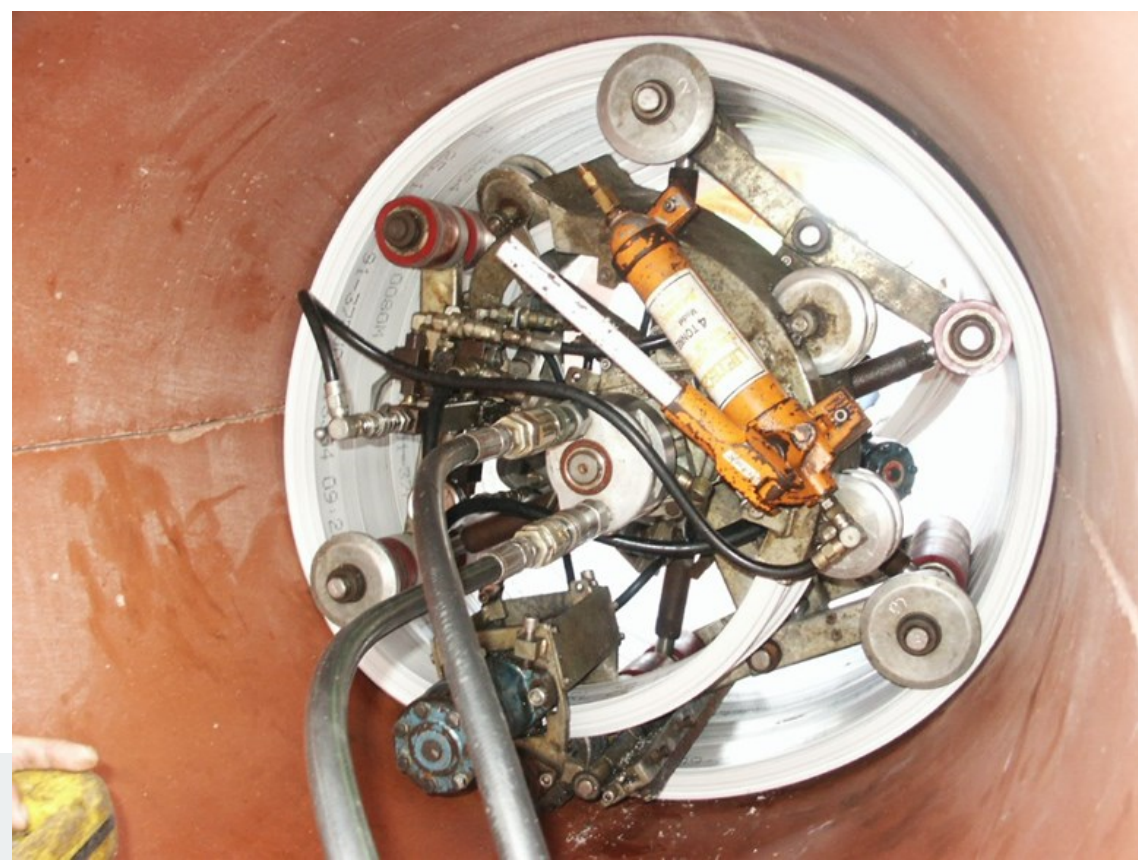
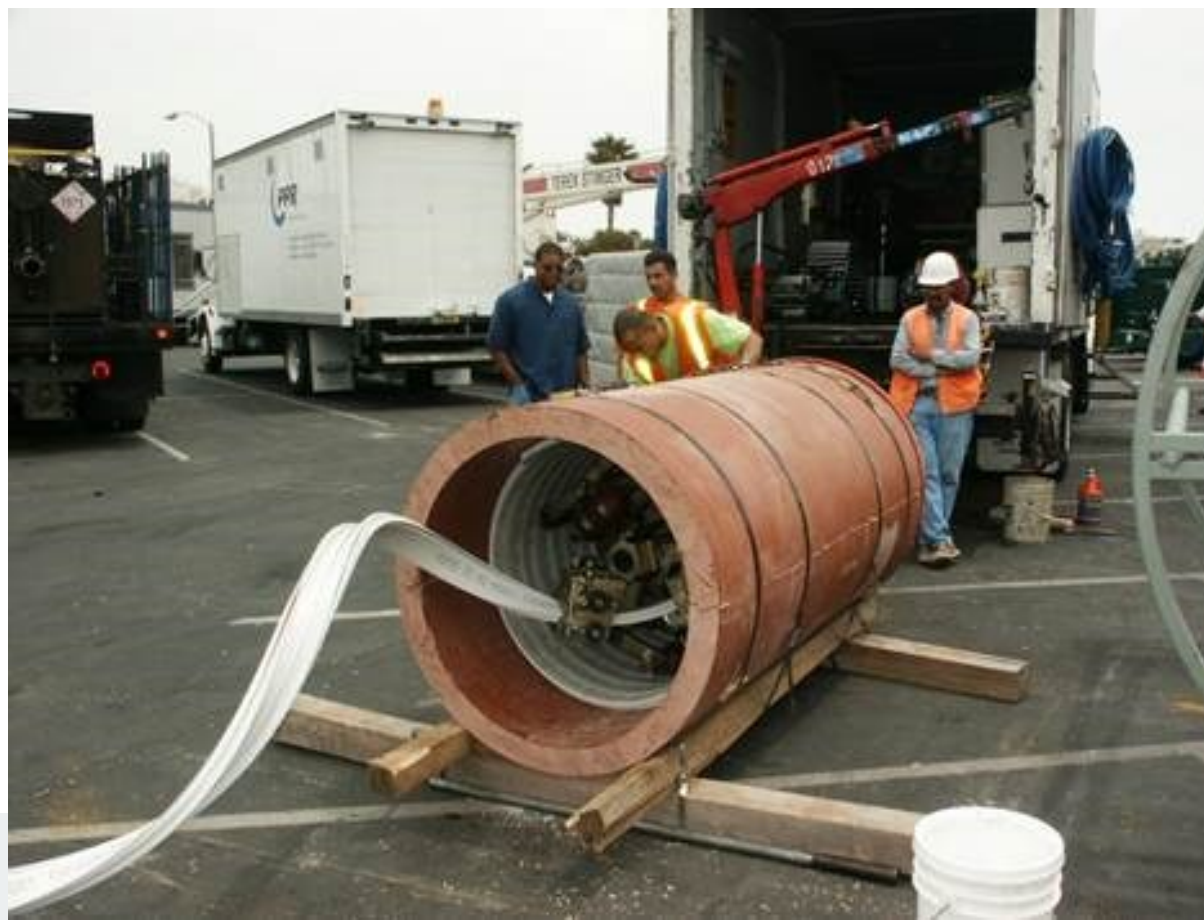
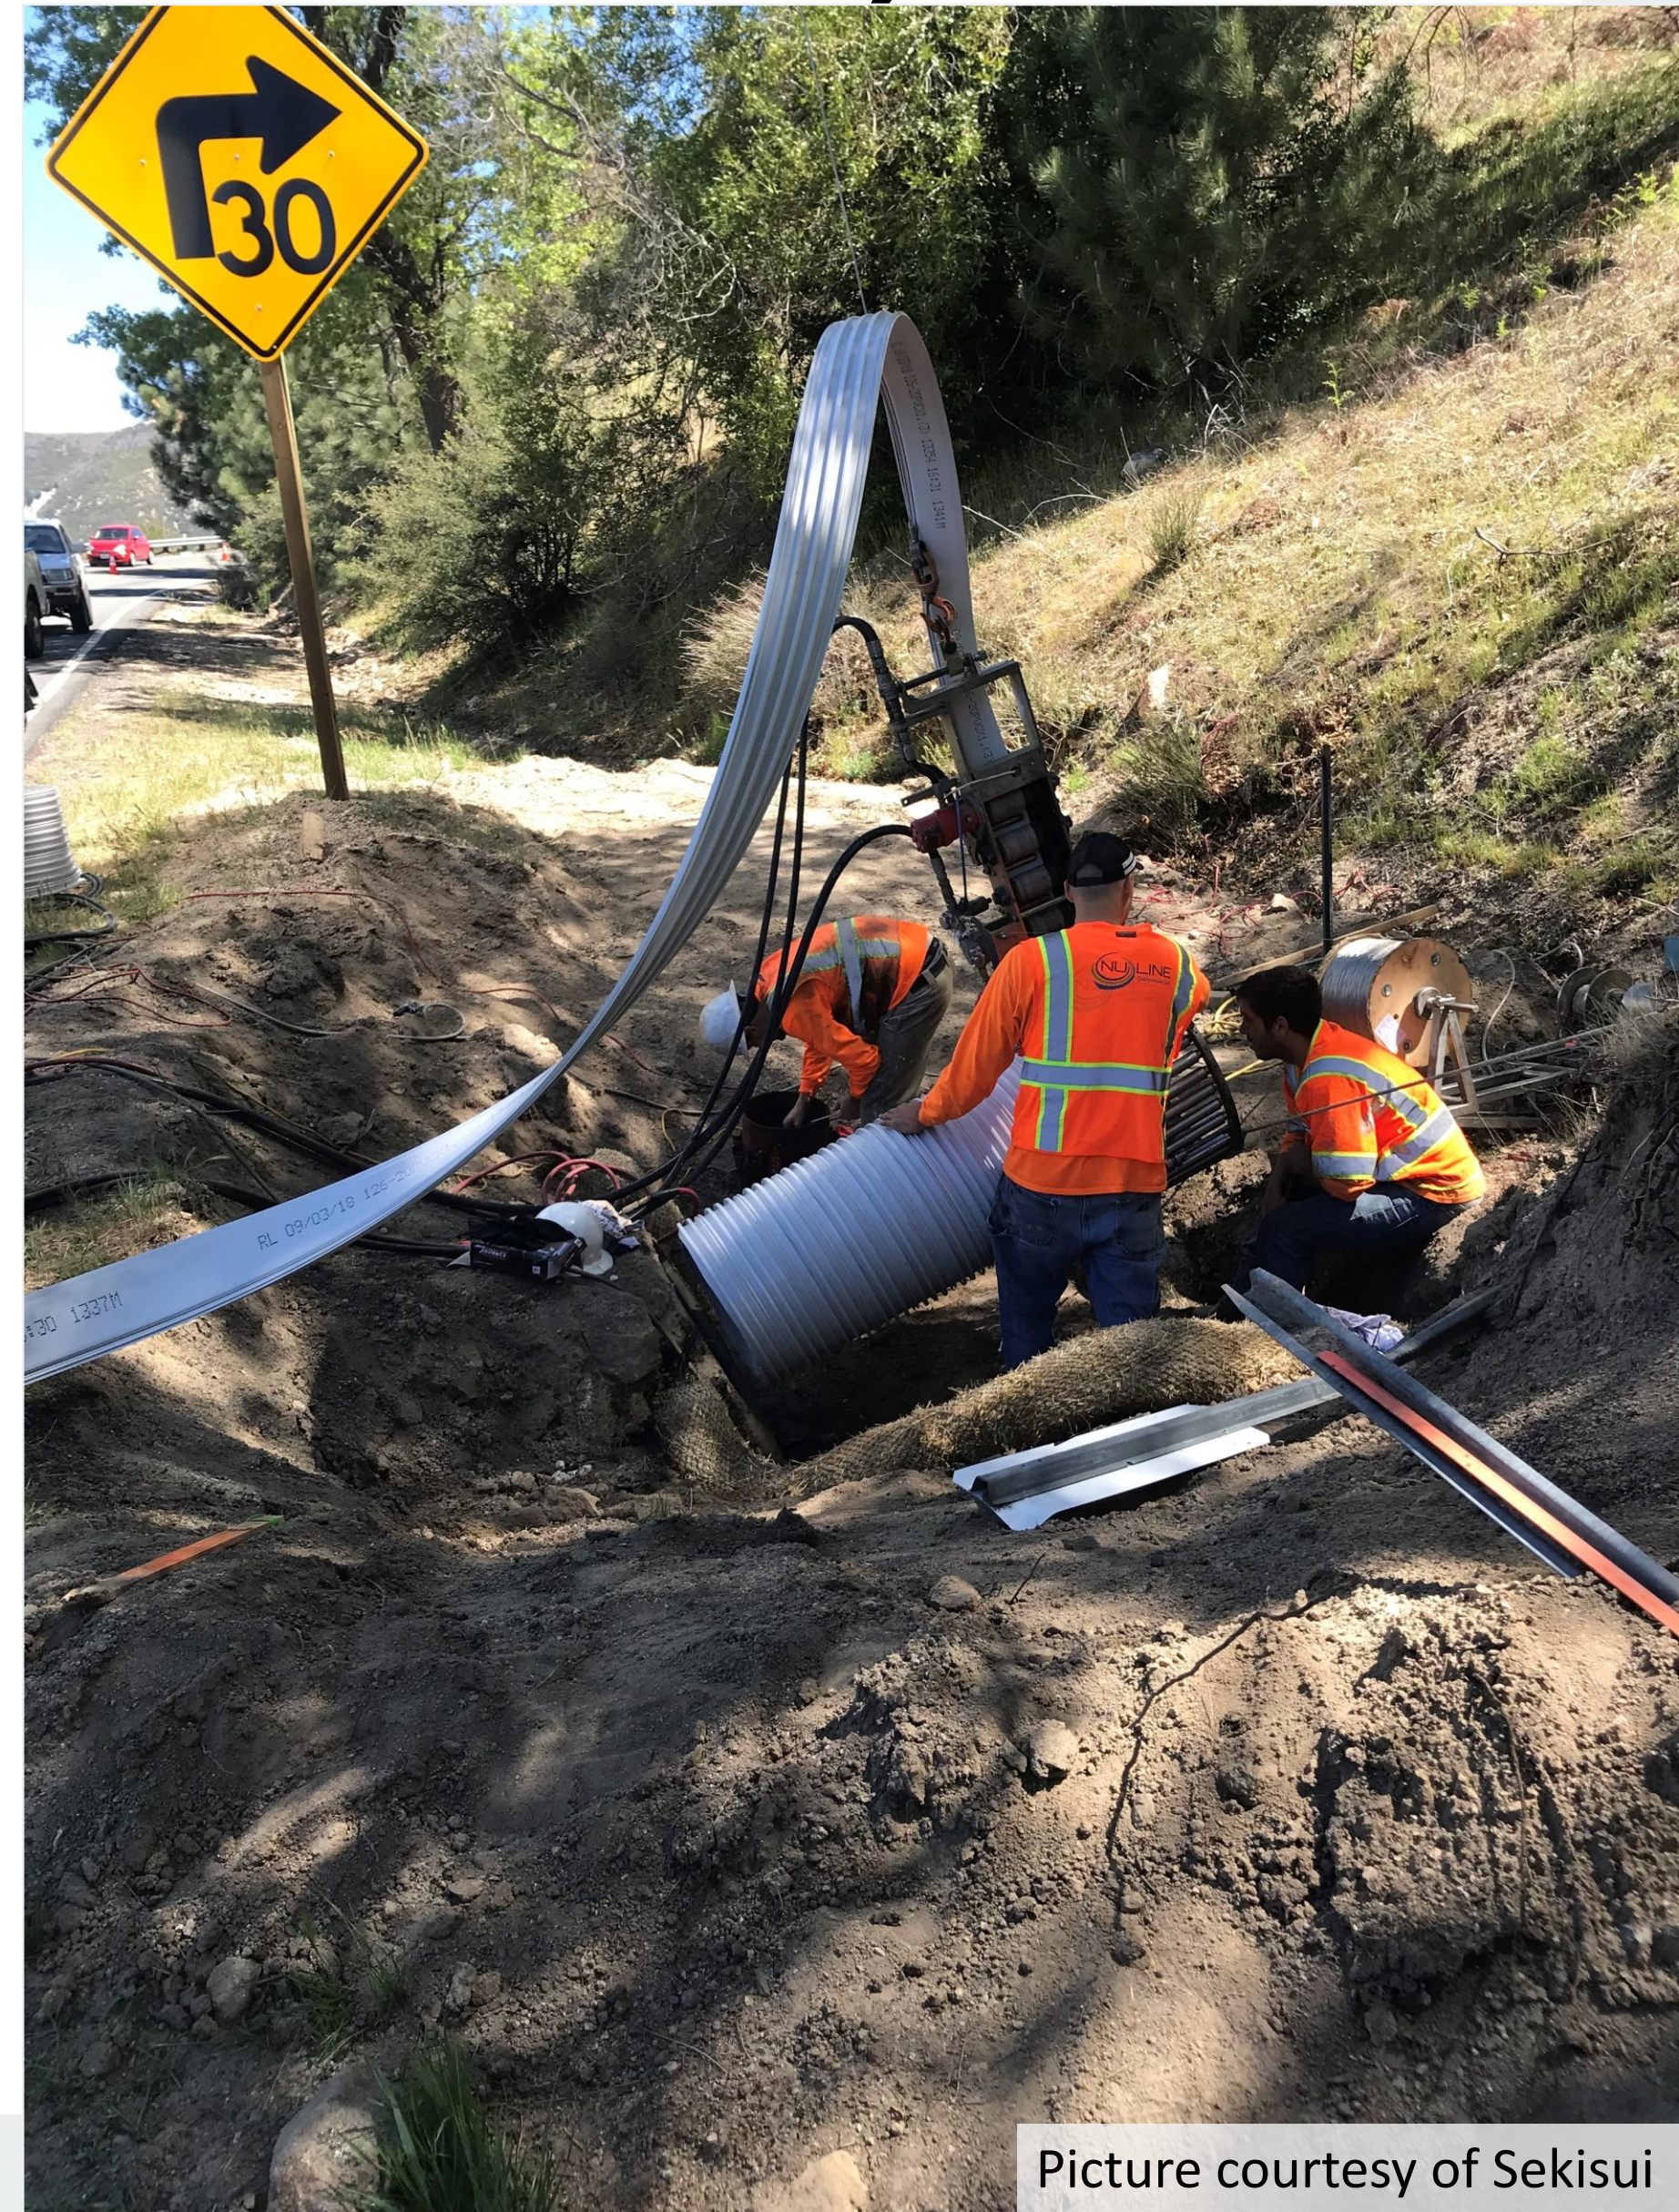
## METHOD: SPIRAL WOUND LINING

- Northridge Earthquake in 1994 damaged sewer pipelines throughout the city
- City received \$78M from FEMA to perform repairs.
- Spiral Wound Pipe was used for a majority of the small diameter pipes < 48- inches
