# MULTI-SENSOR INSPECTIONS

**National Plant Services, Inc., a Carylon Company**

- WATER MAIN/FORCE MAIN TECHNOLOGIES
  - Live CCTV and Acoustic
  - Electromagnetic
- SEWER/STORM MULTI-SENSOR INSPECTIONS
  - HDCCTV
  - Laser
    - Lidar
    - Ring Lasers
  - Sonar

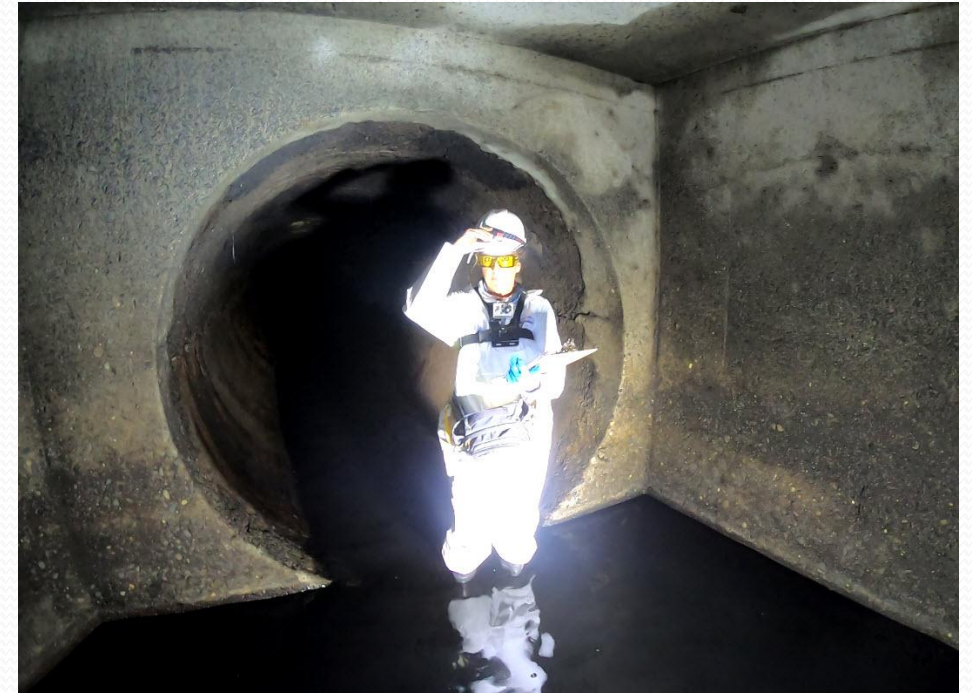
***GOOD OLD FASHIONED PIPE  
WALKS WORK AS WELL! MICHELLE  
WALKING A 84" COMBINED SEWER***

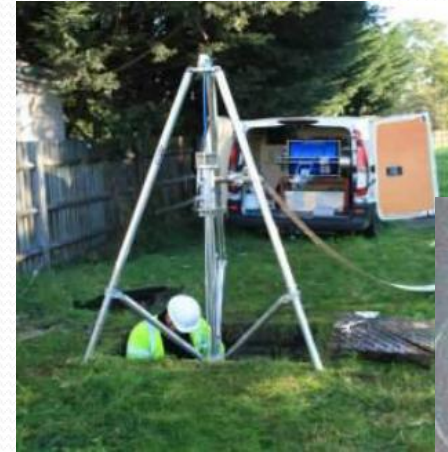
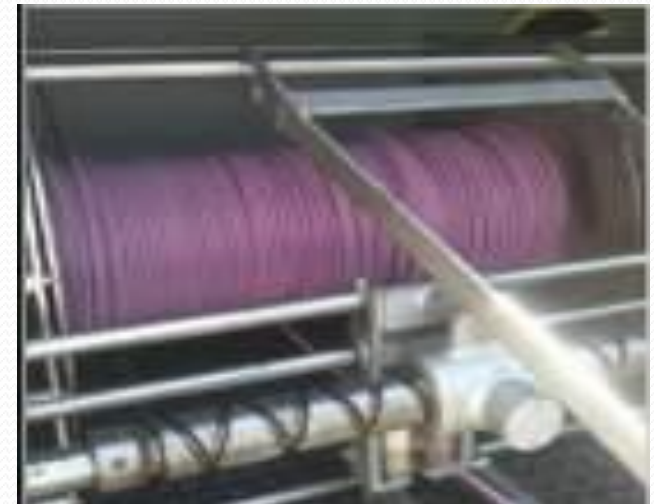
# JD7 LDS 1000<sup>©</sup>

- 12" and greater pipe diameter (all pipe materials)
- Access: ARV, hot tap, gate valve, pigging wye
- **HD quality CCTV and footage**
- **Acoustic leak detection**
- **Sonde for locating**
- **3,300' in a single deployment (neutral buoyant cable)**
- Up to 250 psi
- Real-time observations in the field

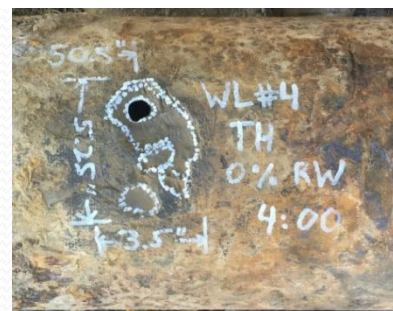
Reported: 3% Remaining  
Actual: 0% Remaining

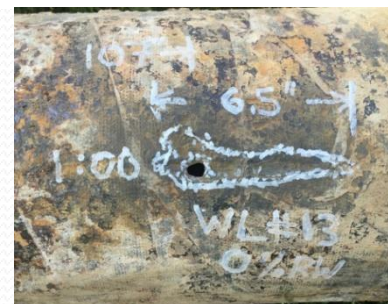
Reported: 0% Remaining  
Actual: 0% Remaining

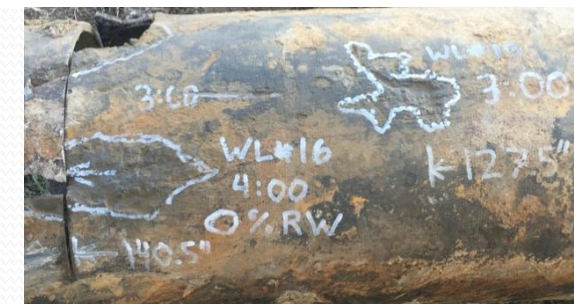
Reported: 0% and 10% Remaining  
Actual: 0% and ~10% Remaining

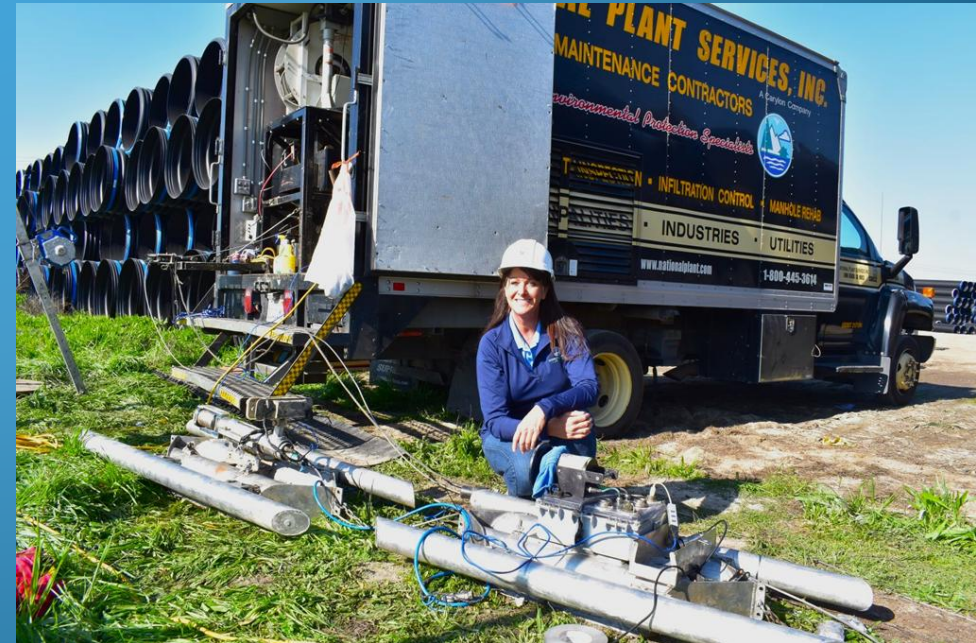
# CARYLON 3D MSI SYSTEM

HDCCTV, LIDAR, SONAR IN ONE INSPECTION PASS

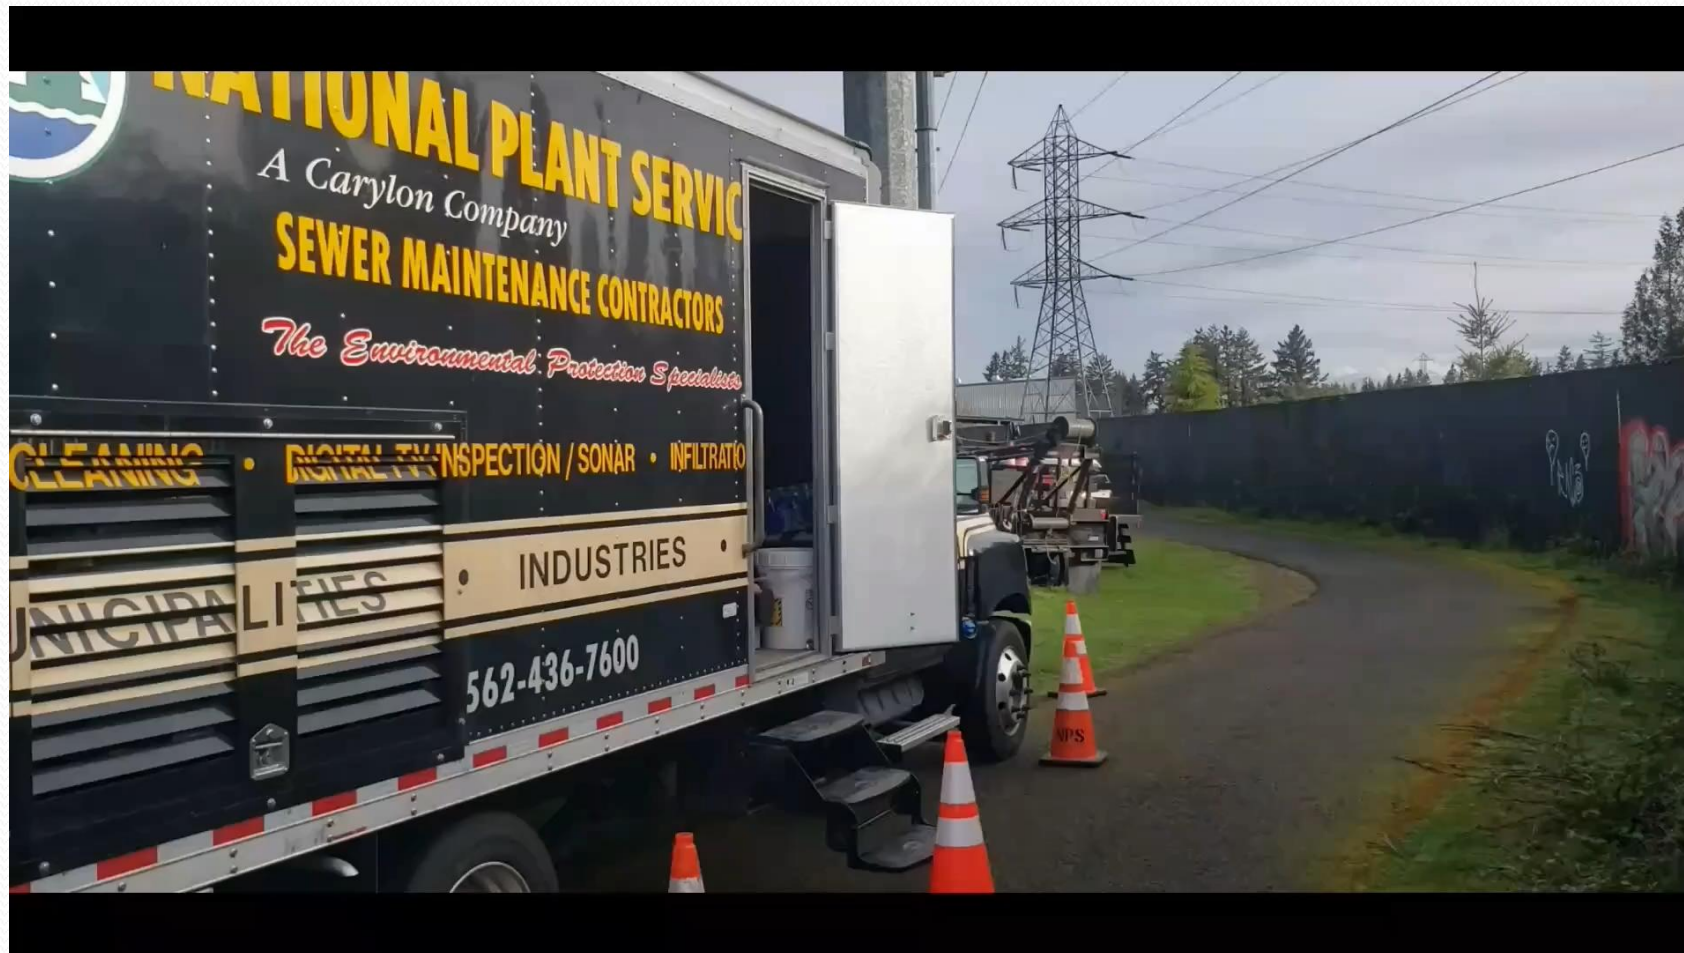
# CARYLON 3D MSI SYSTEM

## HDCCTV/LIDAR/SONAR + GAS LOGGER

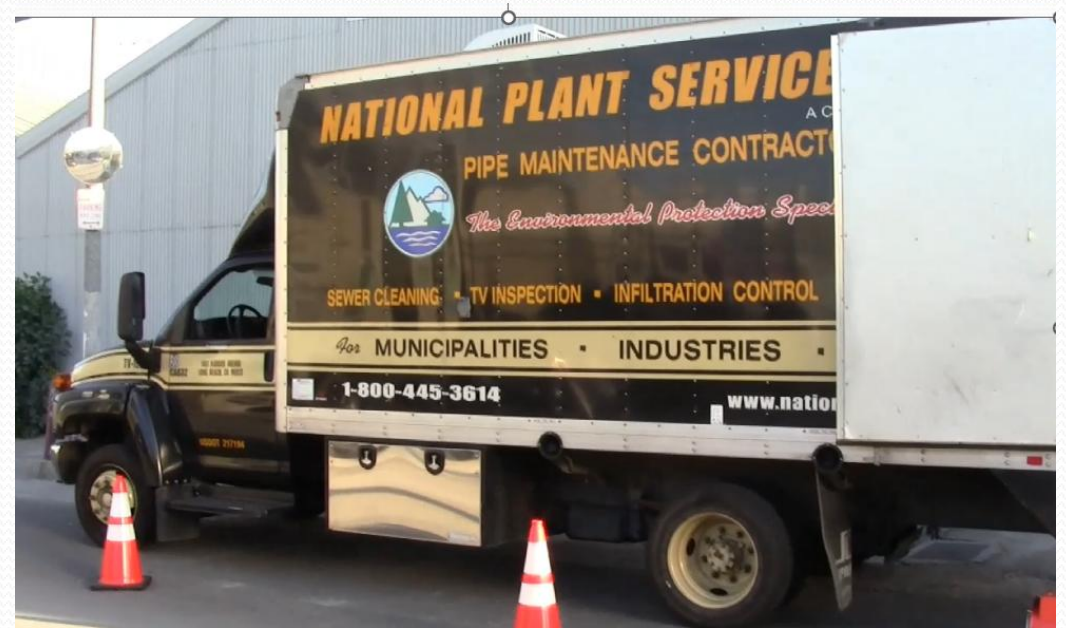
# CCTV

## INDUSTRY-WIDE HD CAMERA LIMITATIONS

- Cable length limitations
- Diameter limitations
- Have to purchase camera manufacturers truck, use their transports
- Lack of sufficient lighting

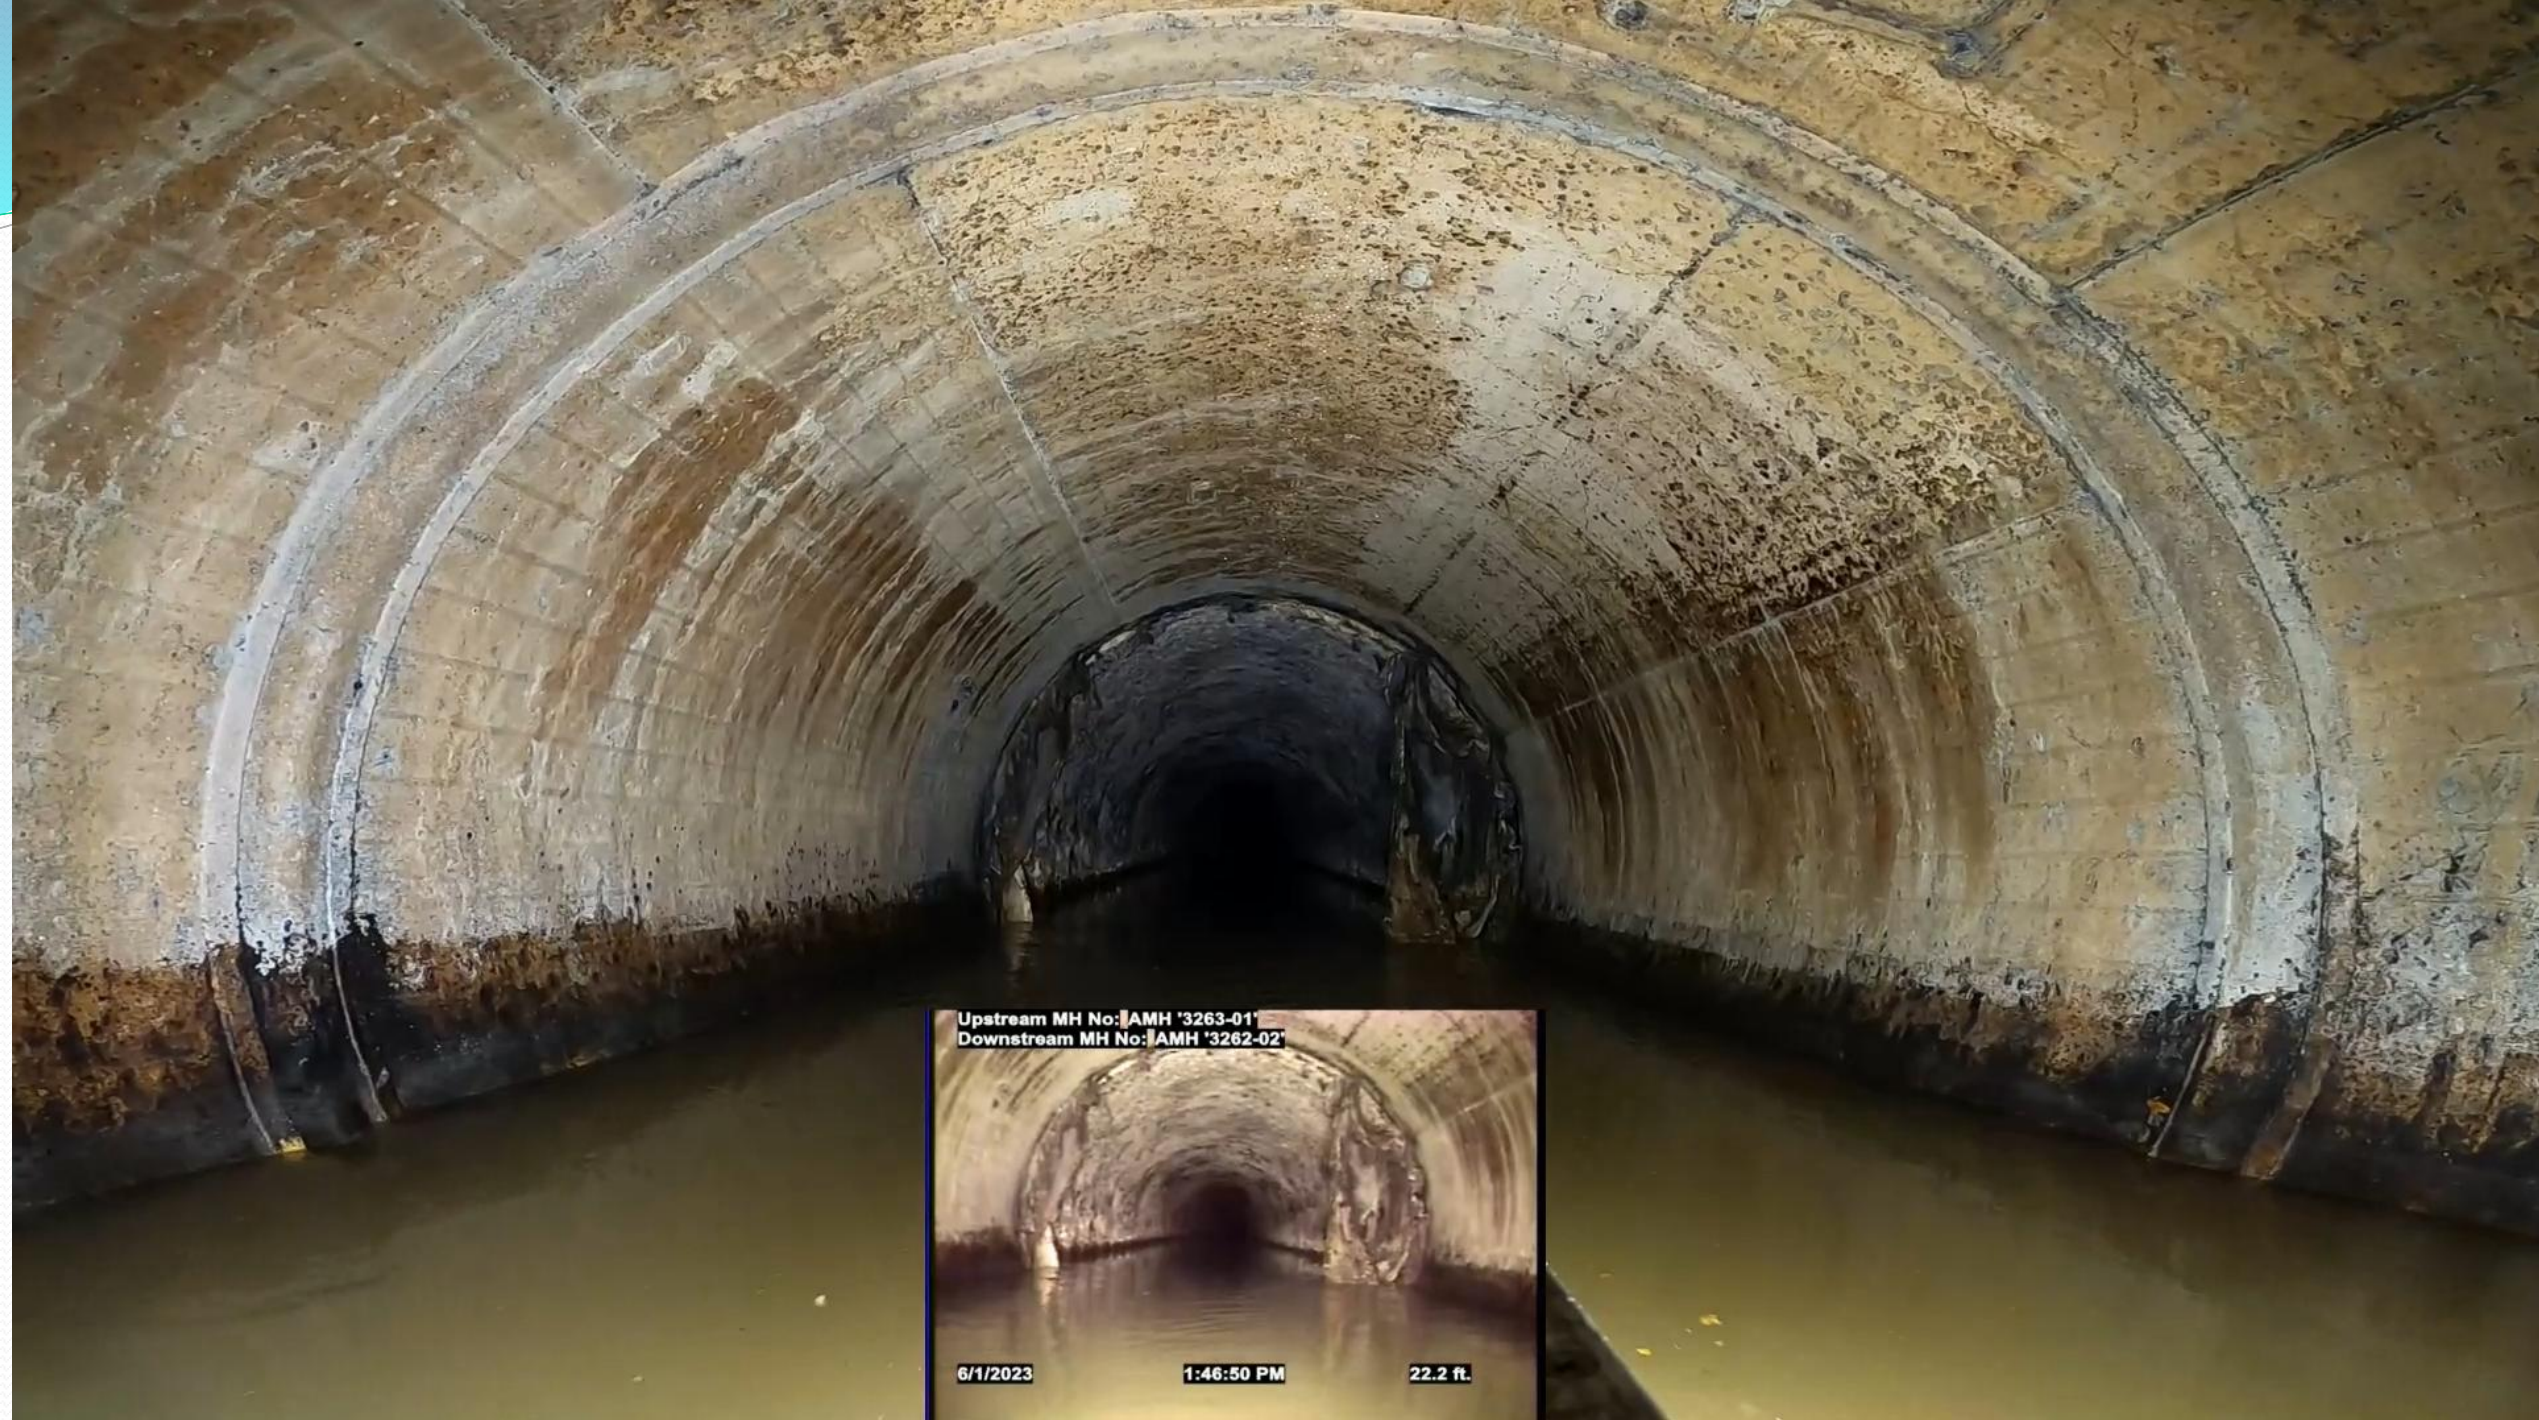
The high-definition video files are LARGE.

Files are over 39 gigs at full resolution, and now 4-7 gigs at the final merged video

Upstream MH No: [AMH '3263-01']  
Downstream MH No: [AMH '3262-02']

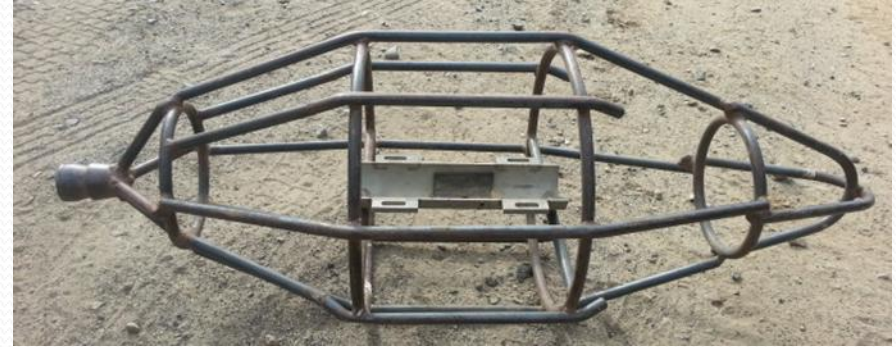
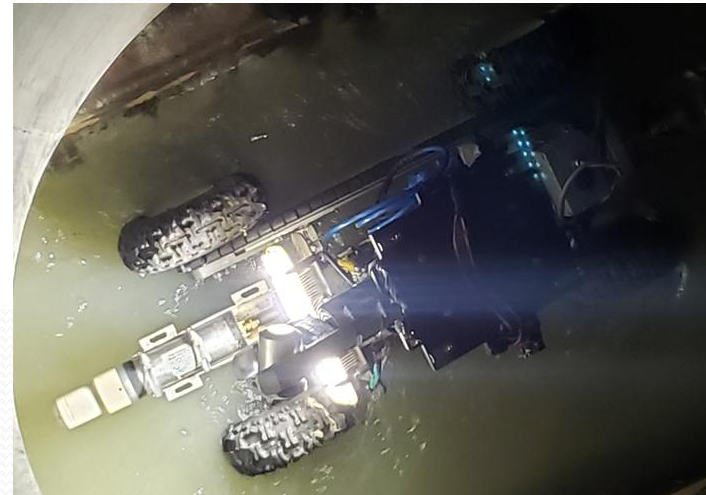
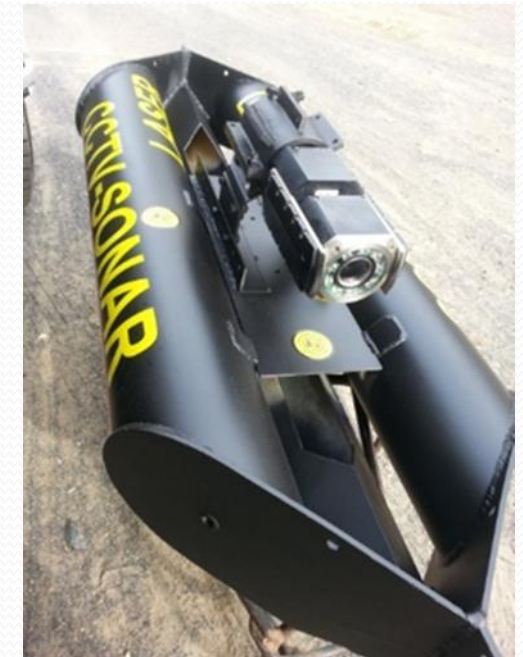
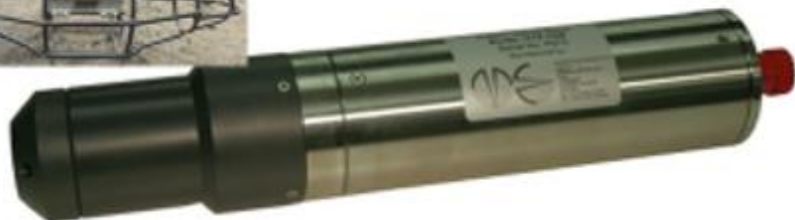
# Sonar

- Continuous Acoustic scanning
- 360 degrees per second.
- Used to determine inside dimensions and changes in pipe shape and size, and to quantify the amount of debris in the pipe.
- Accuracy from  $\frac{1}{4}$ " to  $\frac{1}{2}$ "
- Inspects pipelines from 8" to 108" diameter.

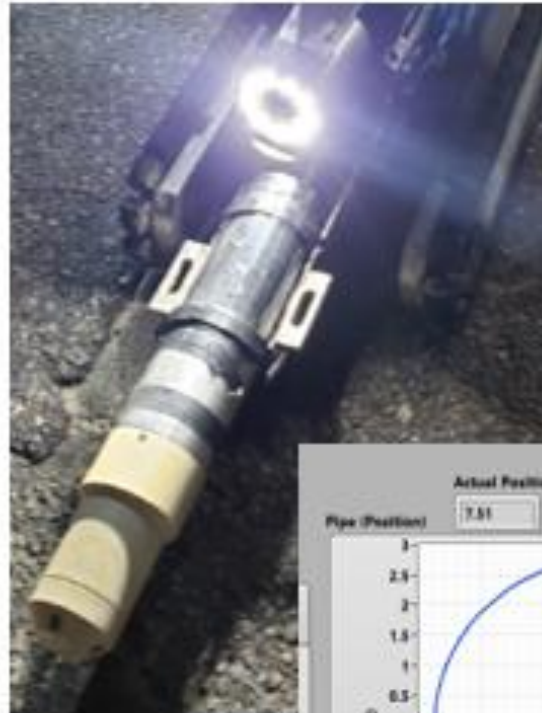
Sonar only works under the water line, and it has to be submerged under water with space between the sonar head and pipe bottom or debris. Turbulent flow, dragging in debris, or ragging will also prevent delivery of sonar scans.

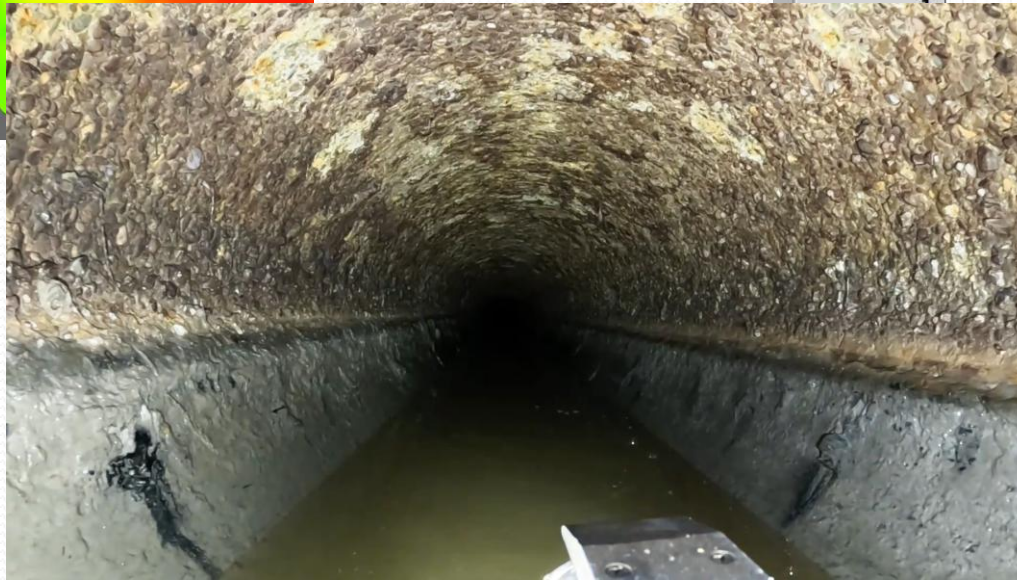
# The normal adjustable color ramp can be boring!

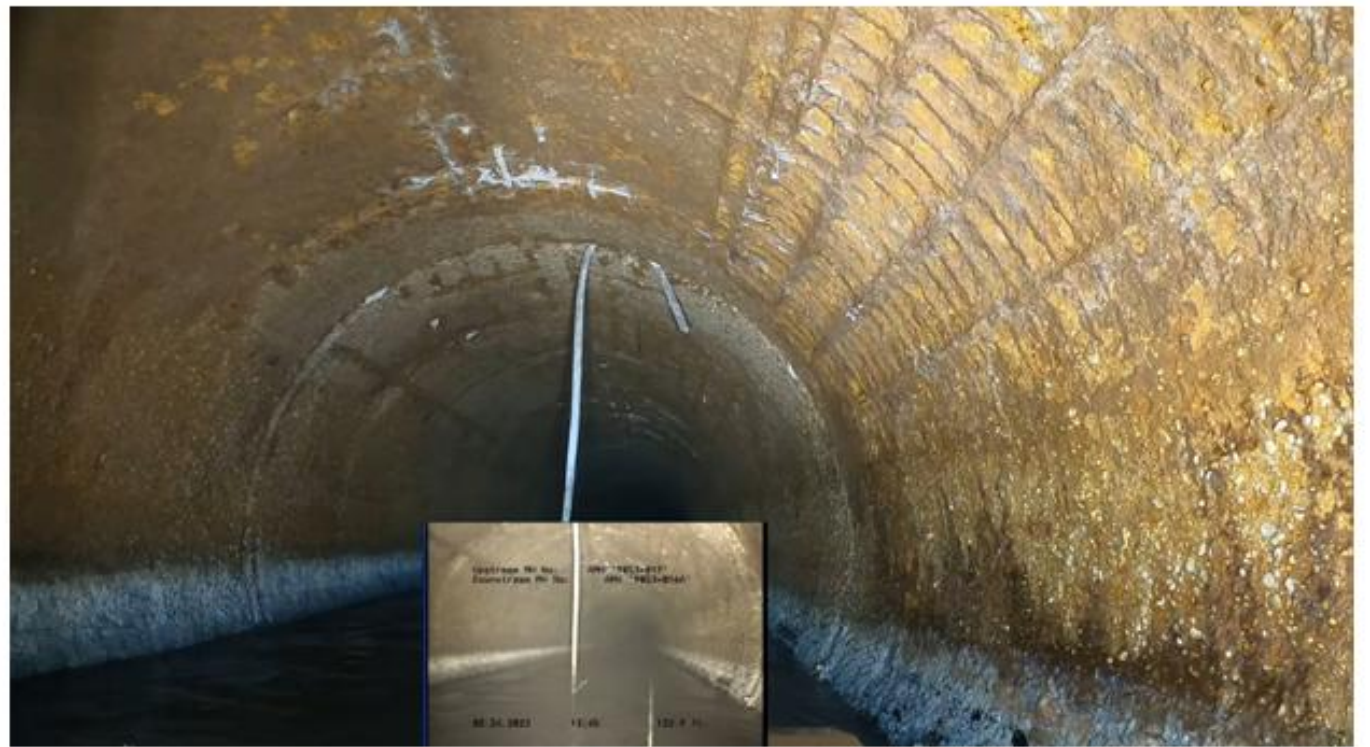
# Wider Color Ramp Improves Definition

**THE WAFFLE  
PATTERN OF THE  
REBAR IS CLEARLY  
VISIBLE**

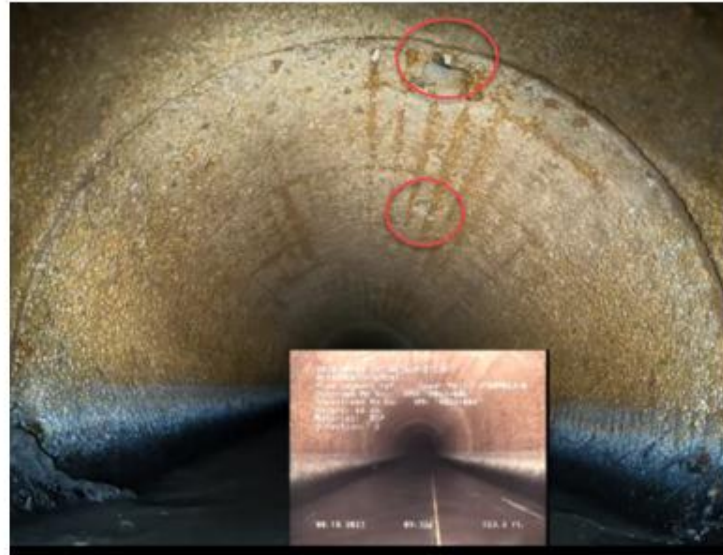
Laser readings indicate corrosion OR measurements outside reference circle.

Will shoot up tap connections

| SCANS 157 AND 160 WERE DELETED FROM AVERAGES ABOVE DUE TO HIGH VALUES CAUSED BY INCOMING TAP/LATERALS. | | | | | |

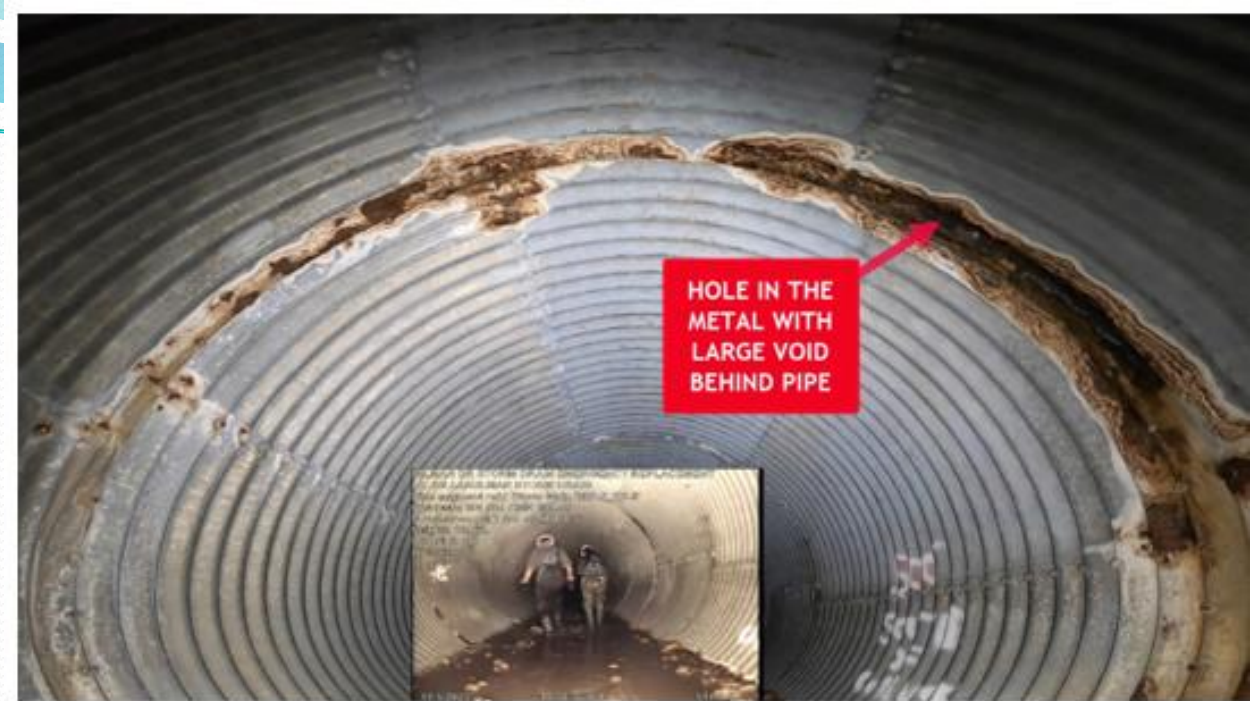
## CMP Storm Drain CCTV/Lidar Inspection

# THE LASER CAN FIND HOLES TOO!

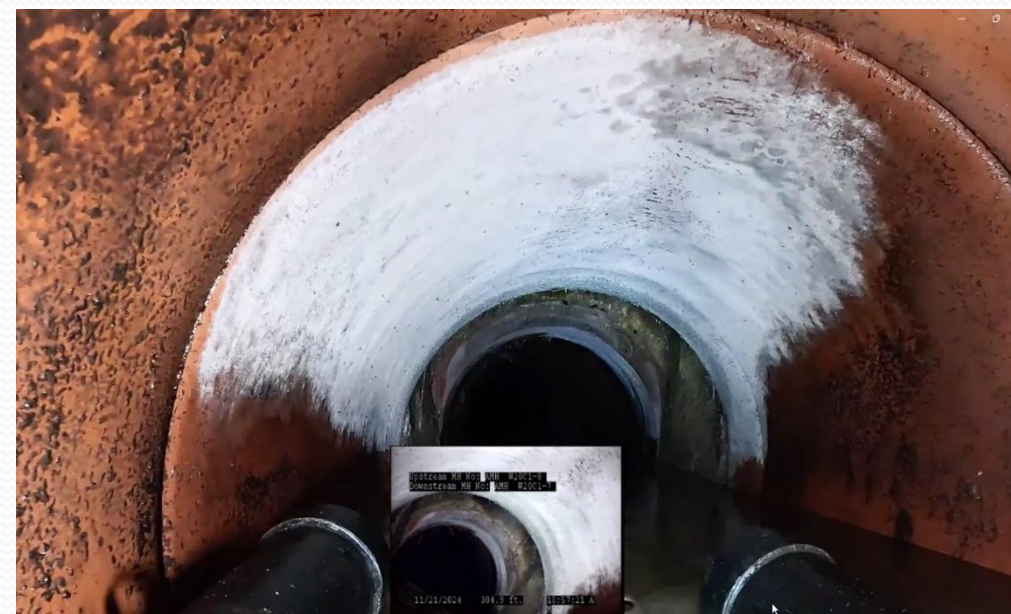
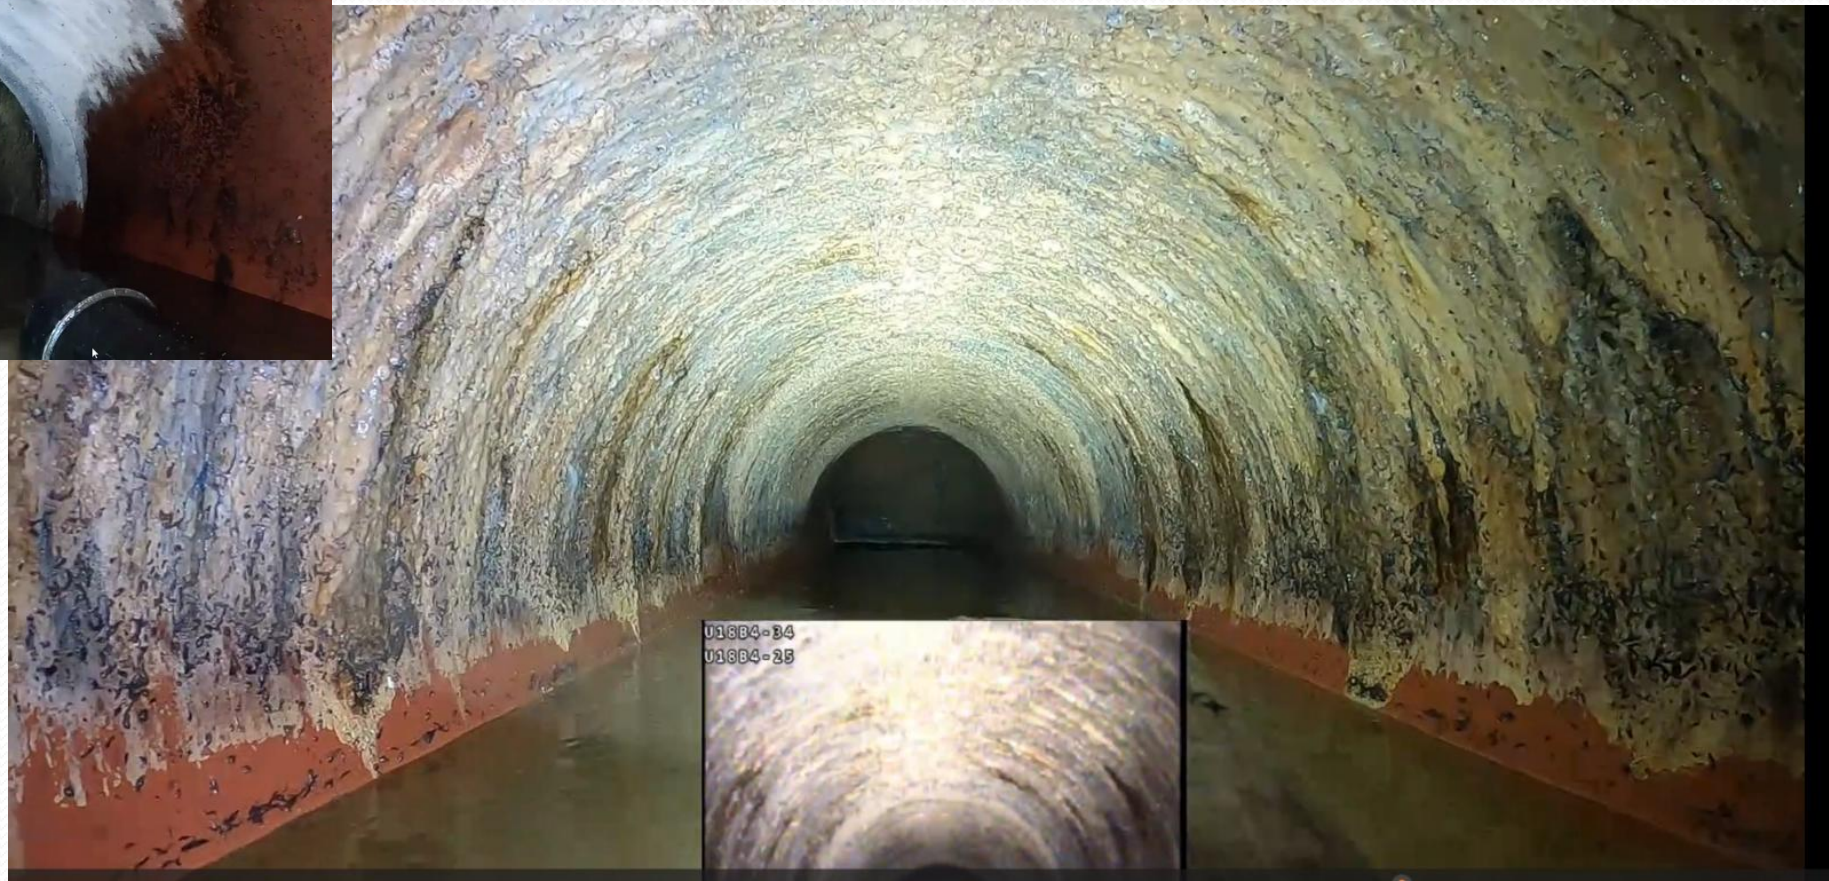
# VCP PIPE CAN CORRODE TOO!

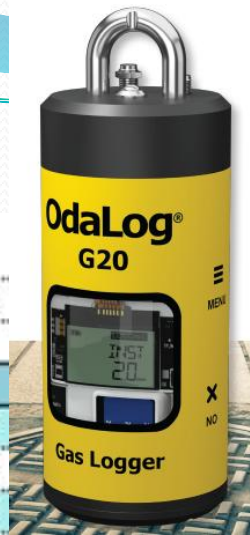
# GAS LOGGERS

**HIGHEST H<sub>2</sub>S READINGS  
WERE AT JUNCTION TO  
THE FORCE MAIN**

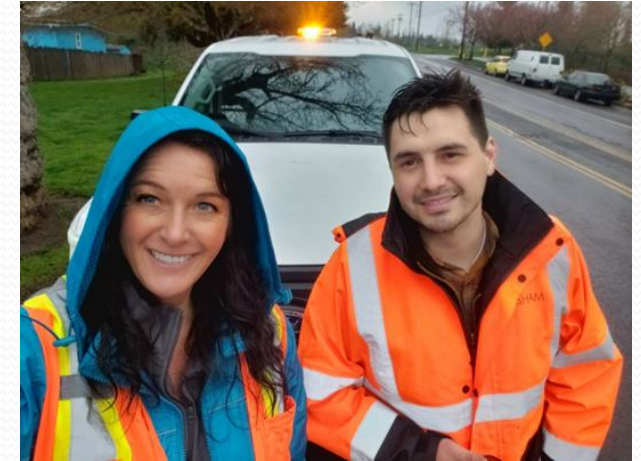
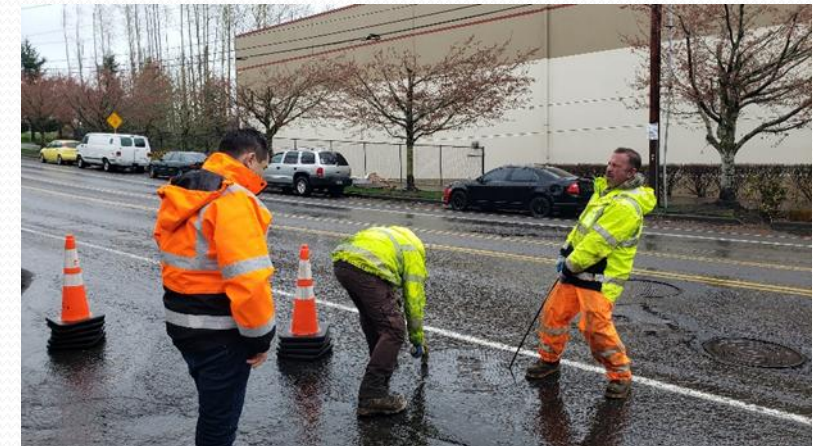
# CONDITIONS TO WATCH FOR DURING PLANNING/SITE RECON:

- Bends in the pipe alignment can stop an inspection
- Obstructions in manholes/pipes
- High pressure/high flow tie-ins that may stop an inspection
- High traffic areas that can slow production and increase TC costs
- Select continuous pipe runs to maximize daily footage production
- Is flow too turbulent for Lidar?

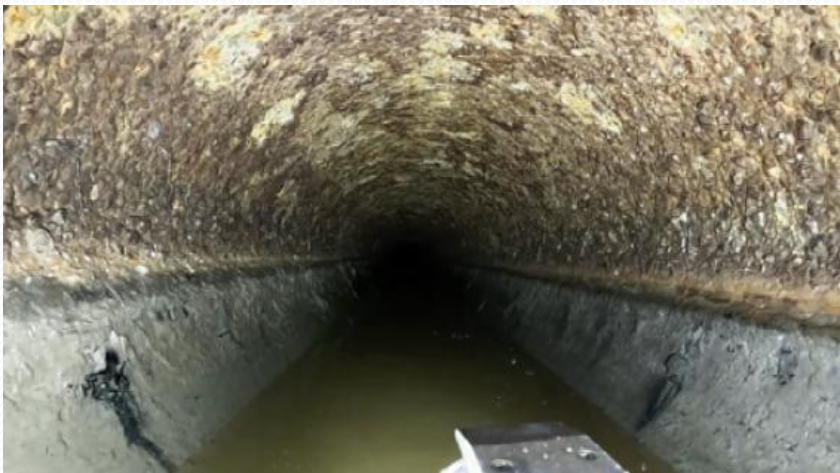
1. COMPARE TV  
AND PACP  
SCORES AGAINST  
LASER DATA
